**An Analytical Investigation of Transverse Joints in Precast-Panel Bridge-Deck
Replacement Systems**

A Thesis submitted to the Graduate Faculty of
Auburn University
in partial fulfillment of the
requirements for the Degree of
Master of Science

Auburn, Alabama
December 8, 2012

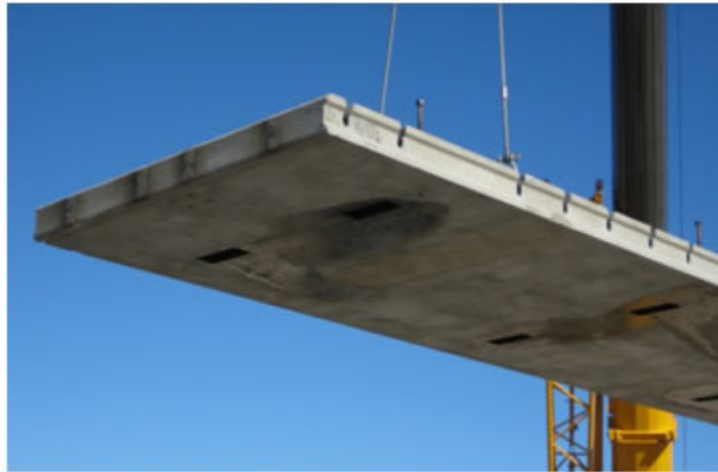
Figure 1.3: Typical Full-Depth Precast Panel (Culmo 2000)

By following these directives, effort was devoted to two deck replacement options: exodermic fully precast and full-depth precast concrete panels (Figures 1.2 and 1.3). Both of these panel systems meet the listed requirements above, and they both have a variety of transverse panel joint connection options.

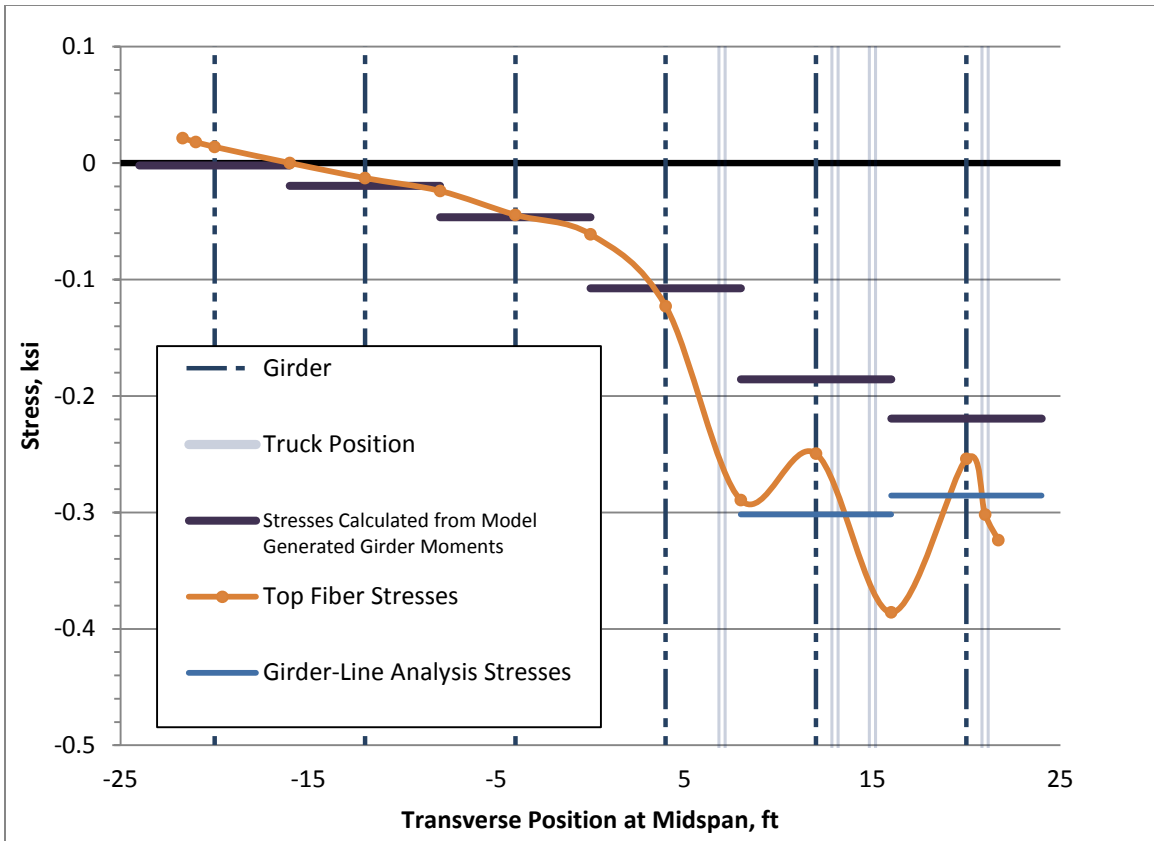
Figure 3.3: Top Fiber Stress Comparisons at Midspan (Simple Span Bridge)

After having located the critical transverse cross section(s) in each bridge, a step-by-step analysis was conducted to determine the locations of the trucks causing the maximum stresses in the deck. A step-by-step analysis involves specifying a truck to cross the bridge at a certain transverse point, and with a certain number of discretization points. Choosing a discretization of every 3 inches, this process essentially moved the fatigue truck across the bridge, recording element data for the entire bridge every 3 inches that the truck progressed. Having determined a critical longitudinal location, the transverse location of the truck needed to be determined. In order to determine this transverse location for an extreme loading scenario, the fatigue truck was run across the bridge repeatedly, each time moving transversely by 1 ft. Figure 3.4 and 3.5 illustrate the transverse movement of the truck from position TR-0 to TR-18.

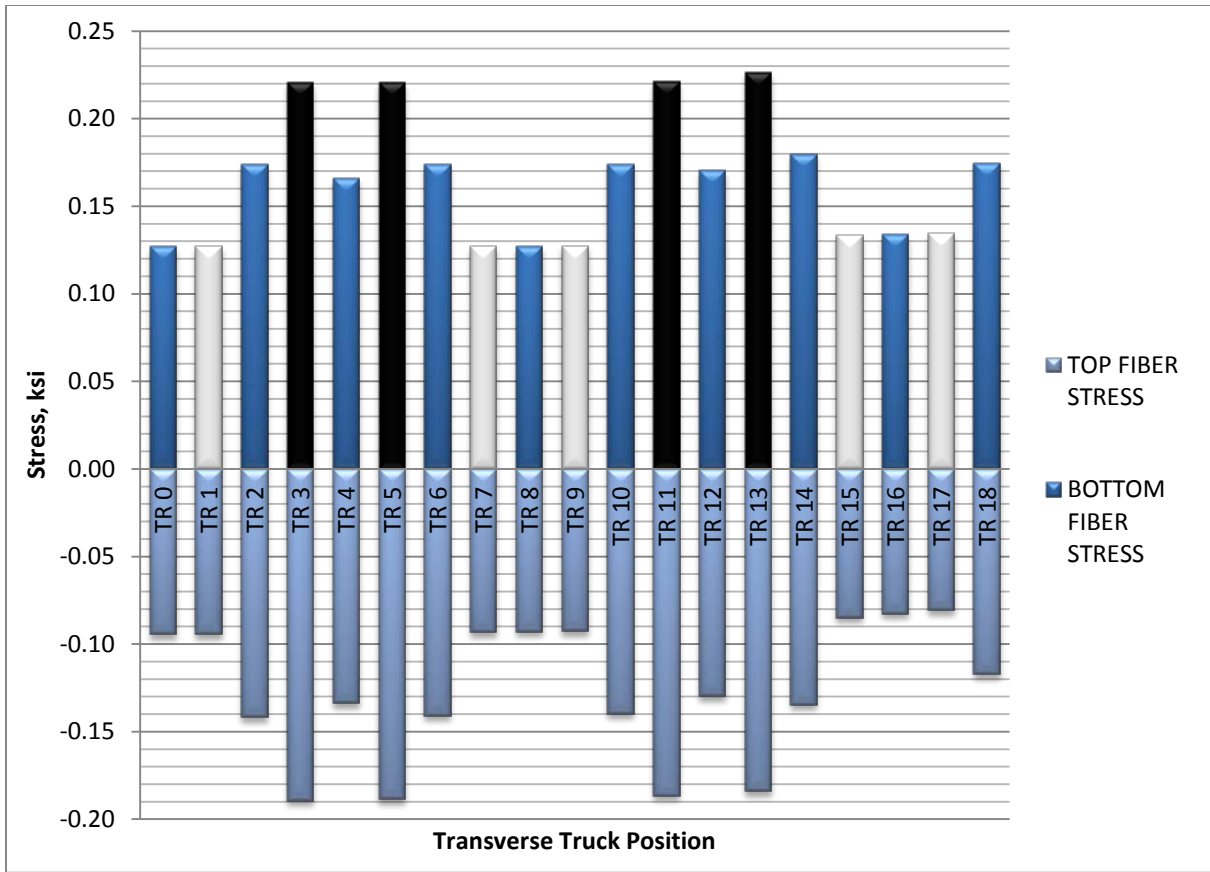
Figure 4.4: Maximum Stresses per Transverse Position due to Positive Flexure (60-80-60 Bridge)

From this extreme positive-flexure stress loading, Figure 4.4 summarizes the values generated by the SAP2000 model. This graph represents the greatest stresses normal to a transverse deck joint for each transverse truck position at the critical longitudinal location. It can be seen from Figure 4.4 that the higher stresses are reached when the truck is positioned at transverse positions TR-3, 5, 11, and 13. These loadings are seen in black in the figure, and they represent trucks having either their left or right side wheels located on the deck exactly between two lines of girders (Figure 4.5). Conversely, the smallest stresses occur when half of the truck loading was located directly above a girder, as seen in truck positions TR-1, 7, 9, 15, and 17. Figure 4.6 illustrates this loading of the girder. It can be seen from Figure 4.4 that the stresses in the panels showed a decreasing trend, as truck tires were moved from the middle between girders to on top of the girders. Furthermore, stresses increased as the truck position was moved into the extreme transverse position at the edge of the bridge roadway. These results show that the extreme case for positive-flexure stress across a transverse joint occurs when a set of wheel loads is placed midway between girder lines.

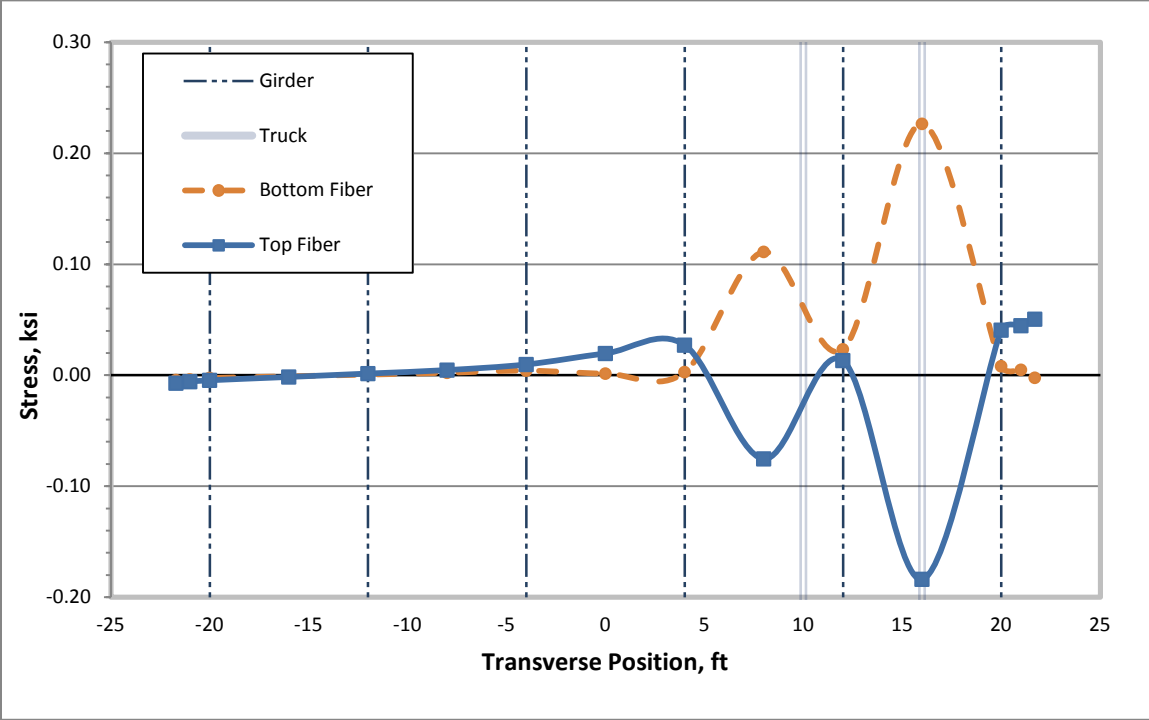
Figure 4.7: Deck Stresses due to TR-13 at Critical Location 2 (60-80-60 Bridge)

girders, and they also show how the force effects due to truck loading are largely localized at the location of the wheels. The localized high stresses normal to a transverse deck joint from truck loading dissipate significantly after the deck panel crosses over a girder support.

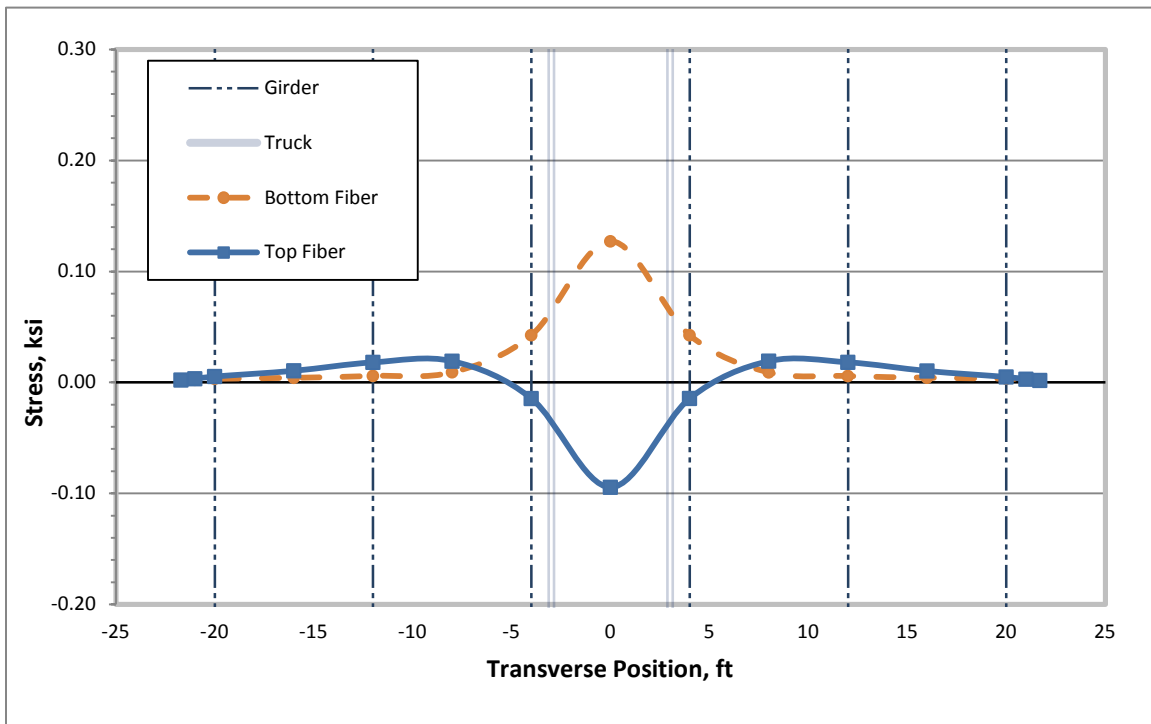
Figure 4.9: Deck Stresses due to TR-0 at Critical Location 2 (60-80-60 Bridge)

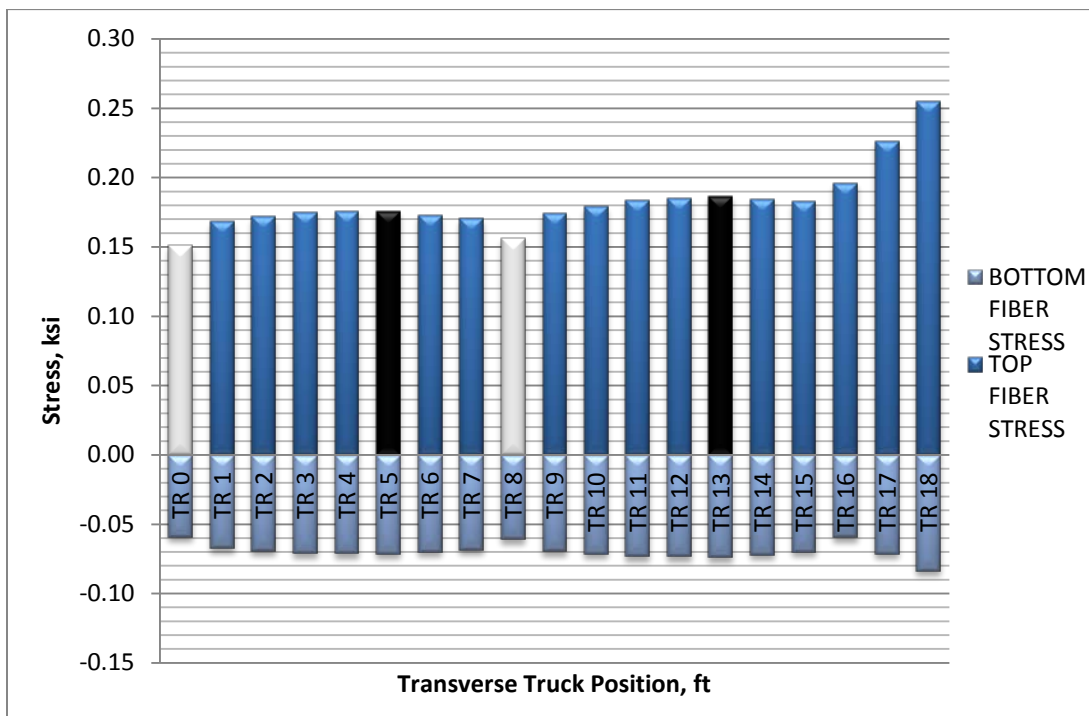
Figure 4.12: Maximum Stresses per Transverse Position due to Negative Flexure (60-80-60 Bridge)

The maximum tensile stresses found for each transverse truck position can be seen in Figure 4.12 and Table 4.3. As the trucks moved towards the outer eastern edge of the bridge, top

fiber tensile stresses increased. The general trend followed the same pattern as for the extreme positive-flexure stress case; truck positions centered directly over or within a foot of the girder created the highest interior deck stresses. Correspondingly, stresses were lowest at TR-0 and TR-8, as the trucks were centered over the midpoint between the girders, thus placing their tires near portions of the panel directly above the girders. The difference between this case and the positive-flexure stress scenario is that these transverse truck positions caused higher tensile stresses in the deck directly above the girder, as opposed to in between girders. This is because the deck is acting as a tension flange for composite girder bending at these locations. The negative-flexure stresses in the deck were critical at these above girder locations. Another difference in the extreme negative-flexure stress case was that the edge of the deck experienced the highest tensile stresses, with tensile stresses growing rapidly as the truck was moved to the exterior most position TR-18.

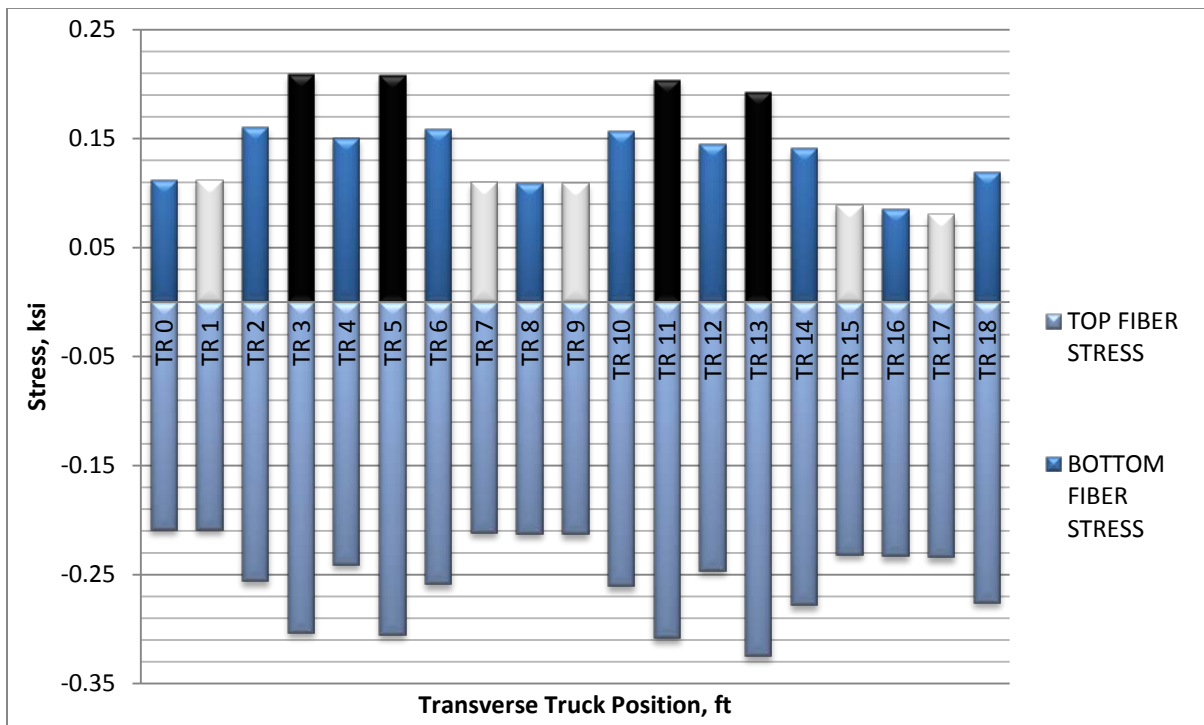
Figure 4.26: Maximum Stresses per Transverse Position due to Positive Flexure (Simple Span Bridge)

for the Collinsville Bridge coincides with the critical compressive location. The critical truck location is located at TR-3, which is somewhat consistent with other data, as this position loads the center between two girders at position 0. Additionally, since the span of this bridge is only 56 ft 10 in., trucks with 14' rear axle spacing were run to determine the amount of stress increase expected. The results showed a negligible increase of less than 1 percent in most cases. It should also be noted that when this bridge is loaded on the eastern edge, a small tensile force is created on the other edge in the bottom and top fibers (Figures 4.27 and 4.28). This tensile stress is well below the modulus of rupture, but could pose durability issues in a joint. Furthermore, joint shear forces were of the same magnitude as for the positive-flexure stress case of the continuous span bridges, and well within limits.
