**Performance Evaluation of Sediment Control Practices**

Brian Gerald Roche

A thesis submitted to the Graduate Faculty of  
Auburn University  
in partial fulfillment of the  
requirements for the Degree of  
Master of Science

Keywords: Sediment Control, Vegetated Buffers, Sediment Barriers

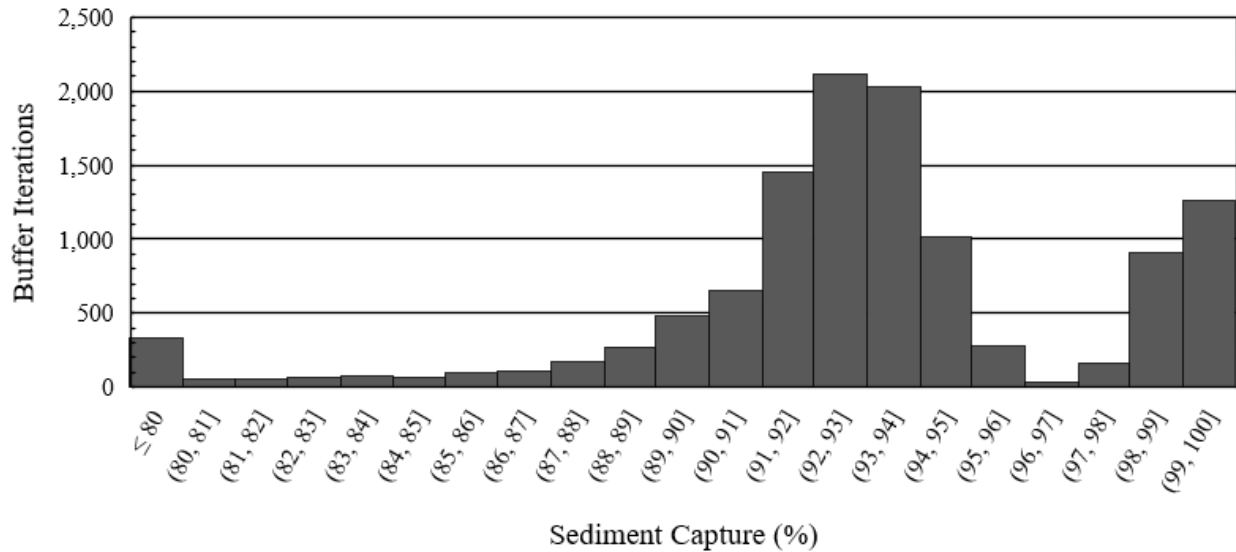
(a) histogram of buffer iterations

(b) box plot of buffer iterations

The distribution of all buffer iterations modeled is shown in Figure 2.4. The spread of performance of buffer iterations indicates that half of the buffers modeled captured between 91 and 93% of introduced sediment. The spread suggests a normal distribution for many of the buffers; however, a second peak of capture values is apparent between 98 and 100% of sediment capture, which represents buffers with sandy soils. At approximately 90% sediment capture, there is a drop-off of buffer iterations; only 13.8% of modeled buffers captured under 90% of introduced sediment.

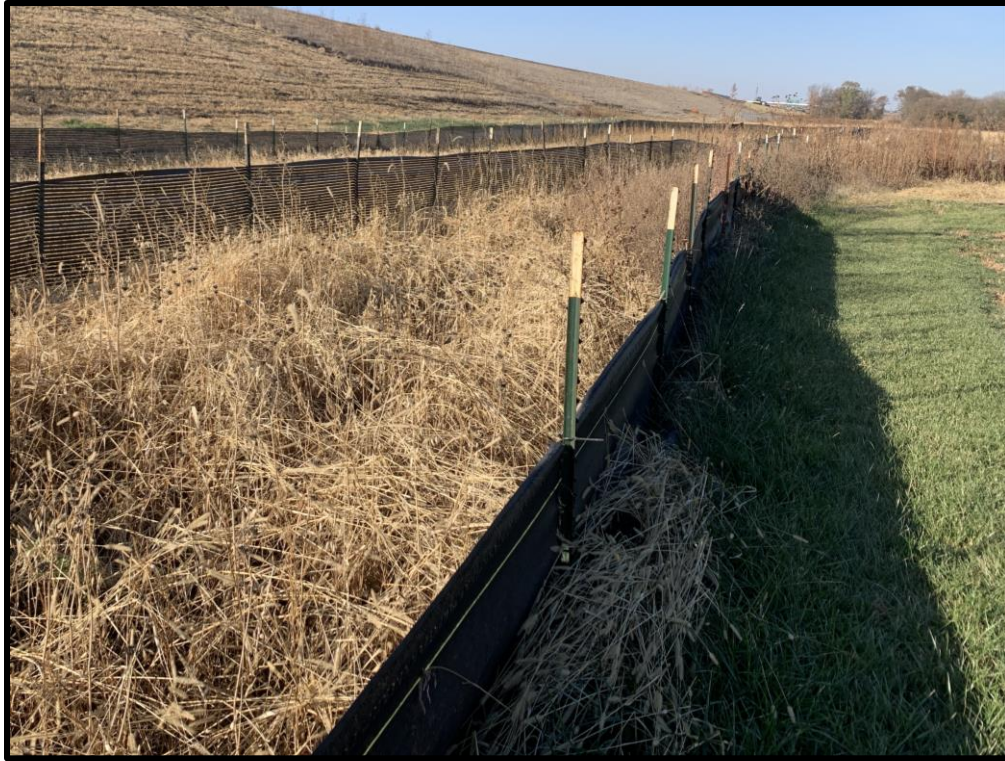
**Figure 3.1 Nebraska DOT Silt Fence Installation**

Silt fences are composed of a geotextile fabric attached to posts; geotextile fabric, means of attachment, and post material can vary. The purpose of silt fence installations is to intercept sediment-laden stormwater runoff and form impoundment to facilitate sedimentation to keep eroded soil on site and prevent pollution of natural water bodies and municipal stormwater systems. Silt fence is typically installed at the toes of slopes and on the perimeter of sites; long runs of fence often include j-hooks to allow for more storage area of impoundment and sediment. Installation is completed by trenching the fabric in manually or using a slicing machine to insert the fabric into the ground (USEPA 2021a). Figure 3.1 shows a silt fence installation on a Nebraska DOT highway project.

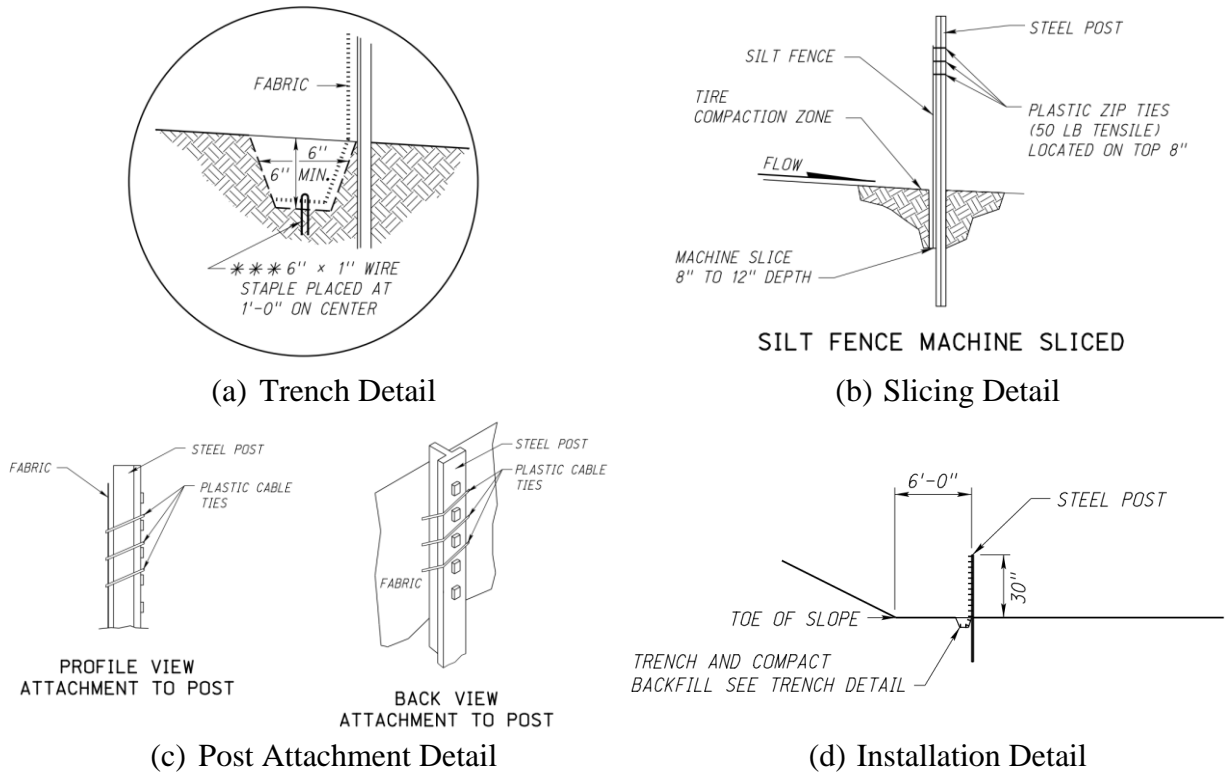
**Figure 3.2 Nebraska DOT Silt Fence Installation Details**

t-posts must be at least 1.25 lb/ft (1.86 kg/m) and spaced at most 6 ft (1.82 m) apart (Nebraska Department of Transportation 2017). Figure 3.2 shows installation diagrams for the Nebraska DOT standard silt fence installation (Nebraska Department of Transportation 2021a).

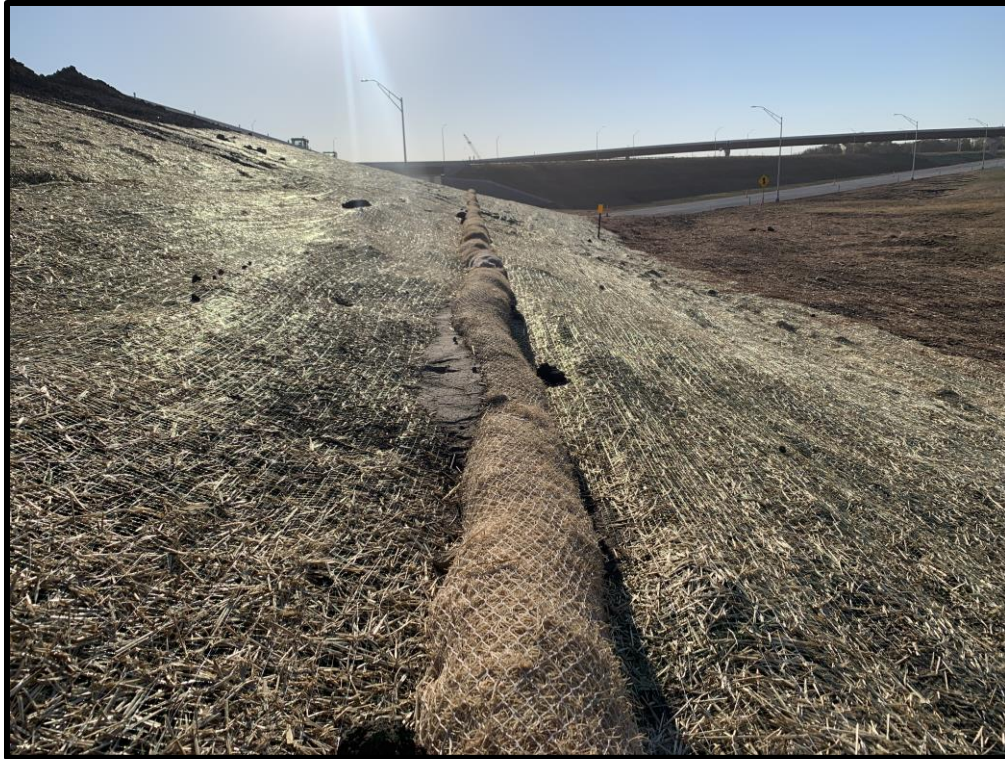
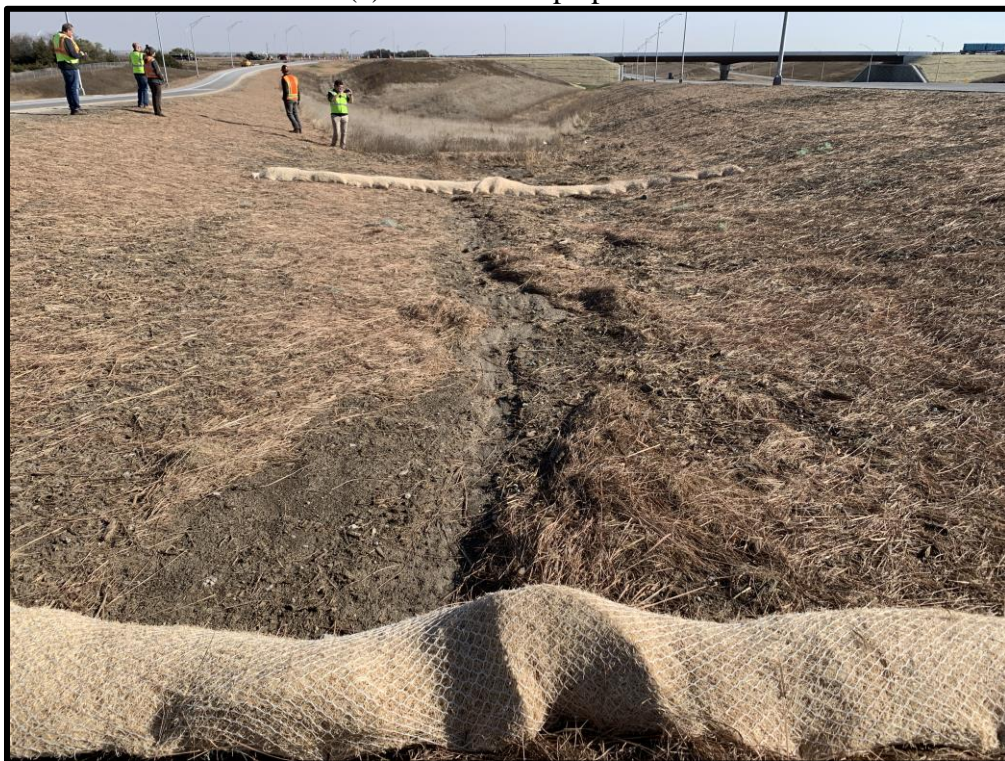
(a) wattle as slope protection

(b) wattles as ditch checks

Wattles, fiber logs, or other tubular sediment barriers are often used for velocity reduction on slopes and in channels but can also be used as perimeter control. The installation is composed of a netting material and a fill material; however, both the netting and the fill material can vary, leading to varying hydraulic performance based on the fill and netting material (Whitman et al. 2021b). Figure 3.3 shows two applications of tubular sediment barriers on a highway construction project as ditch checks and slope protection.

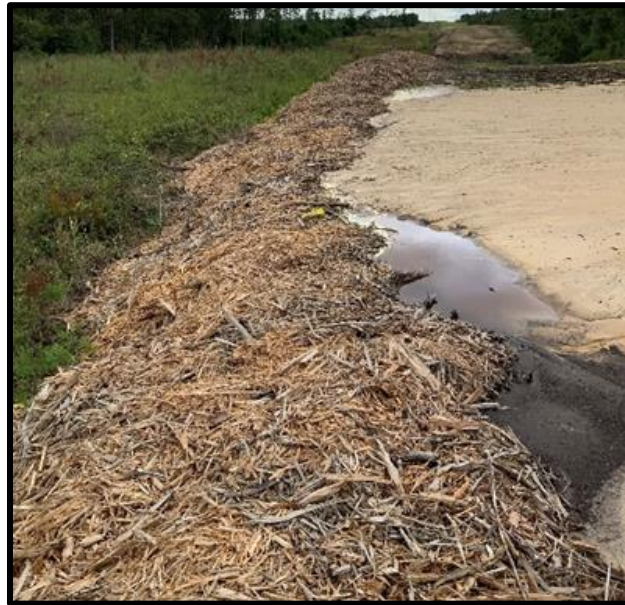
**Figure 3.5 Slash Mulch Berm Installation** (photo courtesy of Cliff Young 2021)

slash mulch berm installation on a construction project in Alabama and the sediment deposited upstream of the barrier.

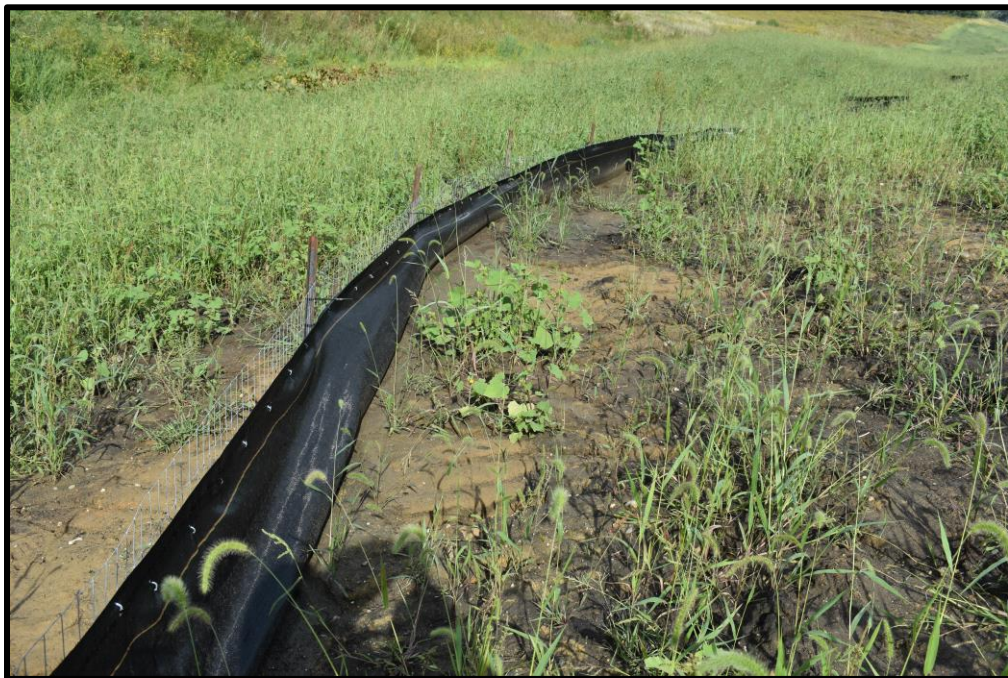
(a) Iowa standard silt fence installation experiencing excessive post deflection

(b) Reinforcement preventing post deflection

such as storm events and runoff differences for different installations of sediment barriers (Schussler et al. 2020).

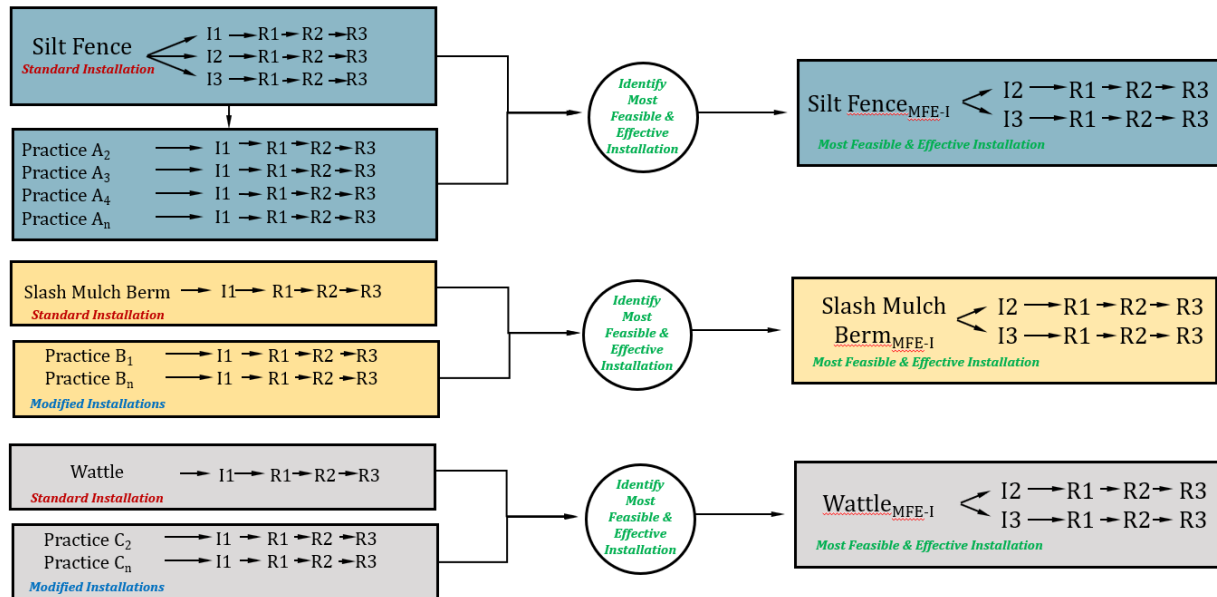
**Figure 3.11 Sediment Barrier Testing Regime**

MFE-I was selected that considers performance, installation difficulty and cost; testing of the MFE-I was triplicated to generate more data for recommendations.

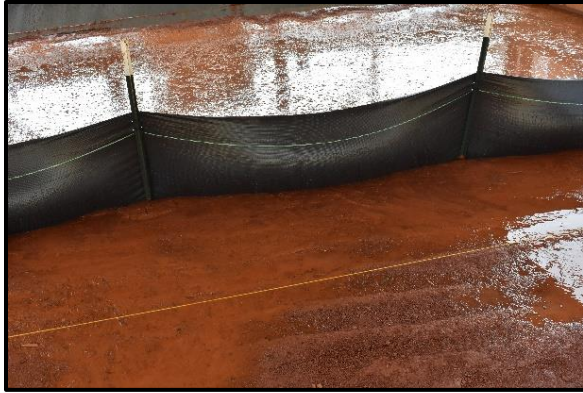
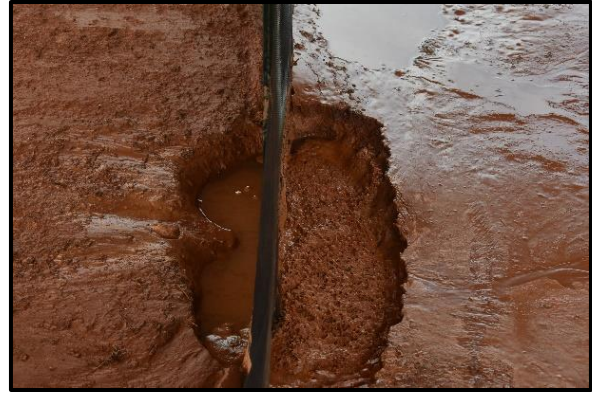
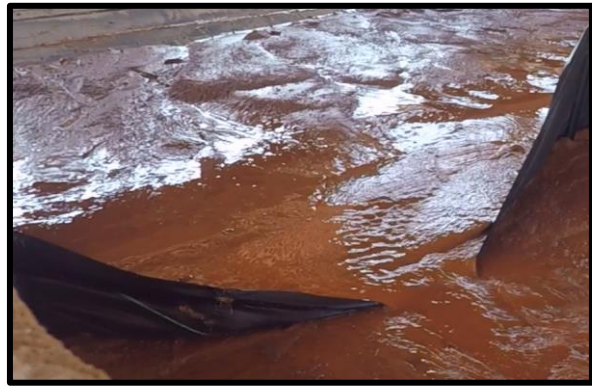
(a) undermining and sagging

(b) trench failure

(c) stretching of fabric around zip-ties

(d) complete installation failure due to excessive impoundment conditions

The standard Nebraska DOT silt fence installation experienced multiple structural inefficiencies after being subjected to three installations of three back-to-back simulated stormwater runoff events. Undercutting and a complete trench failure were experienced, as shown in Figure 3.13. Excessive impoundment conditions leading to complete failure and overtopping were unable to be experienced under the 2-yr, 24-hr storm conditions used in the three back-to-back simulated stormwater runoff events; however, under excessive impoundment conditions, once impoundment behind the installation reached approximately 20 in. (51 cm), due to excessive sagging, the zip-ties tore through the fabric leading to fabric separating from the posts and the installation completely failing. Figure 3.13 shows the structural performance issues shown through testing the Nebraska DOT standard installations.

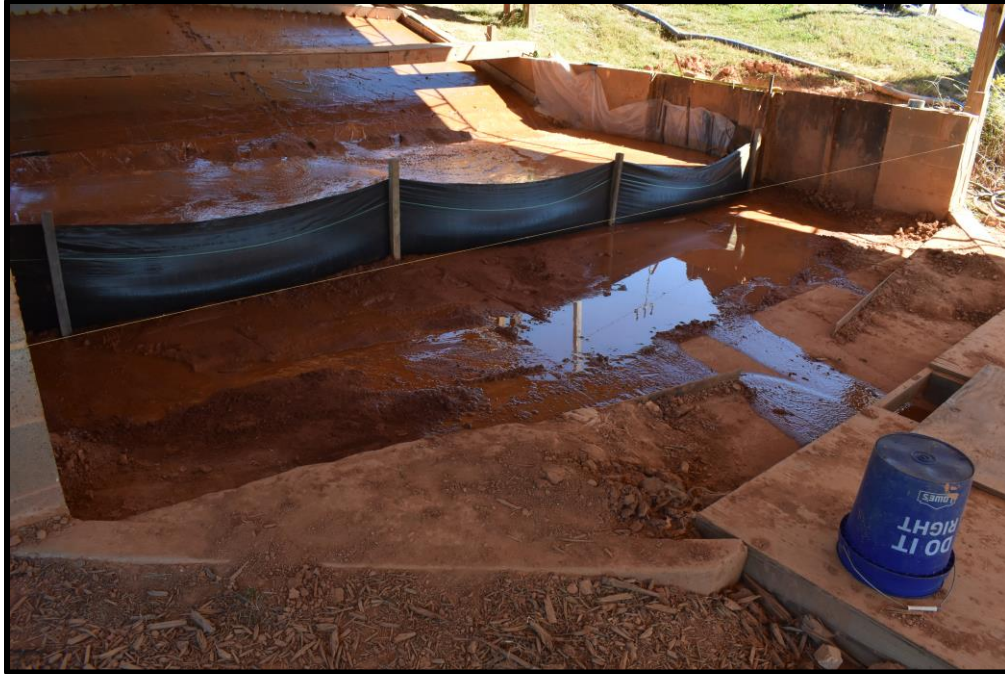
**Figure 3.14 Reduced Sagging Experienced by M2**

Despite the reduced height of installation, the silt fence fabric still experienced excessive sagging, leading to the effective height of the installation being reduced as much as nearly 6 in. (15.2 cm) from the height at the posts and zip-ties partially tearing through the fabric at the attachment points to the posts at the top of the fabric. The hydraulic pressure of the impoundment on the fabric led to it being pushed downstream, leading to the effective height reduction of the installation. M2, using 2 in. by 2 in. (5.1 cm by 5.1 cm) wooden posts instead of studded steel T-posts, was developed due to wooden posts allowing for the attachment of fabric to posts using staples along the entire height of the post without causing holes in the fabric instead of solely at the top of the fabric where zip-ties must be attached. Under testing of Nebraska standard conditions and the extreme-case storm event, sagging was visibly reduced compared to M1 but still occurred. Figure 3.14 shows the reduced sagging experienced by M2.

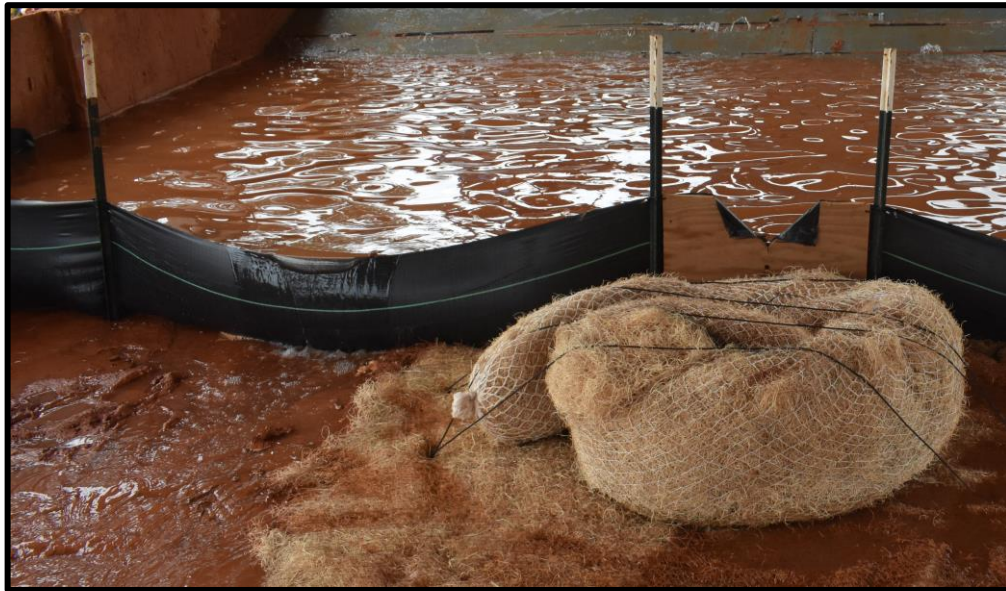
**Figure 3.15 Bypassing of Overflow Weir under Excessive Impoundment Conditions**

overflow weir due to sagging experienced by the silt fence fabric between posts, shown in Figure 3.15.

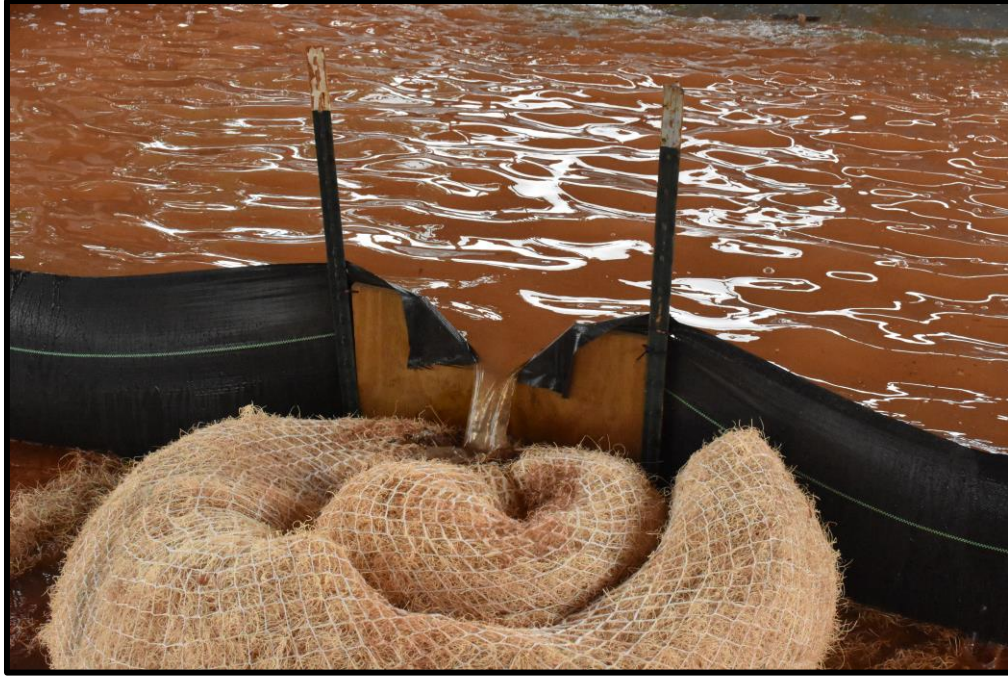
**Figure 3.16 Overflow Weir Dewatering**

To prevent flow from bypassing the overflow weir and splash pad and causing scour downstream, the post spacing was adjusted from 6 ft (1.8 m) to 4 ft (1.2 m) to prevent excessive sagging from occurring and ensure flow overtopped the installation only at the dewatering board. Reducing the post spacing successfully reduced sagging and led to flow overtopping at the overflow weir under excessive impoundment and not in other locations along the installation, as shown in Figure 3.16.

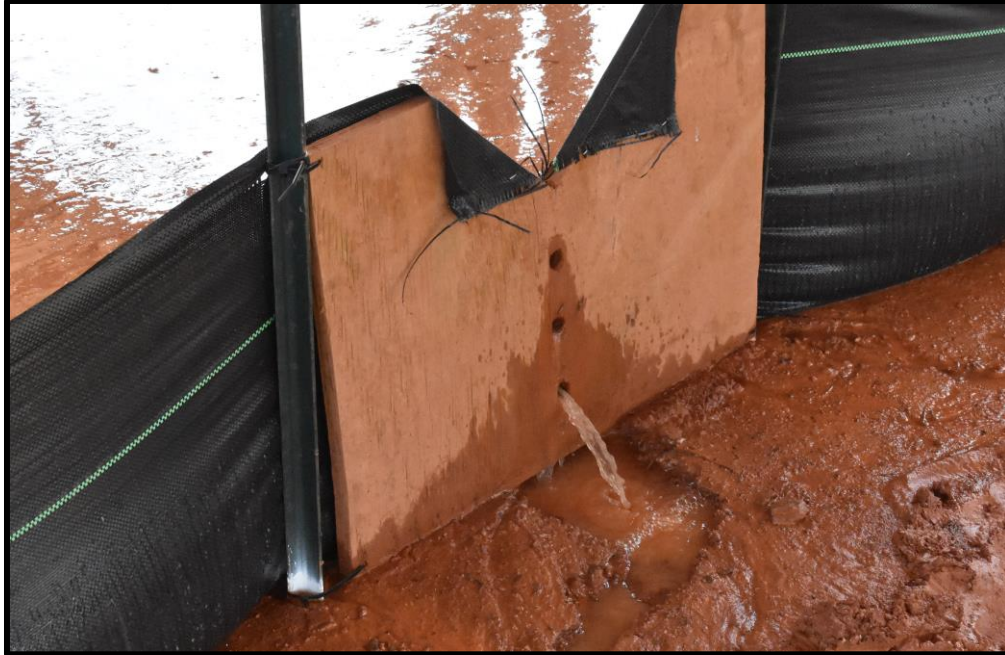
**Figure 3.17 Scour Downstream of Dewatering Board Installation without Energy Dissipation Device**

One installation of the silt fence MFE-I was run through the three back-to-back simulated storm events without an installed energy dissipation device to determine water quality through the dewatering board and the scour caused by flow passing through the board. Figure 3.17 shows that downstream erosion did occur, indicating a need for an energy dissipation device to prevent further erosion off-site.

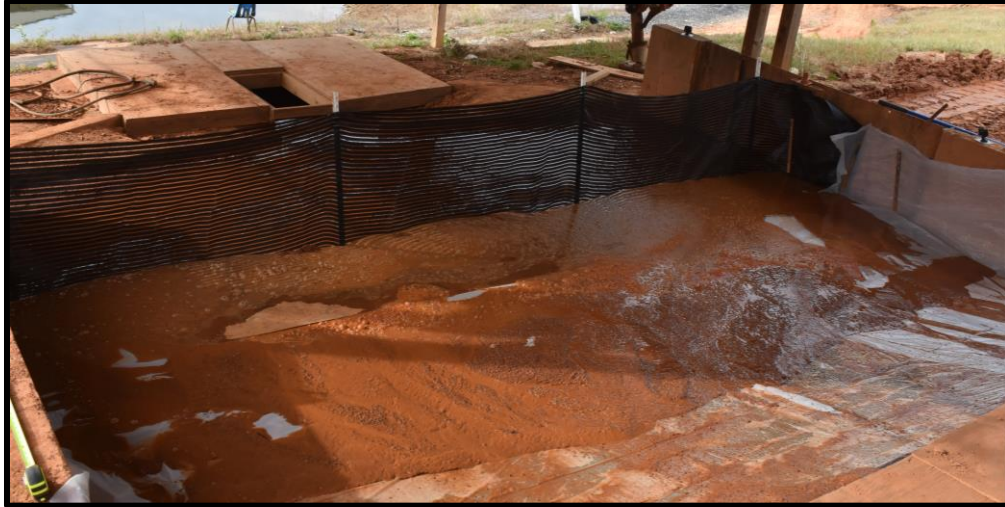
**Figure 3.18 Performance of High Porosity Silt Fence Installation**

The high porosity silt fence installation was not shown to form much impoundment, maxing out at 4.25 in (10.8 cm) in depth; any impoundment formed seemed to be due to the accumulation of material at the base of the installation. Figure 3.18 shows the lack of impoundment formed by high porosity silt fence installation during a simulated stormwater runoff event. The extreme-case simulated stormwater runoff did not facilitate any additional impoundment from testing of the standard conditions.

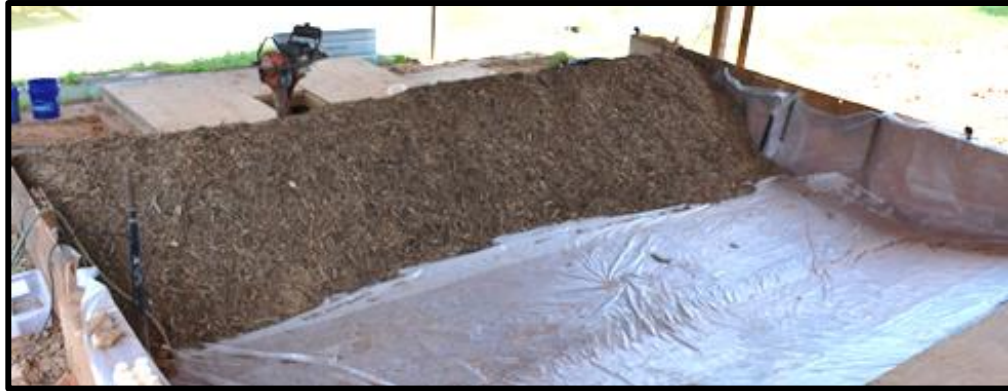
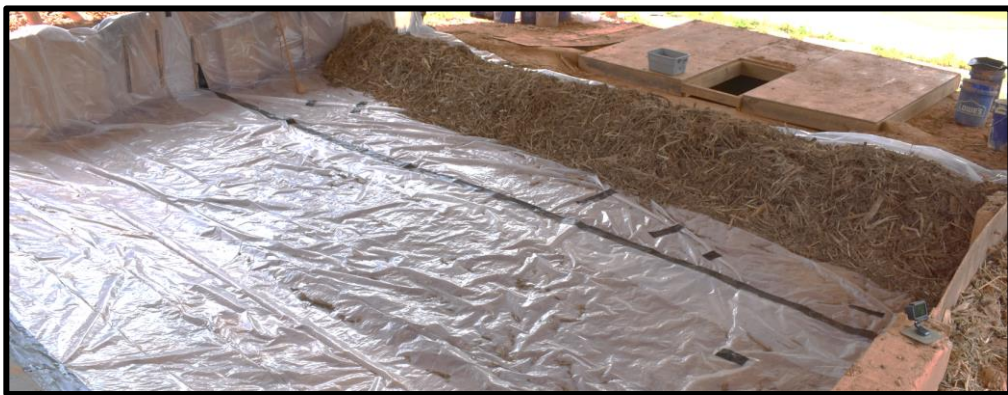
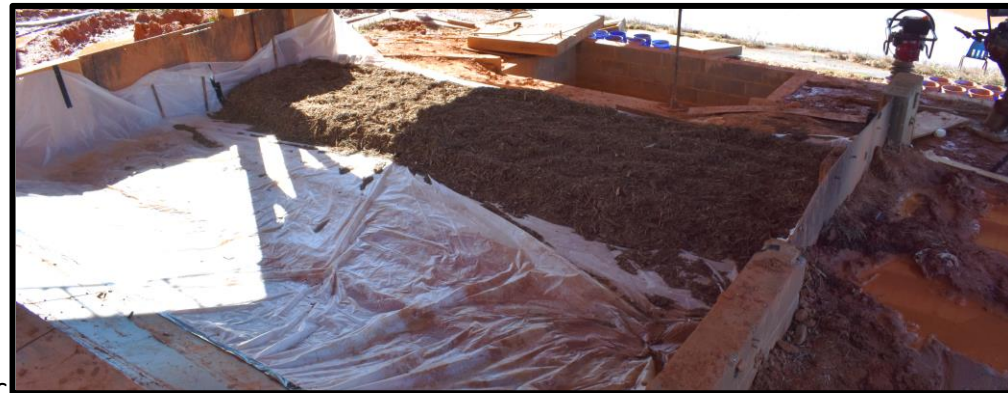
**Figure 3.20 Slash Mulch Berm Installations**

- Standard Nebraska DOT Installation (STD): standard used on Nebraska highway construction projects; trapezoidal berm 3 ft (0.91 m) in height and 6 ft (1.8 m) in width with a top width of 2 ft (0.61 m). The berm was not compacted.
- Modification 1 (M1): Berm with a height of 1.5 ft (0.46 m) and 3 ft (0.91 m) in width. Berm was compacted in three 6 in. (15.2 cm); each lift was compacted with a jumping-jack compactor.
- Modification 2 (M2): Berm with height of 1 ft (0.3 m) and 6 ft (1.8 m) in width; compacted in two 6 in. (15.2 cm lifts)

(a) standard installation

(b) modification 1

(c) modification 2

Figure 3.20 shows all three installations; specifications of all three are shown in Appendix C. The test bed for each installation was lined with plastic sheeting to facilitate the collection of deposited soil upstream and the analysis of sediment reaching the catch basin downstream of the test bed. Additionally, each berm was installed with the back face on the far downstream end of the test bed, to prevent additional deposition from occurring between the installation and the catch basin. This testing methodology adjustment for slash mulch berms was developed through testing of slash mulch berms under Alabama conditions for Alabama Power. Three installations of a trapezoidal slash mulch berm 3 ft (0.91 m) in height and 6 ft (1.8 m) in width with a 6 in. (15.2 cm) key in were tested under Alabama conditions. The results and methodology of this testing can be found in Appendix A; findings from testing were used to develop modifications to Nebraska DOT slash mulch berms.

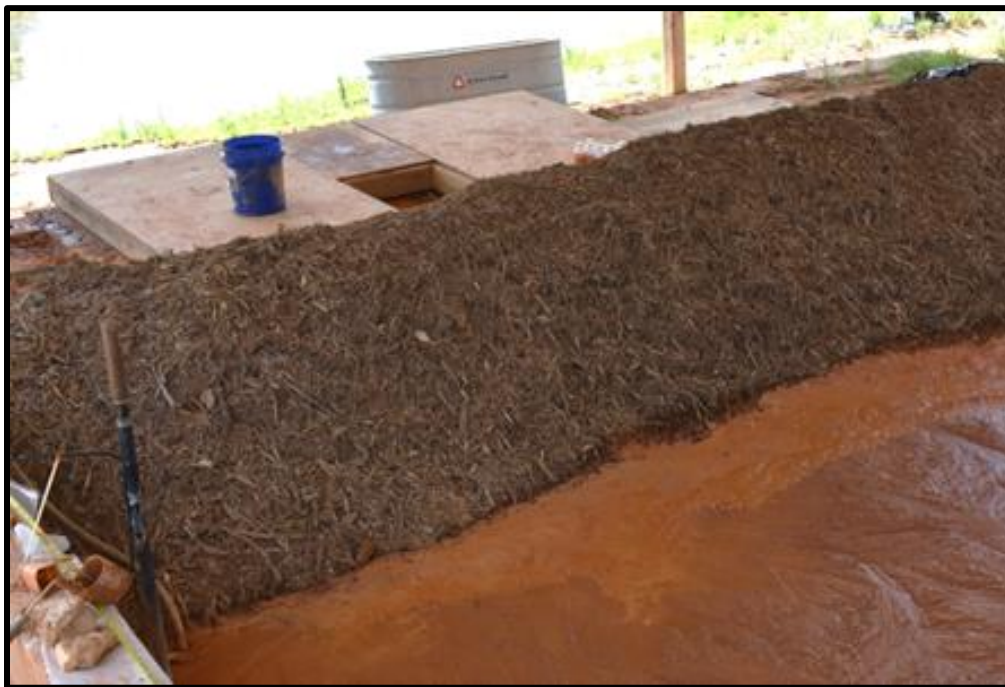
**Figure 3.21 Impoundment formed by Nebraska DOT Slash Mulch Berm Standard**

The standard Nebraska DOT slash mulch berm installation facilitated only a maximum impoundment depth of 4 in. (10.2 cm); the majority of material within the berm, approximately 2.7 ft (0.82 m) of the total height, does not have any flow pass through and only is serving to ensure the berm does not wash away as runoff passes through it. Figure 3.21 shows the impoundment formed by the installation; it does not reach far up the front face of the installation. The first discharge through the installation took just over 3 minutes after the beginning of flow introduction; each subsequent test required less time for flow to pass through the installation. The little impoundment formed behind the berm dewatered within 60-min of the conclusion of flow introduction. Under the extreme-case simulated stormwater runoff, minimal additional impoundment was achieved; however, the berm remained structurally sound and there was no substantial loss of material from the berm.

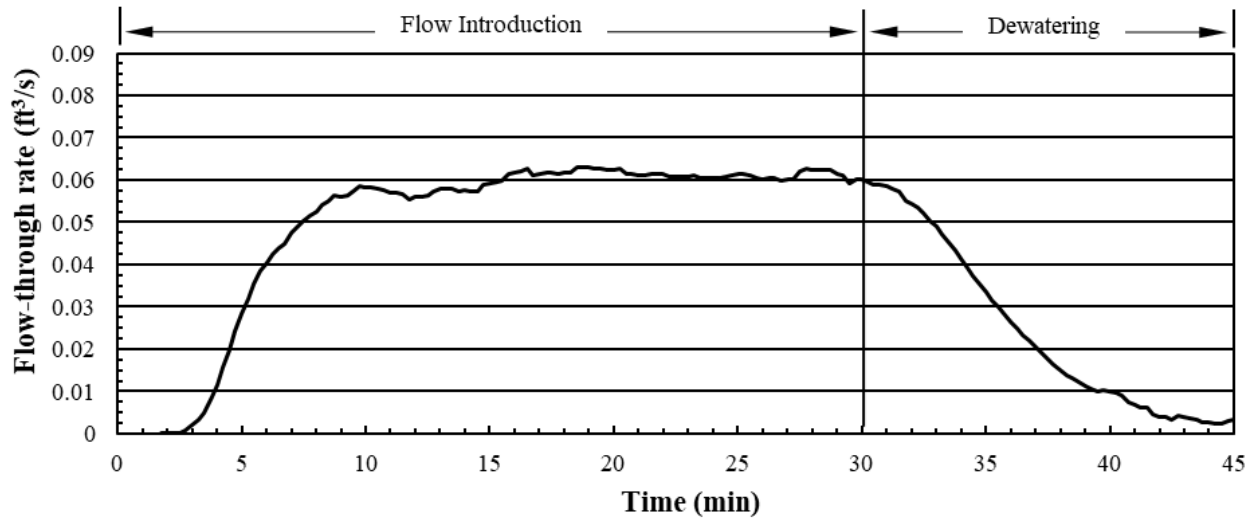
**Figure 3.23 Average Flow Rate through MFE-I Slash Mulch Berm Installations**

Due to M1 facilitating similar impoundment and flow rates to M2 while using less material, M1 was chosen as the MFE-I, and two additional installations of the same design were tested. Both modifications slowed flow through the installations. The average flow rate of the peak 30-min of flow through the berm, starting typically two and half minutes after flow introduction begins, during the test period were 0.056 and 0.061 ft<sup>3</sup>/s (0.0016 and 0.0017 m<sup>3</sup>/s), respectively. Figure 3.23 shows the average flow rate into the catch basin for the MFE-I slash mulch berm installation. Each test of the MFE-I took an average of over two and a half minutes for flow to first pass through the installation and into the catch basin. A filling period where the flow rate is lower, taking approximately five minutes after flow first passes through the berm, is indicated. Flow rate through the berm stays steady throughout the rest of the test period at approximately 0.06 ft<sup>3</sup>/s (0.0017 m<sup>3</sup>/s). At the conclusion of flow introduction, flow through the berm reduces steadily during the first ten minutes of the dewatering period until reaching close to zero approximately 15 minutes after flow introduction stops.

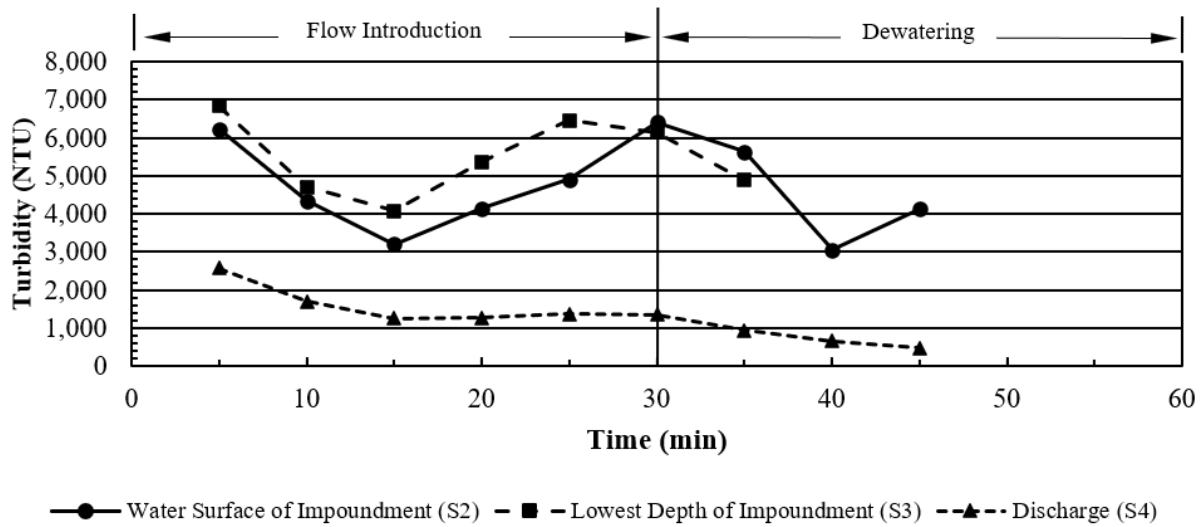
(a) Average turbidity

(b) Average TSS

Figure 3.24 shows the average water quality over time for the slash mulch berm MFE-I installations. On average, through both the testing period and the dewatering monitoring period, the turbidity and TSS of the discharge are lower than both the top and bottom of the impoundment, indicating treatment through the installation. Additionally, for much of the test period, the turbidity and TSS of the top of the impoundment are lower than the bottom; however, both increase through the test period on average. Water quality at the two sampling locations in the impoundment also becomes similar as the dewatering period leads to lower impoundment facilitated upstream of the practice, leading to samples being taken from similar locations within the impoundment.

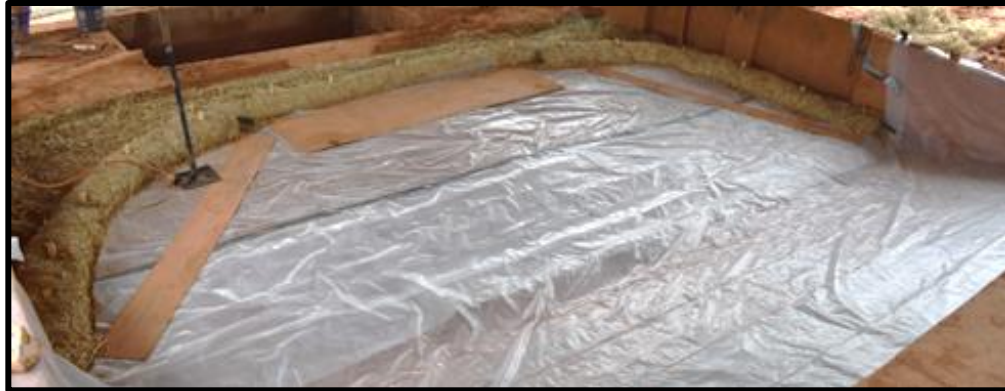
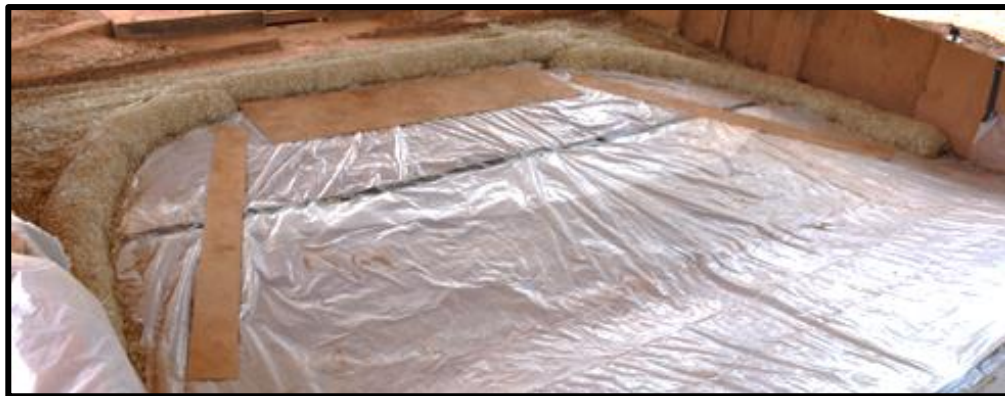
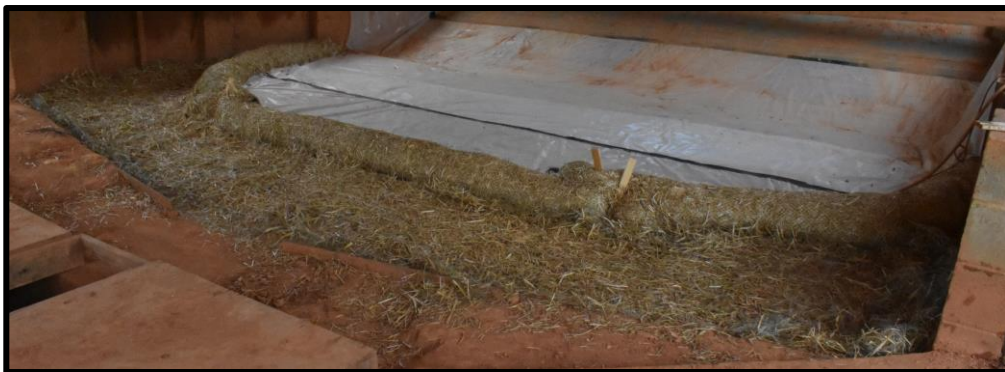
**Figure 3.25 Straw Wattle Installations**

- Modification 2 (M2): identical to M1, with the addition of 1 in. by 2 in. by 24 in (2.54 cm by 5.08 cm by 61 cm) nominal wooden stakes installed at the joints at 45-degree angle, nondestructively. Joint overlap was increased from 1 ft (0.31 m) to 2 ft (0.62 m).

(a) straw wattle standard installation

(b) modification 1

(c) modification 2

Figure 3.25 shows all three types of installations. For each installation, three 10 ft (3.04 m) long wattles were used. Wattles at the end of each side were turned upstream and tucked against the side walls of the testing apparatus to ensure flow passes through the installation and prevent flow bypass. Additionally, a straw blanket was added in the test bed downstream of the wattle installation to prevent flow overtopping the wattle from causing additional erosion downstream of the installation and allowing for the analysis of sediment discharged into the catch basin downstream of the test bed.

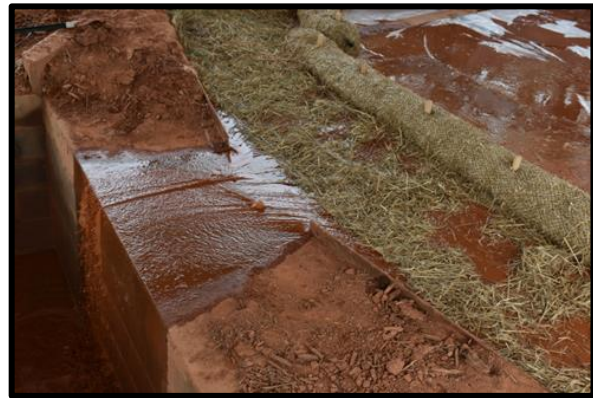
**Figure 3.26 Straw Wattle Standard Installation Undermining**

(b) high flow through-rate

Immediately after the start of flow introduction into the standard straw wattle installation, stormwater could pass beneath the installation, as shown in Figure 3.26. The stakes that attached the wattles to the ground did not facilitate ground contact with the straw wattle. Minimal impoundment was facilitated; the maximum impoundment through testing was 1.5 in. (3.8 cm),

and a high flow-through rate was apparent. Due to the evident failure of the installation in facilitating any impoundment or treating stormwater, only one test of one installation was run. Additionally, no impoundment was facilitated under the higher flow rates during the extreme-case simulated stormwater runoff event.

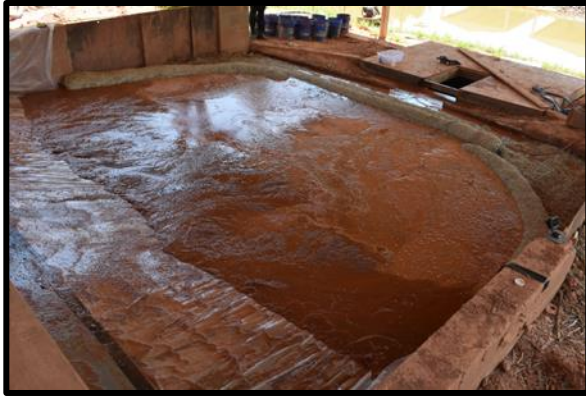
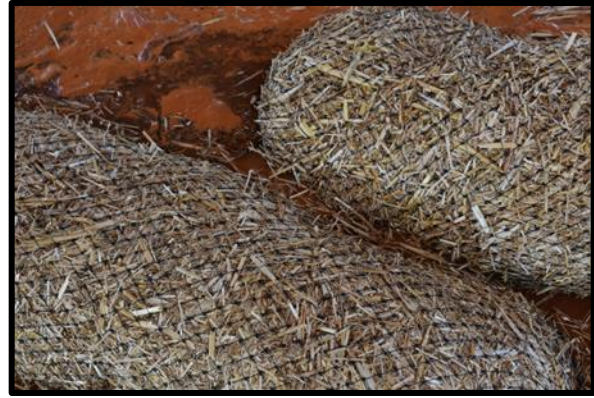
**Figure 3.27 Performance of Straw Wattle Modification 1**

(a) impoundment facilitated

(b) overtopping of flow at junctions

To further facilitate ground attachment between the wattle and ground, M1 was developed, which adds sod staples spaced every 1 ft (0.3 m) on each side of the installation. Staples were added upstream and downstream and staggered to maximize contact between wattles and the ground. Adding staples facilitated more impoundment than the standard installation, with a maximum impoundment of 5.25 in. (13.3 cm), as shown in Figure 3.27a. The impoundment depth, however, did not reach the maximum height of the wattle; flow could overtop the installation at the joints between wattles, where the effective height of the installation was the lowest, shown in Figure 3.27b. The impoundment also was limited to the height of the joints between wattles under extreme-case simulated stormwater runoff conditions.

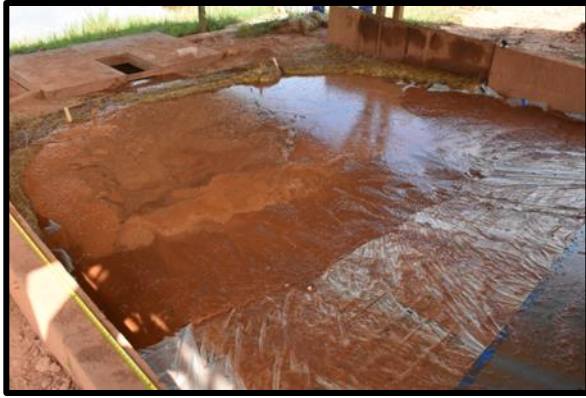
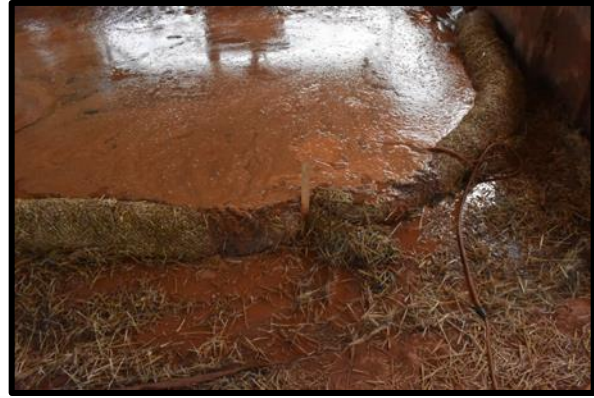
**Figure 3.28: Performance of Straw Wattle Modification 2**

(a) impoundment facilitated

(b) overtopping of installation

To prevent flow from overtopping at the joints and allowing impoundment to reach the entire height of the installation, M2 was developed that included wooden stakes were added at the joints between wattles at a 45-degree angle in an A-frame or teepee configuration that does not puncture the wattles in addition to increasing the overlap at the joints between the wattles. Sod stapling pattern was kept the same from M1. The goal of adding stakes at the joints is to facilitate contact between the wattles and preventing the area at the joints from having a lower effective height, therefore prevent flow bypass between the wattles. Under testing, an impoundment depth greater than M1 with only sod staples was facilitated, with a maximum depth of 6.825 in. (17.34 cm) facilitated, which was the height at which the installation overtopped as shown in Figure 3.28. Overtopping was also facilitated during the extreme-case simulated stormwater runoff event.

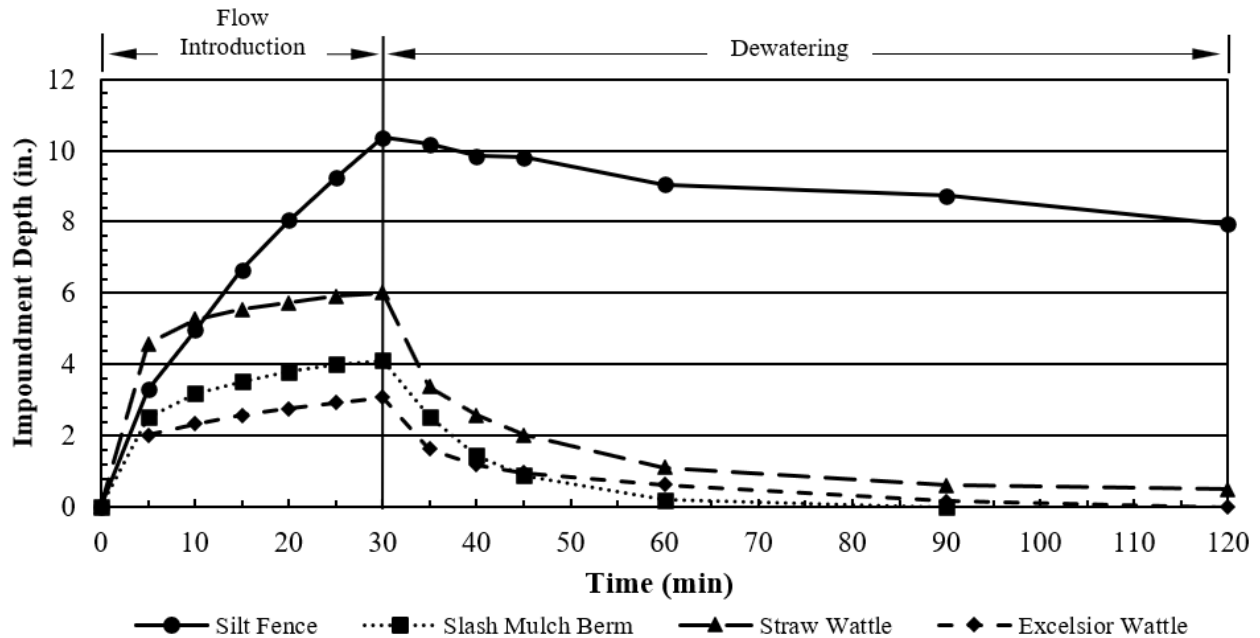
**Figure 3.33 Impoundment Facilitated by Sediment Barrier MFE-Is**

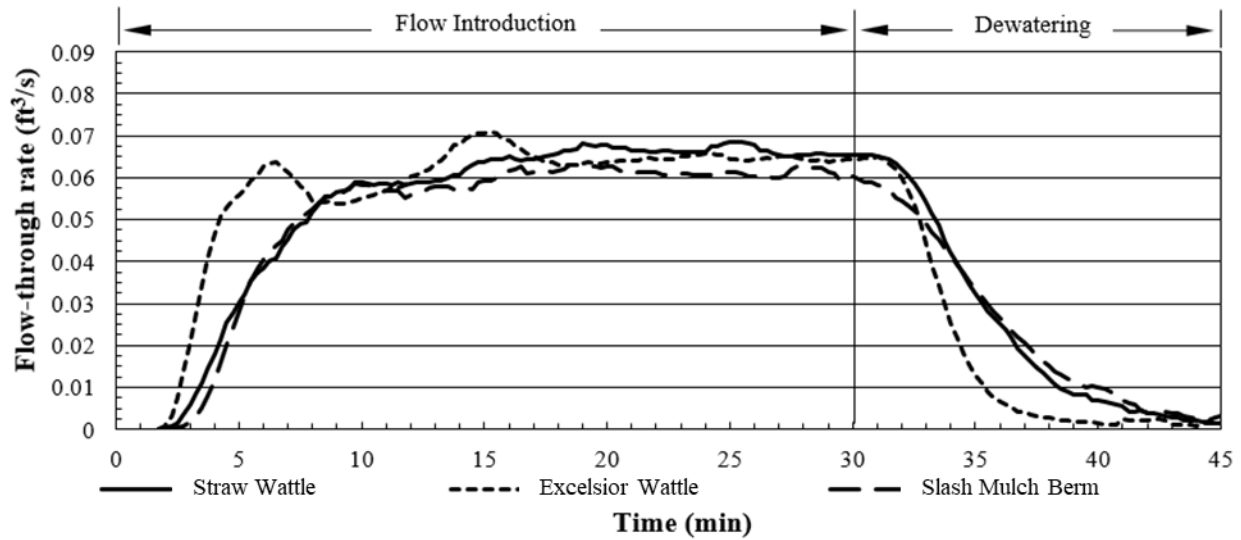
**Figure 3.34 Flow-through Rates of Sediment Barrier MFE-Is**

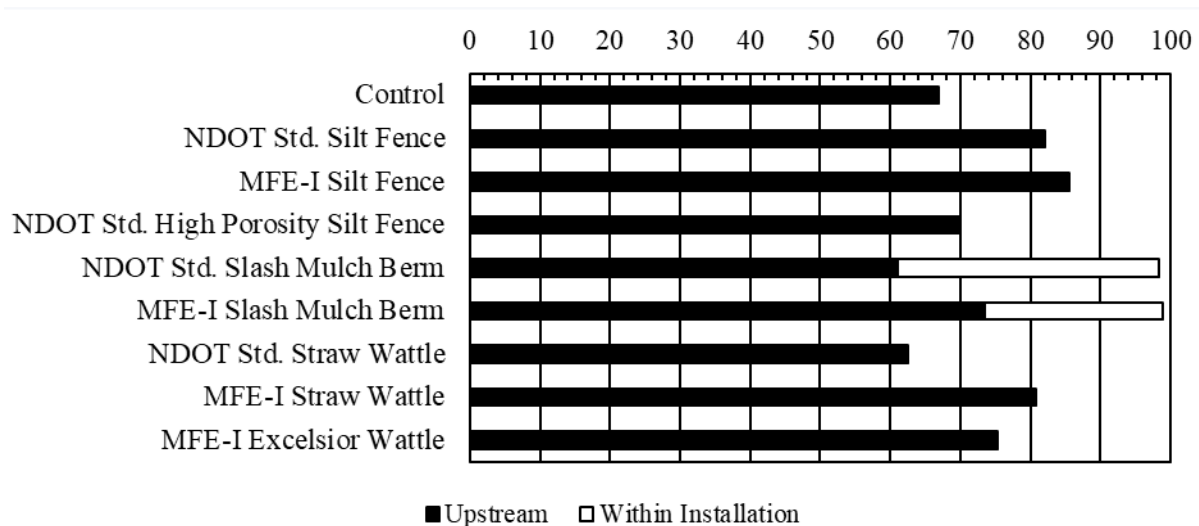
**Figure 3.36 Average Sediment Capture for Standard and Modified Sediment Barrier Installations**

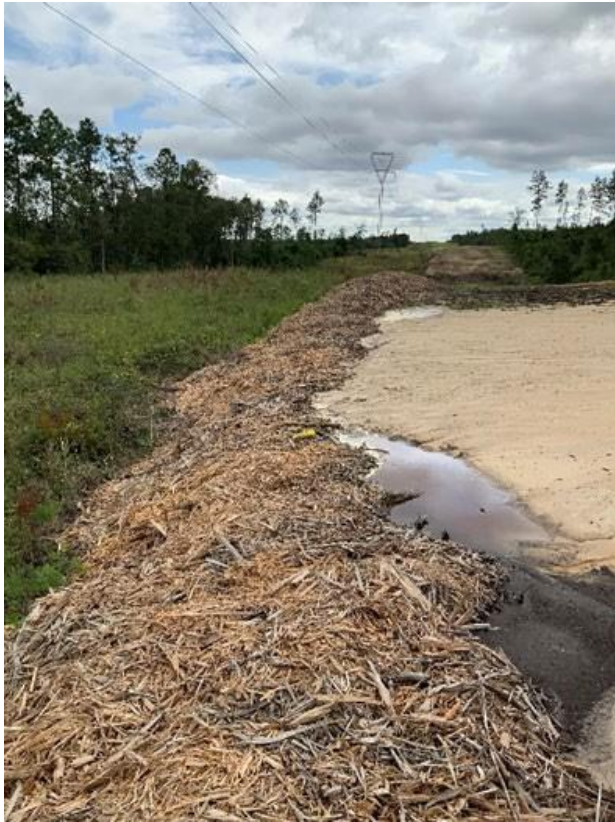
(a) installed slash mulch berm
