**Performance Evaluation of Sediment Control Practices**

Brian Gerald Roche

A thesis submitted to the Graduate Faculty of  
Auburn University  
in partial fulfillment of the  
requirements for the Degree of  
Master of Science

Keywords: Sediment Control, Vegetated Buffers, Sediment Barriers

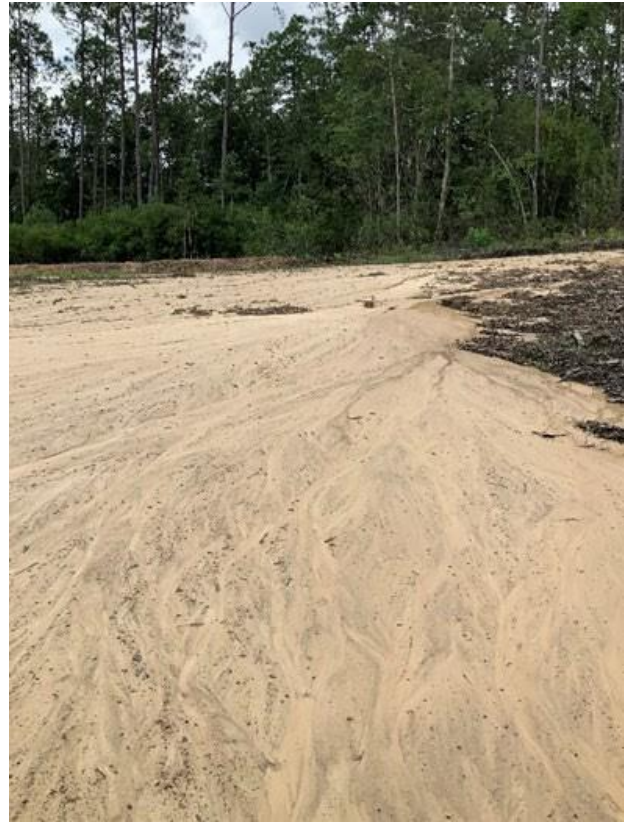
**Figure 1: Field installation of slash mulch berm (photos courtesy of Cliff Young).**

(b) sedimentation upstream of berm

One less common sediment barrier practice that is growing in use is a slash mulch berm. Slash mulch is a material by-product created by shredding and chipping timber that has been removed during land clearing. Slash mulch can be arranged into berms to serve as a natural biodegradable sediment barrier. Not only are slash mulch berms biodegradable, but they also have the advantage of utilizing materials that would otherwise be burned or hauled off site and landfilled. Additionally, as the slash mulch berm breaks down, carbon is sequestered in the soil on-site. Multiple regulatory bodies, including the Georgia Soil and Water Conservation Commission (GSWCC) and the Minnesota Department of Transportation (MnDOT), have approved slash mulch berms as a viable sediment barrier practice (GSWCC 2016, MnDOT 2020). Slash mulch berms are typically arranged in a trapezoid cross-section, ranging from 2 to 4 ft (0.61 to 1.22 m) high and from 5 to 8 ft (1.52 to 2.44 m) wide. (MnDOT 2020). Alabama Power has started using slash mulch berms on their construction sites in lieu of traditional sediment barriers (e.g., silt fences). The Alabama Power berms are constructed using bulldozers and can be as large as 4 ft by 8 ft (1.22 m by 2.44 m). Figure 1 shows field images of a slash mulch berm, taken on an Alabama Power construction project, installed to prevent sediment from passing beyond the practice and discharging offsite. Despite field observations indicating the possibility of a slash mulch berm serving as an effective sediment barrier practice, there has been little research on determining their effectiveness.

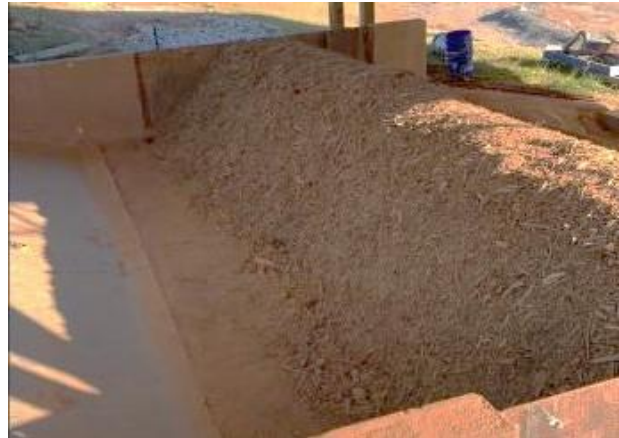
**Figure 2: Slash Mulch Berm Installation in AU-SRF Sediment Barrier Testing Apparatus.**

(b) initial installation, pre-test photo

Using this testing apparatus, 20 ft (6.10 m) long slash mulch berms were installed in a trapezoidal configuration measuring 3 ft (0.9 m) tall and 6 ft (1.8 m) wide along the base. The berms were configured to a 1:2 H:V side slope configuration, with a 3 ft (0.9 m) top width. The installation includes a 6 in. (0.15 m) deep triangular key along the front face of the berm. Figure 2(a) depicts a schematic of the installation. The berms were installed in three lifts, each approximately 1 ft (0.3 m) tall to allow compaction with the bucket of a Bobcat® E35 mini-excavator. Figure 2(b) shows the installed berm in the testing apparatus.

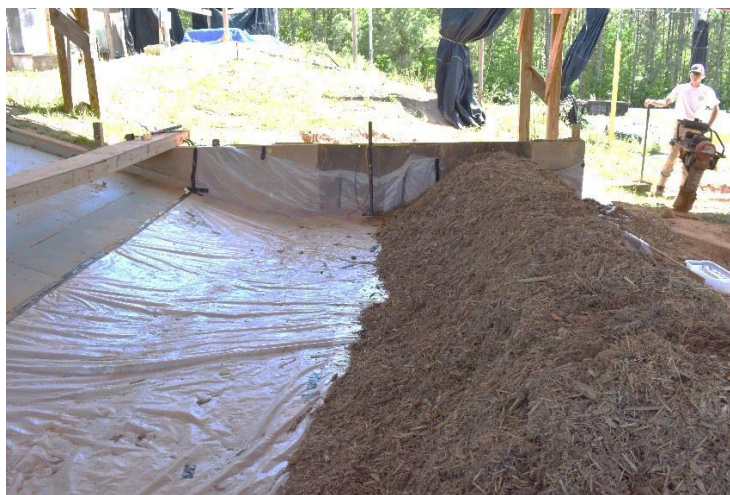
**Figure 3: Updated Slash Mulch Berm Installation, Offset from Toe of Slope**

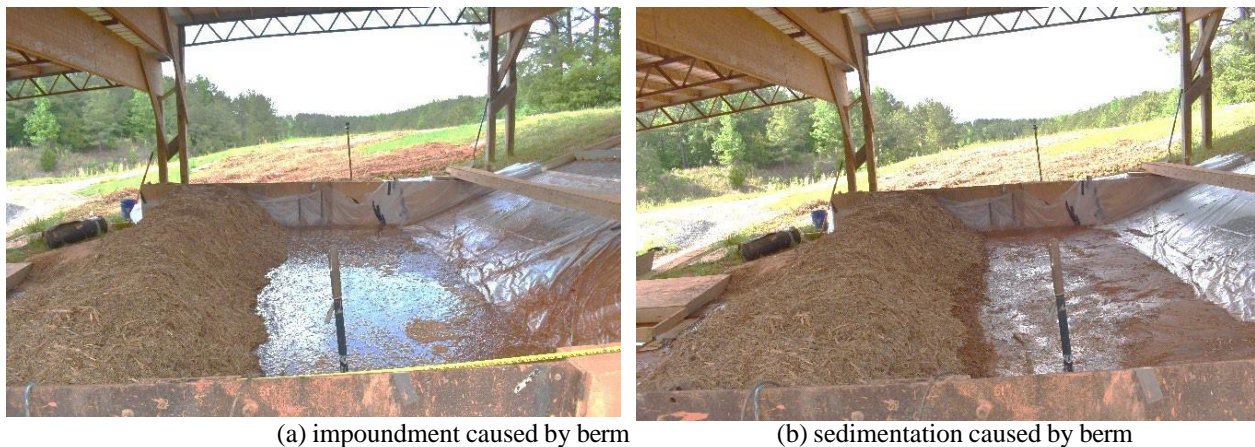
**Figure 4: Slash Mulch Berm Testing.**

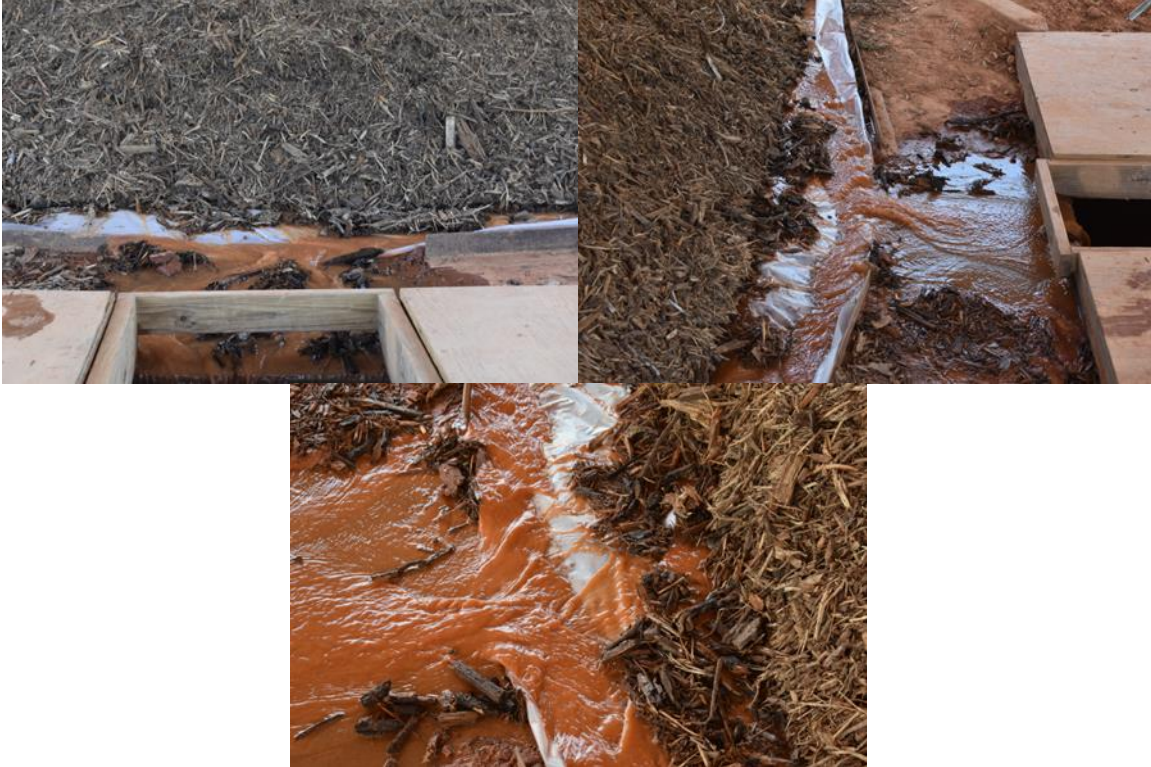
Notes: Increased flow with each subsequent stormwater runoff event, flow coming through entire back edge

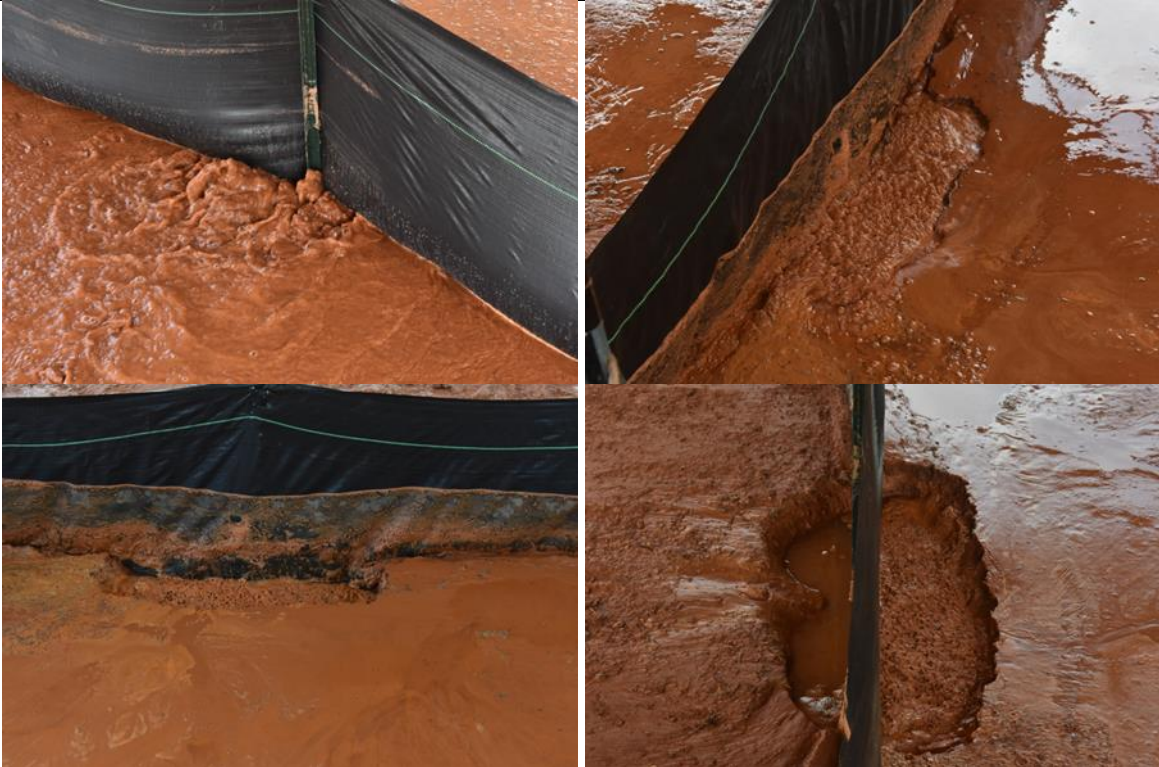
Notes: Undermining caused flow to dewater fully immediately, large hole created on both sides

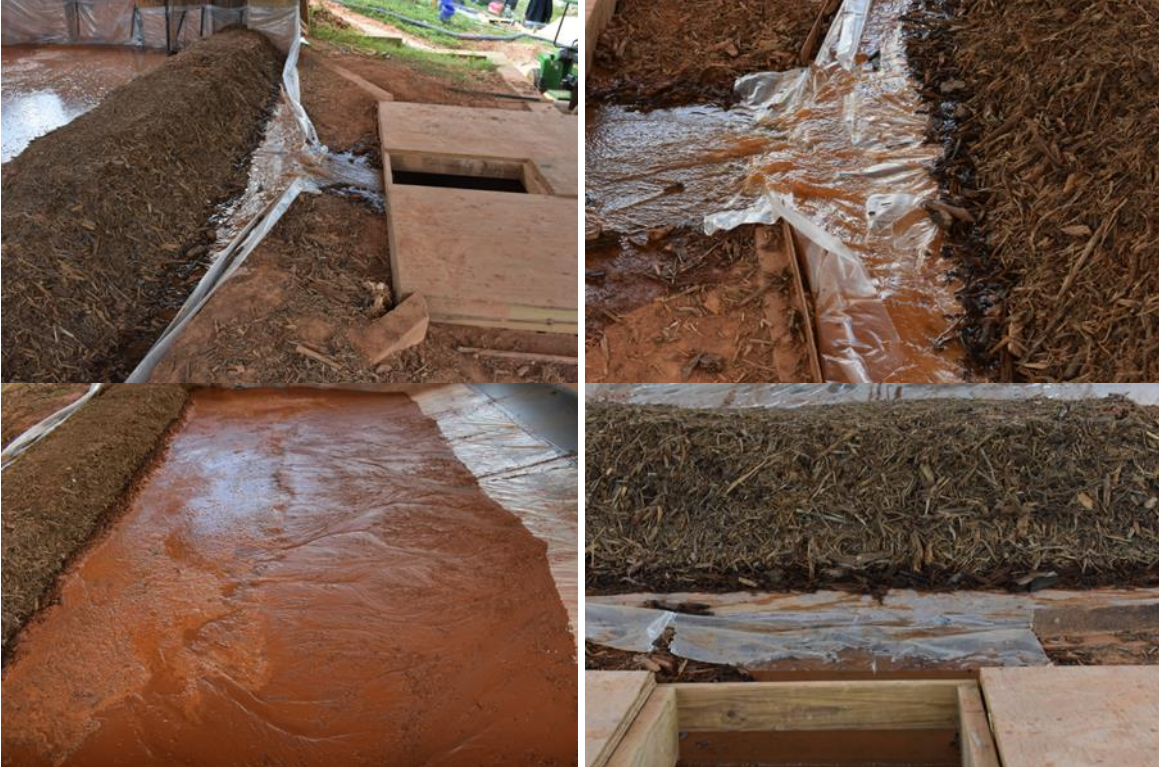
Notes: Flow through berm, sediment deposition, and only bottom of berm having flow pass through

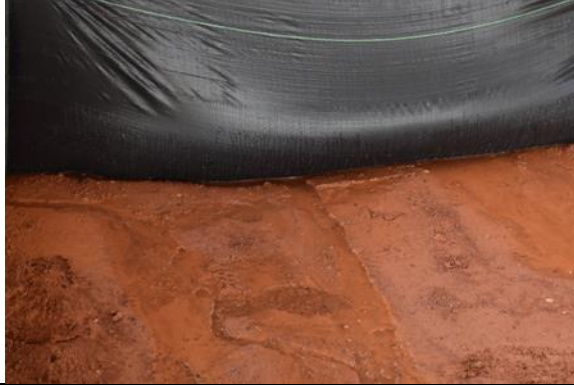
Notes: Flow under installation

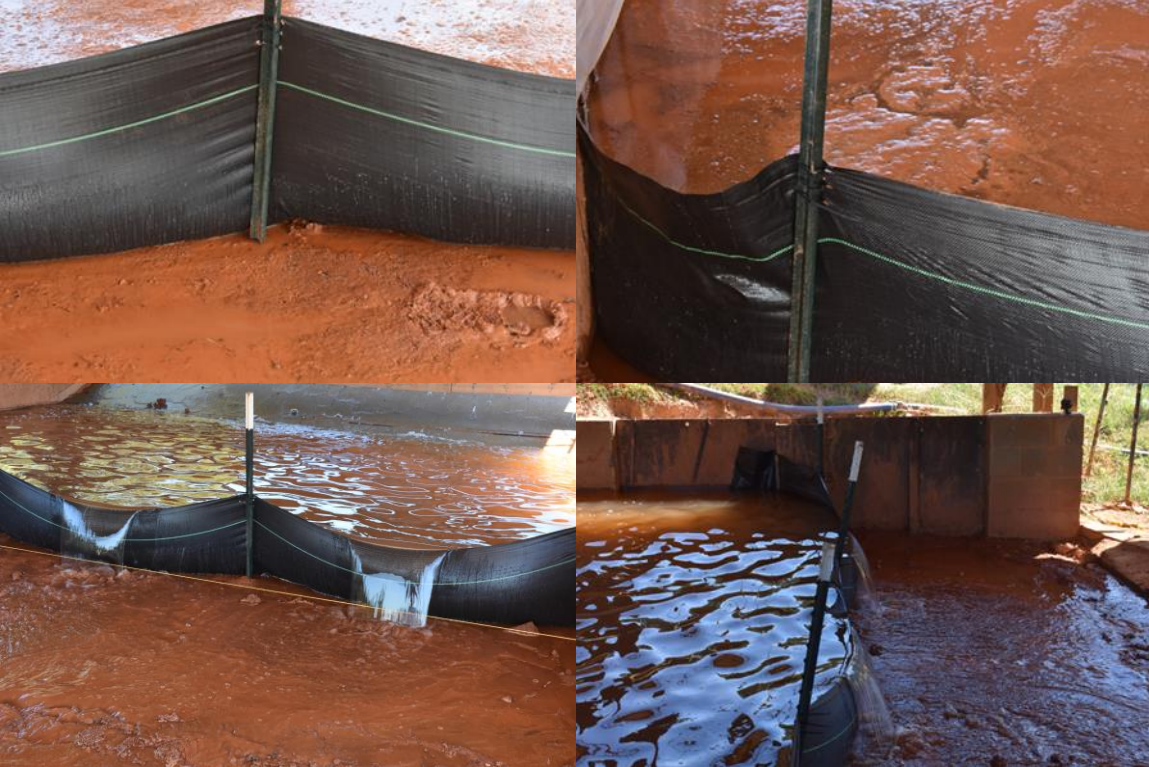
Notes: No clear undermining, less tearing of zip ties through fabric, overtopping and post deflection under extreme-case simulated stormwater runoff event

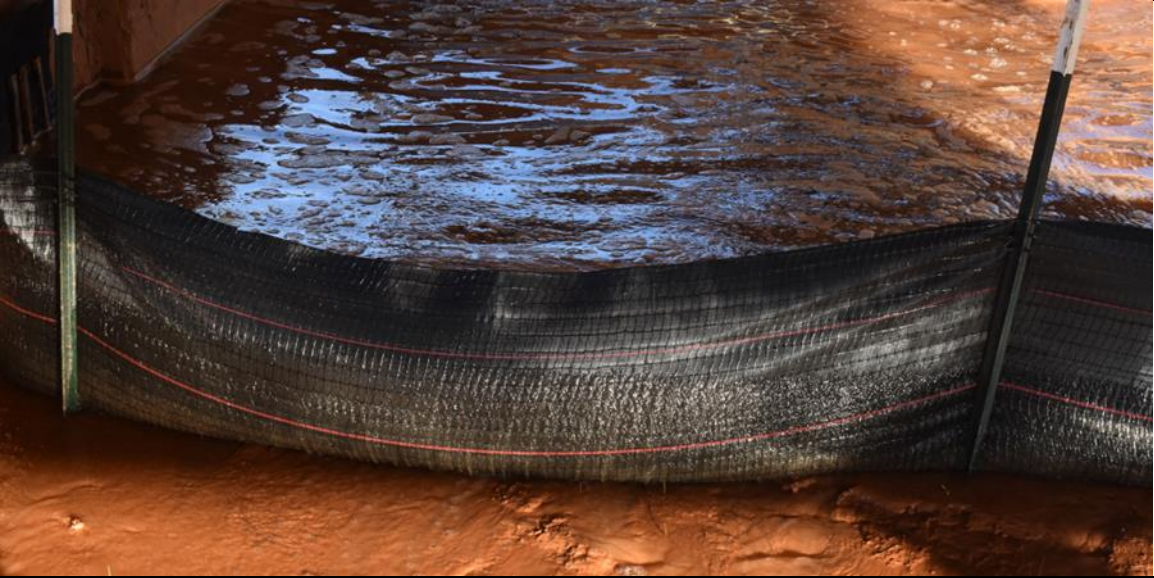
Notes: Visibly higher flow through fabric than other woven fabric tested

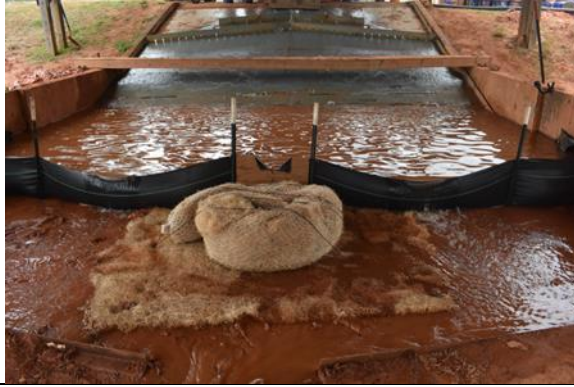
Notes: Overtopping at fabric under excessive impoundment conditions due to sagging

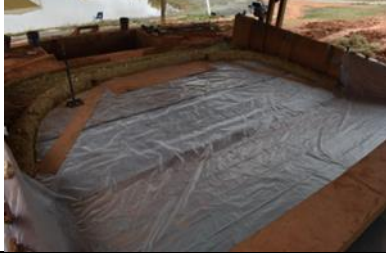
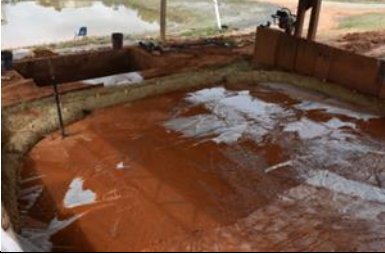
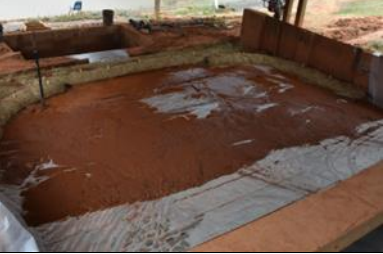
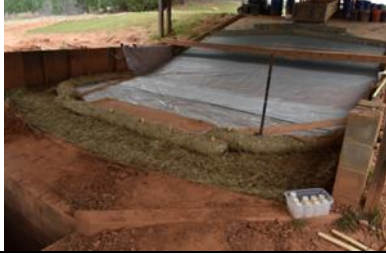
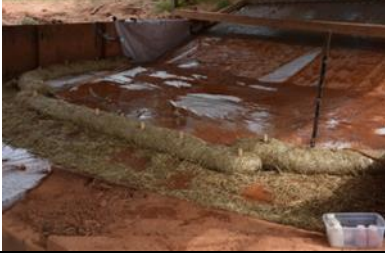
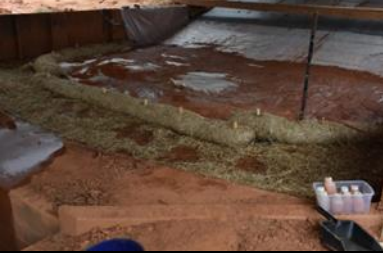
Pre-Test	During Test (Second)	Post-Test

<b>Observations</b>
Clear undermining occurred due to lack of contact between wattles and ground. Very little impoundment facilitated. Only ran one test on installation due to clear failure. 59.3% of introduced sediment captured upstream

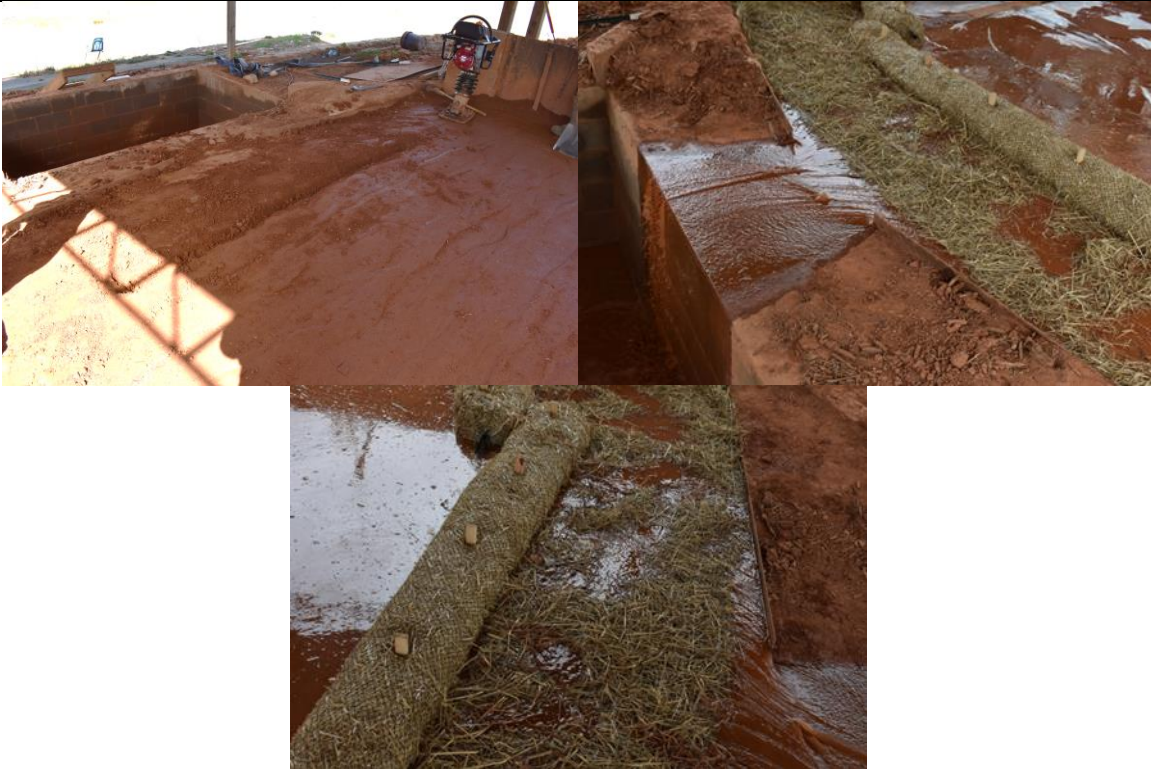
Notes: Trench during installation, flow under during testing, lack of impoundment formed by extreme case

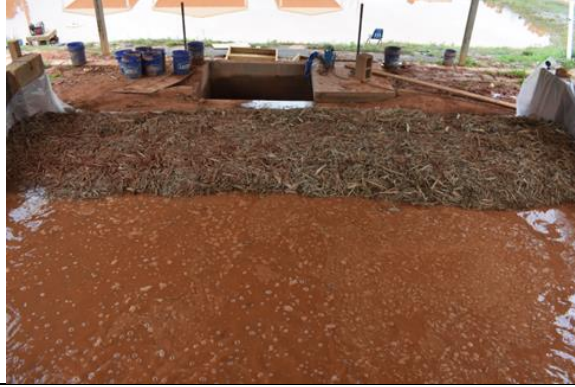
Notes: Impoundment formed during extreme-case runoff event, did not overtop

<b>Observations</b>
Similar impoundment and flow rate from Slash Mulch Modification 1. First discharge 4 minutes into test, earlier under each subsequent test. Under extreme conditions, installation did not overtop.

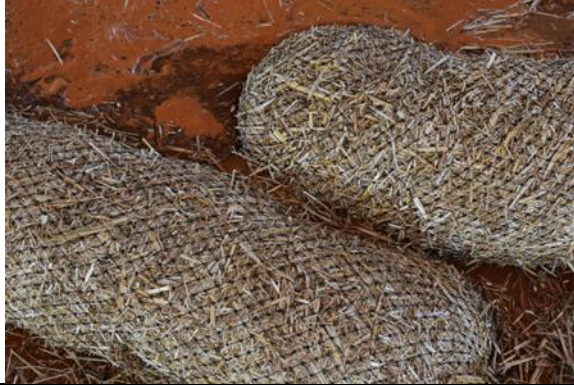
Other Relevant Photos

Notes: Overtopping at low point at joints

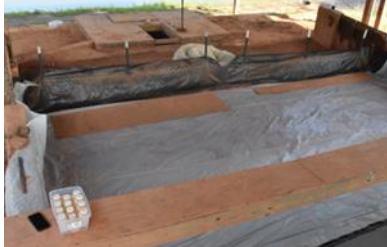
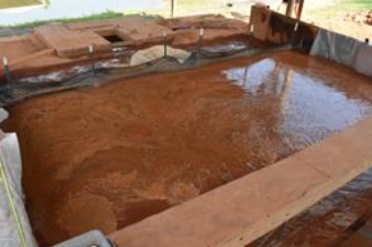
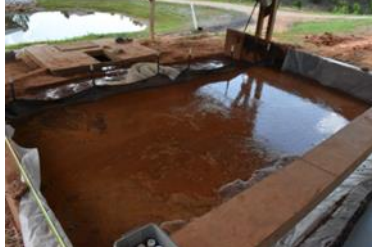
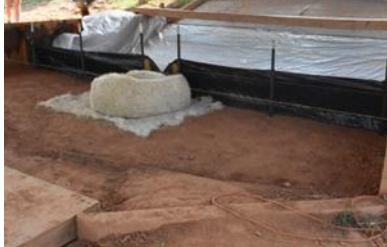
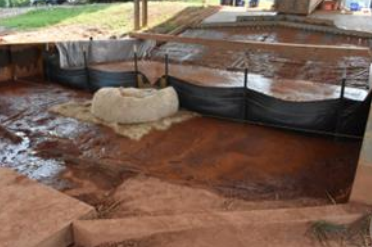
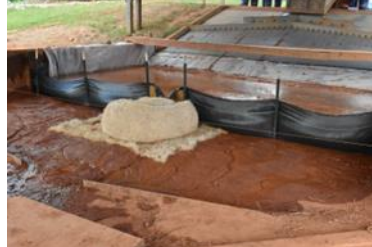
<b>Pre-Test</b>	<b>During Test (Second)</b>	<b>Post-Test</b>

<b>Observations</b>
Under excessive impoundment conditions, excess flow overtopped at dewatering weir into energy dissipation splash pad. Average flow through of 0.0033 during test period

Notes: Zipties tearing at post more than other installs due to flipped posts, not reaching weir under standard conditions, reduced sagging due to post spacing adjustment, flow overtopping at weir under extreme-case conditions

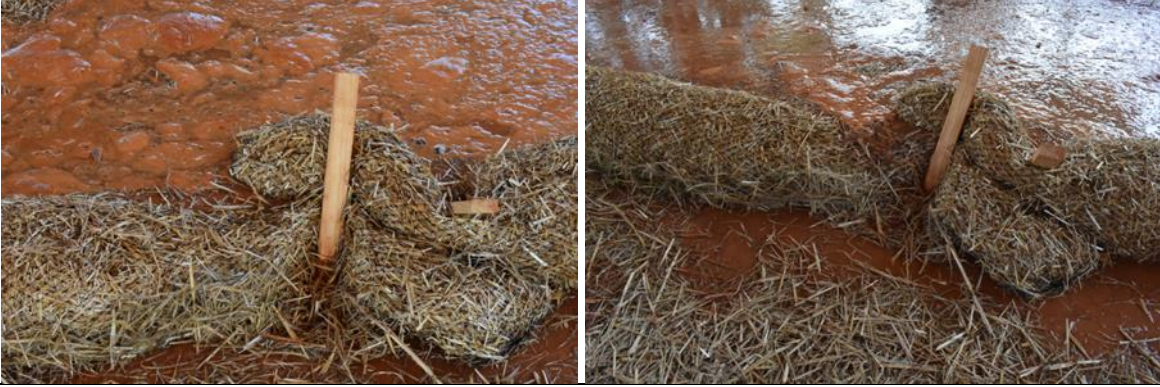
Other Relevant Photos

Notes: Overtopping at maximum height of wattles

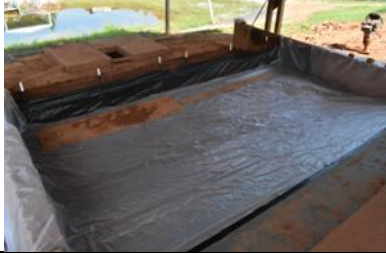
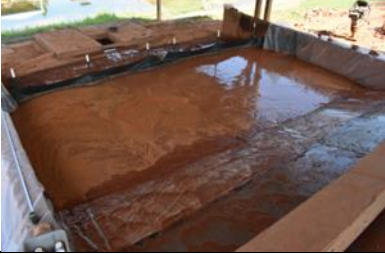
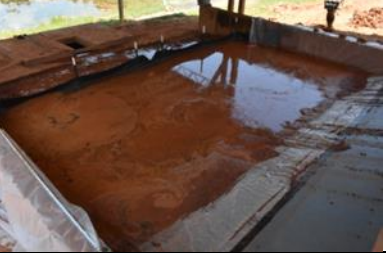
Location 1	Location 1	Location 1

Notes: Flow through dewatering board holes and scour caused by lack of energy dissipation device

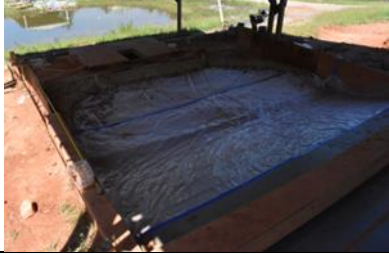
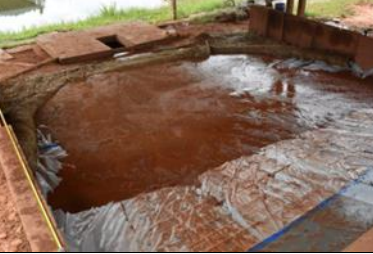
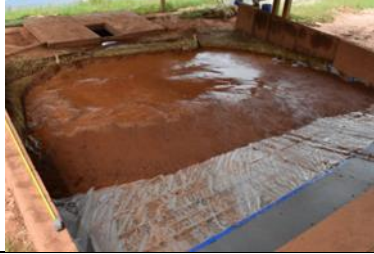
Location 1	Location 1	Location 1

Notes: Installation overtopping under standard conditions

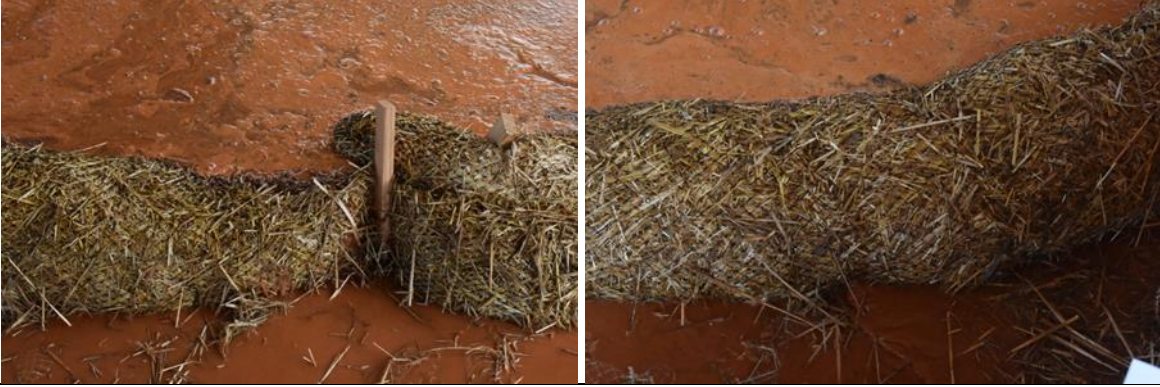
Notes: Installation reaching max impoundment height

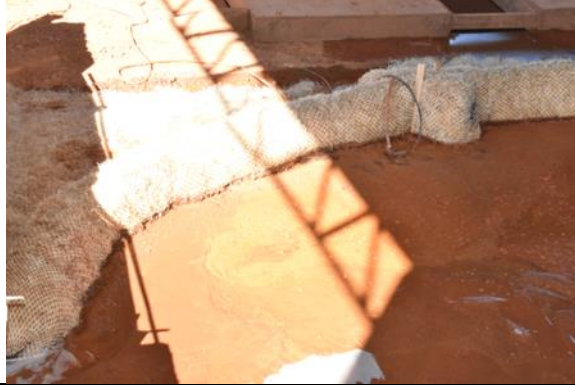
Notes: Lack of impoundment formed, high water line is well below even the middle of the installation

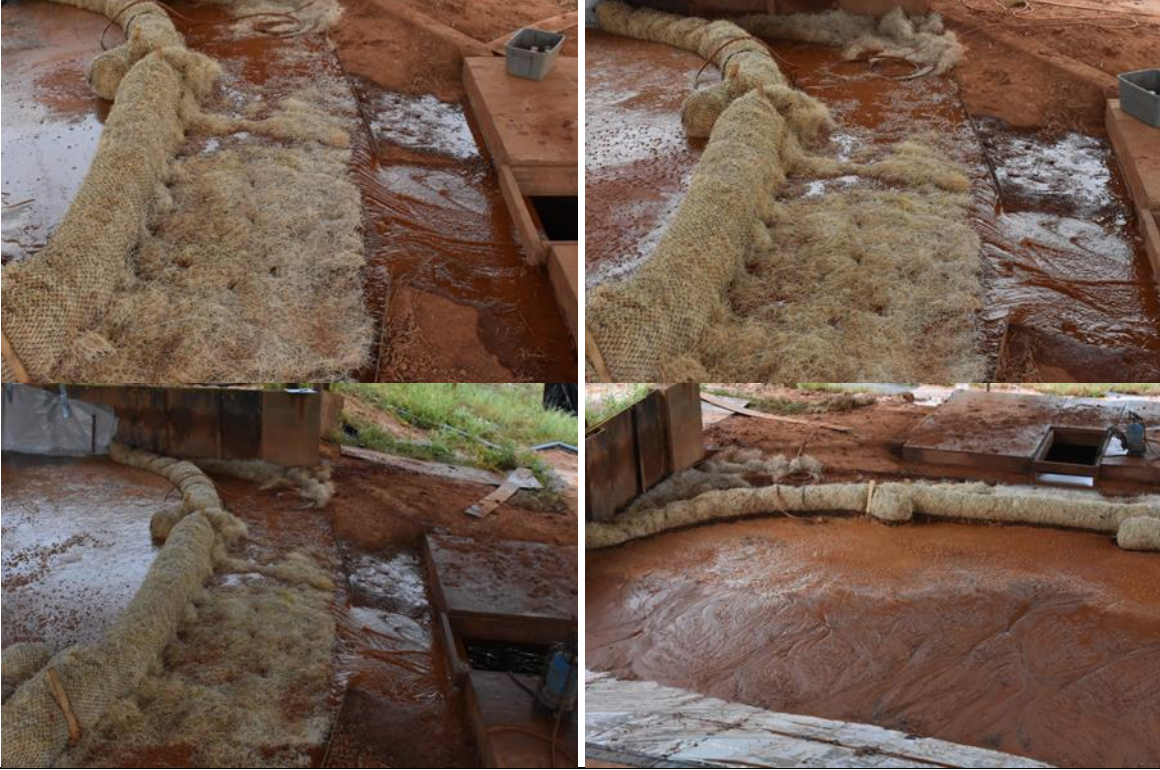
Notes: Visibly high flow-through rates and sediment deposition upstream

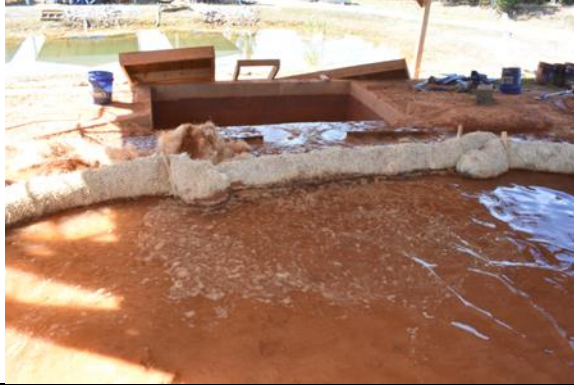
Other Relevant Photos

Notes: Lack of impoundment formed under an extreme case simulated stormwater runoff event
