**Determination of the Effective Bond Strength for Near-Surface Mounted
Titanium-Alloy Bars in Reinforced Concrete**

A thesis submitted to the Graduate Faculty of
Auburn University
in partial fulfillment of the
requirements for the Degree of
Master of Science

Keywords: Bond strength, Bridge Strengthening, Reinforced Concrete, Near Surface Mounting,
Titanium-Alloy Bars,

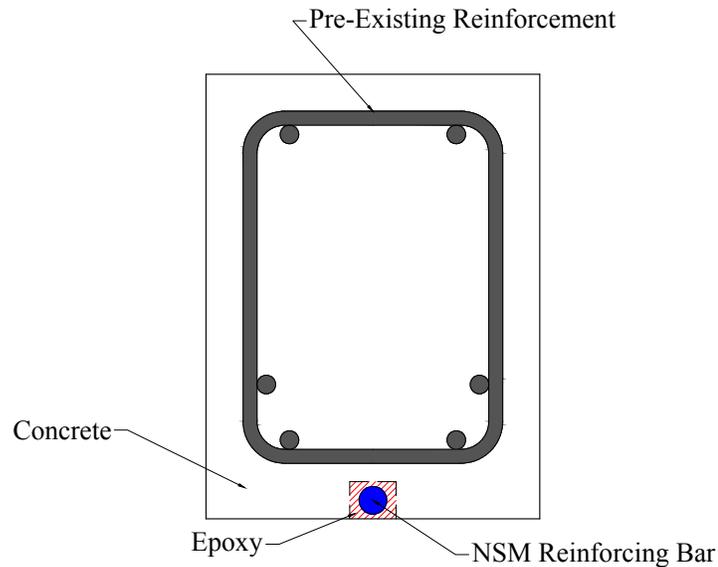
Figure 1.1 – Near Surface Mounting of Reinforcement

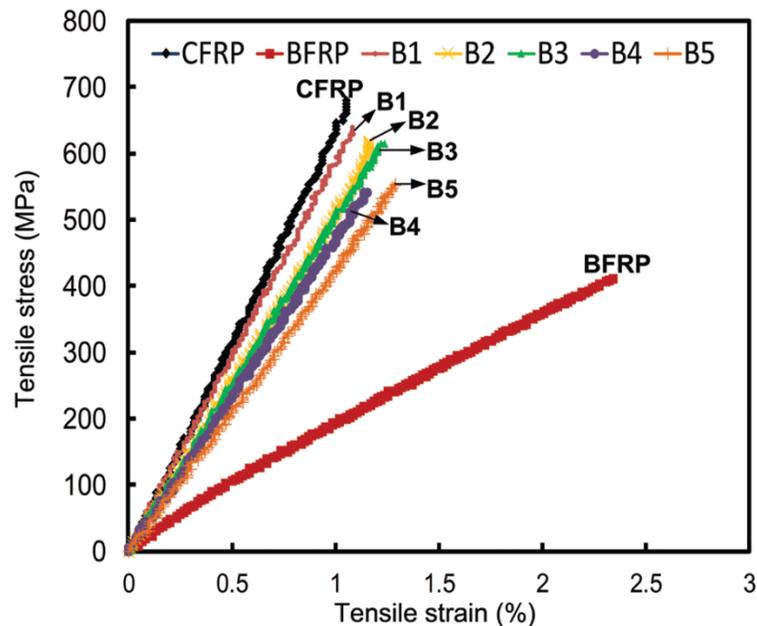
Figure 2.1 – Stress Strain Curve of CFRP and Other Fibers (Subagia and Kim, 2014)

Figure 2.1 demonstrates the tensile strength of CFRP can reach 689.7 MPa (100 ksi). The maximum tensile strain for CFRP in this case is slightly above 1%. It has become an accepted strengthening method because it is capable of reaching significant strengths. However, as illustrated in the figure, CFRP does not have a yield plateau. This causes significant amounts of

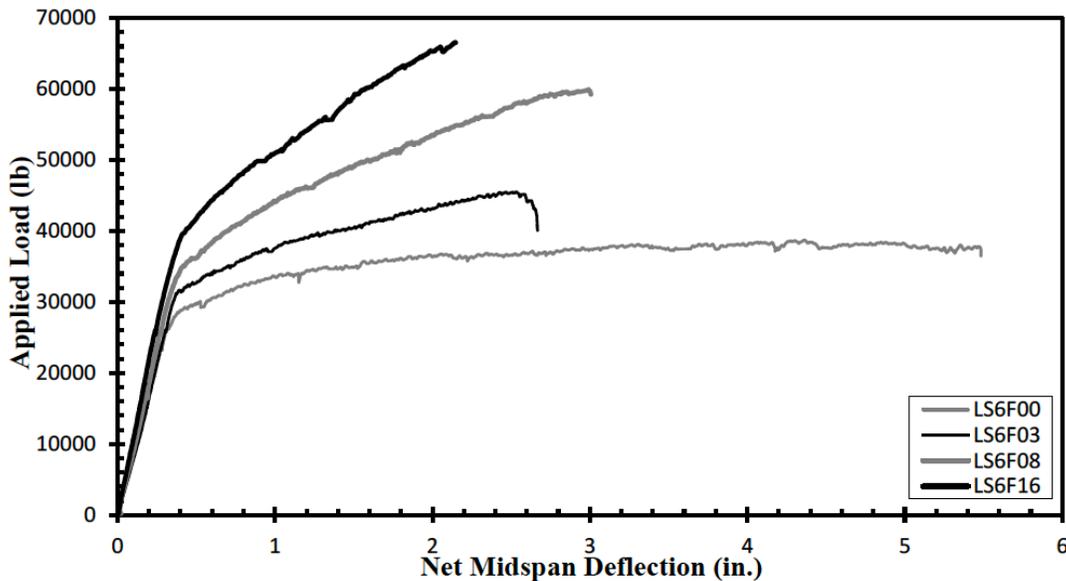
Figure 2.2 – Load vs Deflection FRP Reinforced Bridge Girder (Bertolotti, 2012)

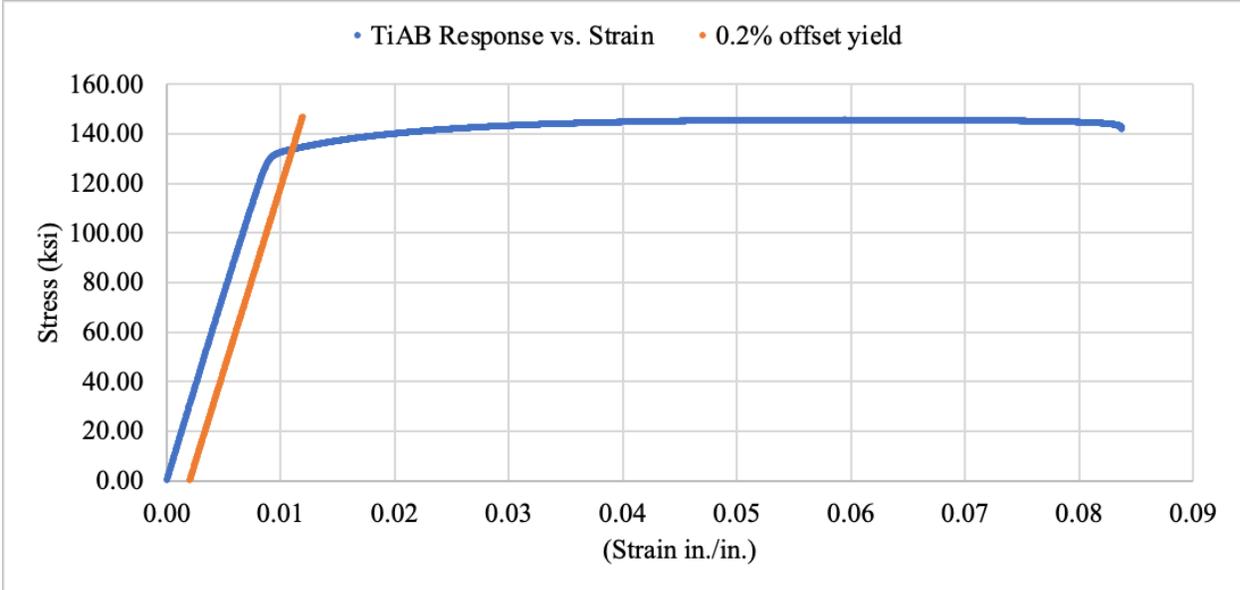
Figure 2.3 – Stress Strain Curve of TiAB with 0.2% offset yield

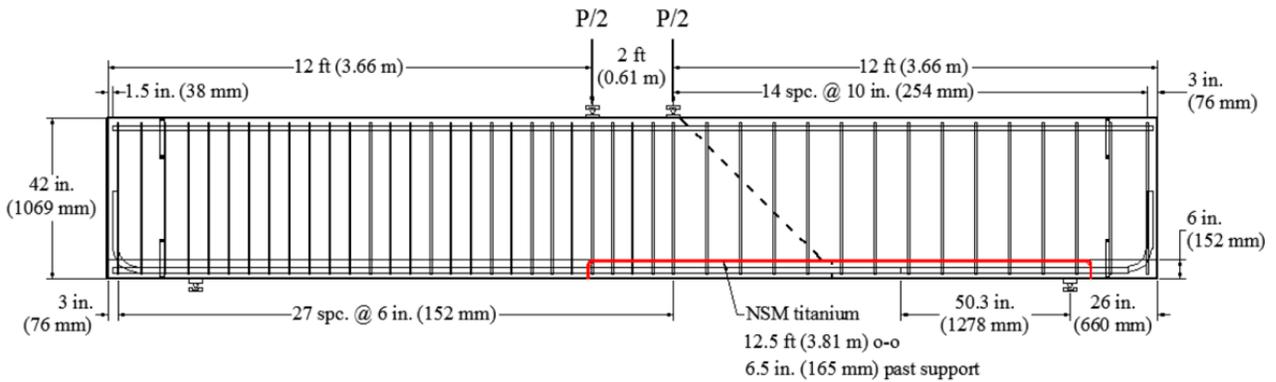
terminating a bar before development, or by leaving a gap between the longitudinal rebar at midspan to simulate inadequate lap splicing. Figure 2.4 illustrates a 45° crack with terminating reinforcing steel that was retrofitted with NSM TiAB. The beam in Figure 2.4 held 420.5 kips and displaced 1.12 inches at failure while the unreinforced comparison held 358.9 kips and displaced 0.98 inches at failures.

Figure 2.4 – NSM TiAB Retrofitted Beam with Inadequate Detailing (- Moment) (Barker, 2014)

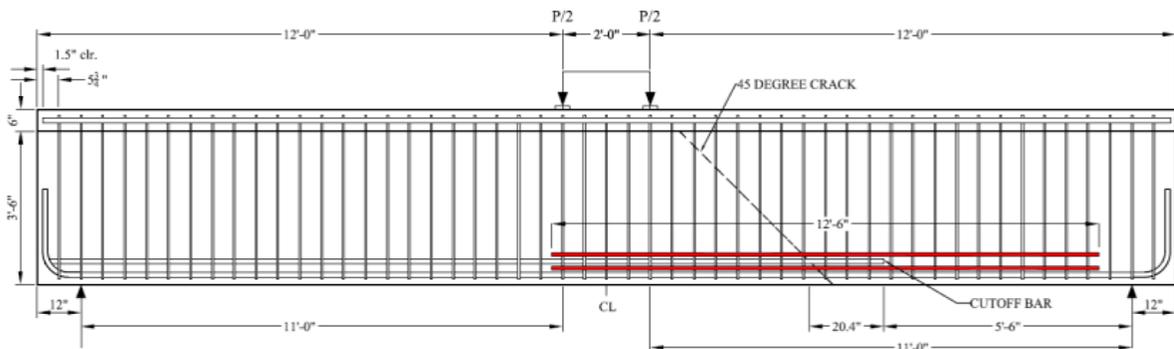
Figure 2.5 - NSM TiAB Retrofitted Beam with Inadequate Detailing (+ Moment) (Amneus, 2014)

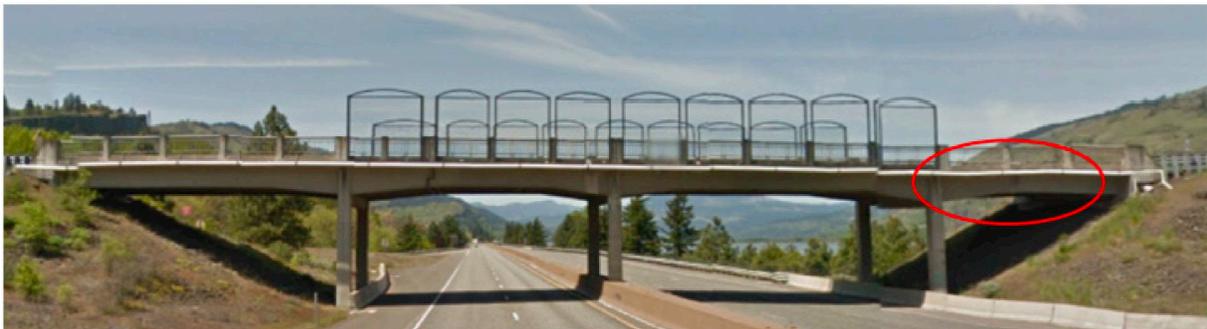
Figure 2.6 - Mosier Bridge with Critical Section circled (Higgins et al., 2015b)

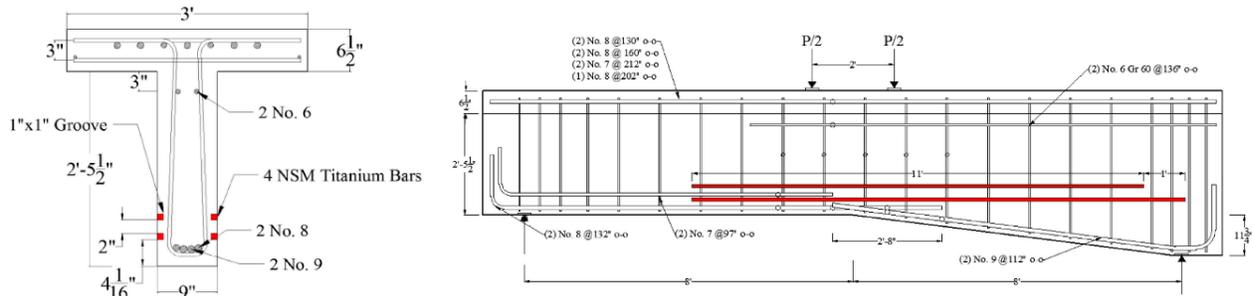
Higgins et al. (2015b) tested three beams to evaluate the NSM TiAB repair application experimentally before implementing it on the Mosier bridge. The beams were called Mosier 1, Mosier 2, and Mosier 3, Mosier 1 was a replica of the bridge as it was without any strengthening, Mosier 2 implements the NSM TiAB after failing the reinforcing steel anchorages, and Mosier 3 applies the TiAB with the steel anchorages fully intact. Figure 2.7 illustrates the location of the added NSM TiAB reinforcement.

Figure 2.7 - Mosier Girder and Cross Section with NSM TiAB (Higgins et al., 2015b)

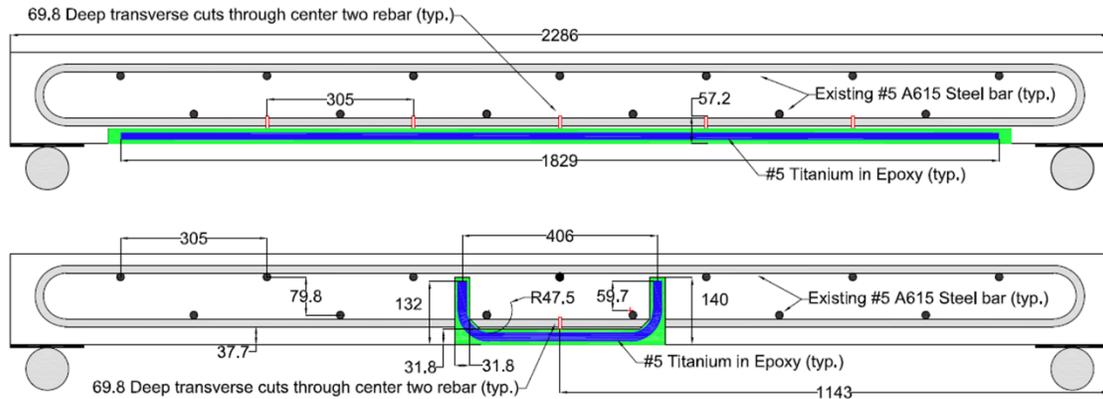
the retrofits as well as the cuts made to the longitudinal rebar to damage the slab is shown in Figure 2.8. The dimensions provided in Figure 2.8 are in millimeters.

Figure 2.8 - Straight Bar (Top) and Hooked Bar (Bottom) NSM Retrofit (Platt et al., 2019)

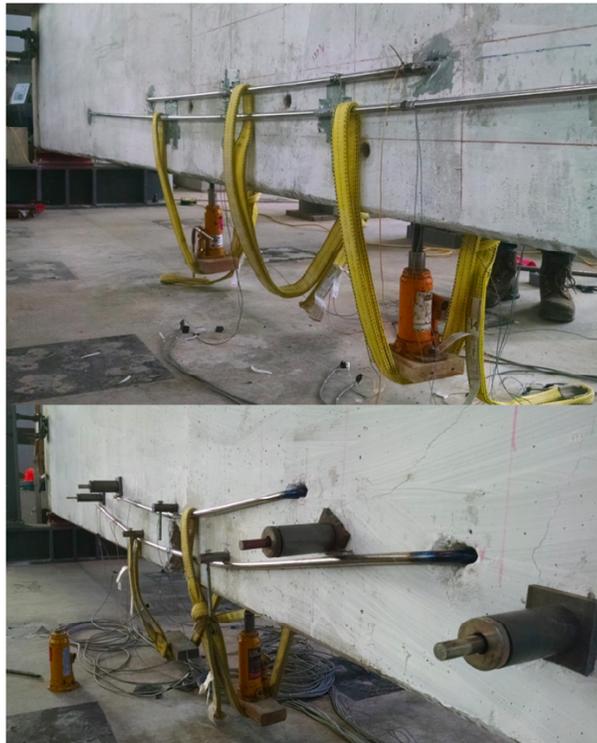
Figure 2.9 – Epoxy Anchors (top) and Prestressing Chuck Anchors (Bottom) (Vavra, 2016)

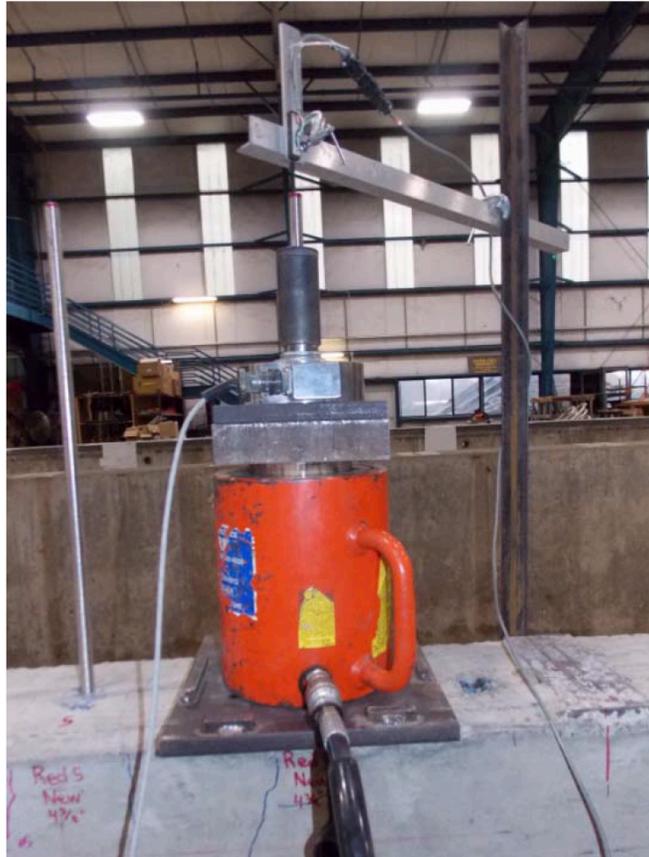
Barker (2014) conducted a study on negative-moment member-level NSM TiAB flexural strengthening- as discussed in Section 2.5.1. This study also conducted pull-out tests to evaluate the strength of several titanium-epoxy interfaces. Five TiABs with different surface deformations/treatments were tested. The surface deformation/treatments were surface blasted, rough finish, as well as light turn, light turn blasted, and heavy turn. “Turn” indicated threading along the bar to increase friction and bond performance. The pull-out test consisted of a 0.75 in. diameter hole drilled 5 in. deep. The hole was filled halfway with epoxy and the bar was set perpendicular to the concrete and allowed to cure for seven days. The pull-out test setup is shown in Figure 2.10.

Figure 2.10 - Pull-out test (Barker, 2014)

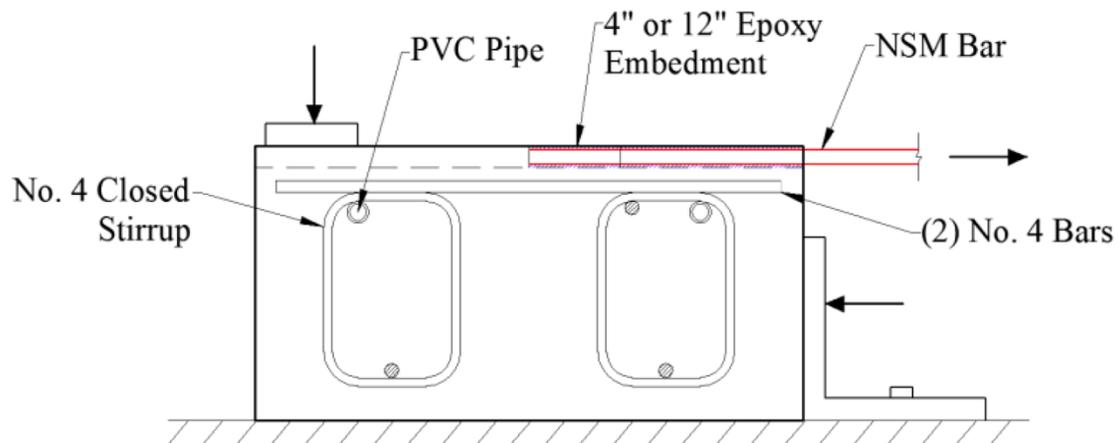
Amneus (2014) commenced member-level work in 2014 highlighted in section 2.6.2. The member-level study reported an average bond strength of 1.2 ksi for TiABs in flexure. Amneus also tested bond lengths of NSM TiABs at a smaller scale. The bond tests used an adapted version of ASTM A944 (2010). Six 9 x 12 x 4 in. blocks were constructed with a 15/16" groove cut into the top. Three 4 in. embedded #5 TiAB and three 12 in. embedded #5 TiAB were epoxied into the groove of these blocks and pulled with a 110-kip actuator. The test configuration can be seen in Figure 2.11.

Figure 2.11 - Modified ASTM A944 (2010) for Development Length (Amneus, 2014)

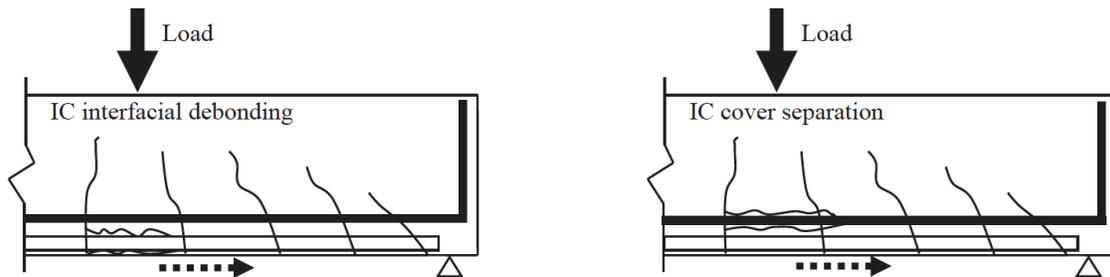
Intermediate-Crack (IC) occurs when a flexural crack, typically at or near the maximum moment region, induces high local interfacial shear stresses because of the geometric discontinuity (Zhang et al., 2017). IC debonding can be further classified into either interfacial debonding or cover separation. IC interfacial debonding can occur between the concrete-concrete interface or more commonly the epoxy-concrete interface. IC cover separation debonding occurs when the failure plane is along the depth of the cover region. The two different types of IC debonding can be seen in Figure 2.15.

Figure 2.15 - IC Debonding (Zhang et al., 2017)

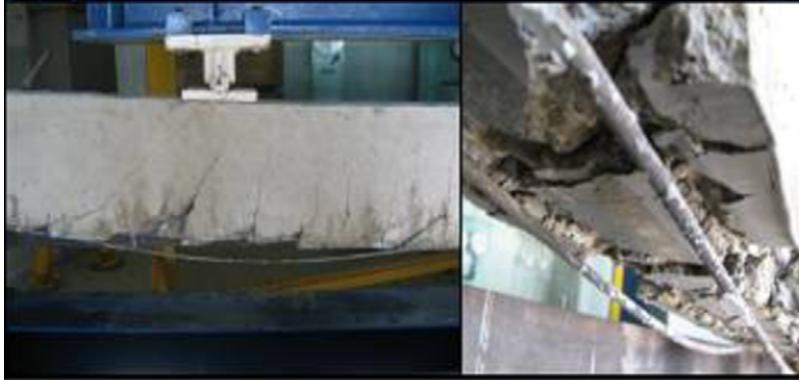
Epoxy rupture is initiated by flexural cracks in the epoxy. More cracks propagate within the epoxy and eventually a continuous failure plane is created, and the epoxy shatters. An example of this failure was observed in a study of NSM CFRP rods conducted by Al-Mahmoud, et. al (2009). The epoxy rupture failure in that study is shown in Figure 2.16.

Figure 2.16 – Epoxy Rupture (Al-Mahmoud, et al. 2009)

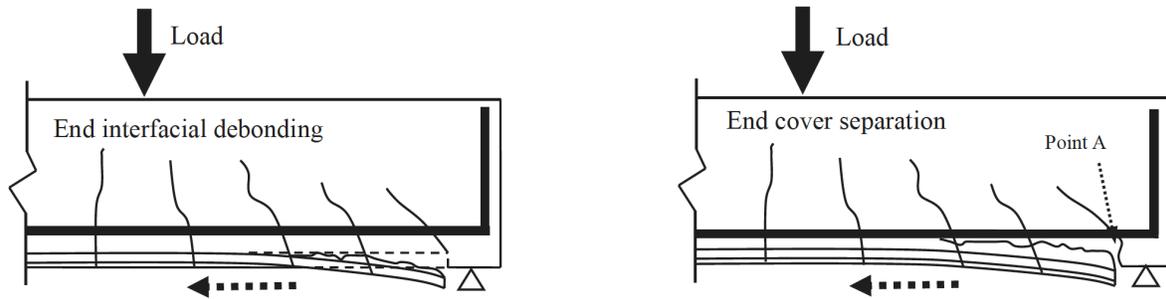
In this failure mode, the debonding of the NSM reinforcement starts from the terminus and propagates to the mid-span of the beam. This failure mode is mainly due to the high interfacial shear and normal stresses caused by the abrupt termination of the NSM reinforcement (Zhang et al., 2017). It can also be further classified as end cover separation if the crack separates the NSM reinforcement and cover from the core of the beam. Figure 2.17 displays end debonding.

Figure 2.17 - End Debonding (Zhang et al., 2017)

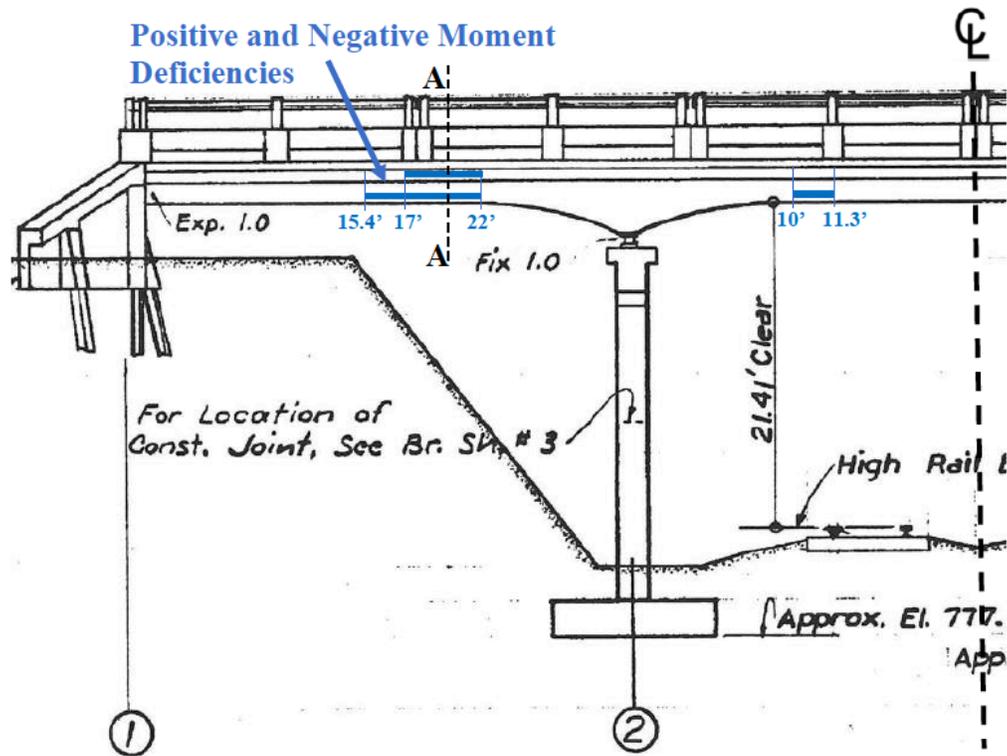
Table 3.1 and Figure 3.3 confirmed that both positive and negative flexural strengthening is required at the reinforcement cutoff locations in the two end spans (e.g., Section A-A in Figure 3.3). Since the bridge passes over the railroad line, there was also limited clearance and access to perform any work under the bridge (positive moment strengthening). Therefore, this bridge was selected as the representative case to demonstrate the use of NSM TiABs for the strengthening method to address both negative- and positive-moment deficiencies.

Figure 3.3 - Cullman Bridge Schematic with Critical Sections Highlighted

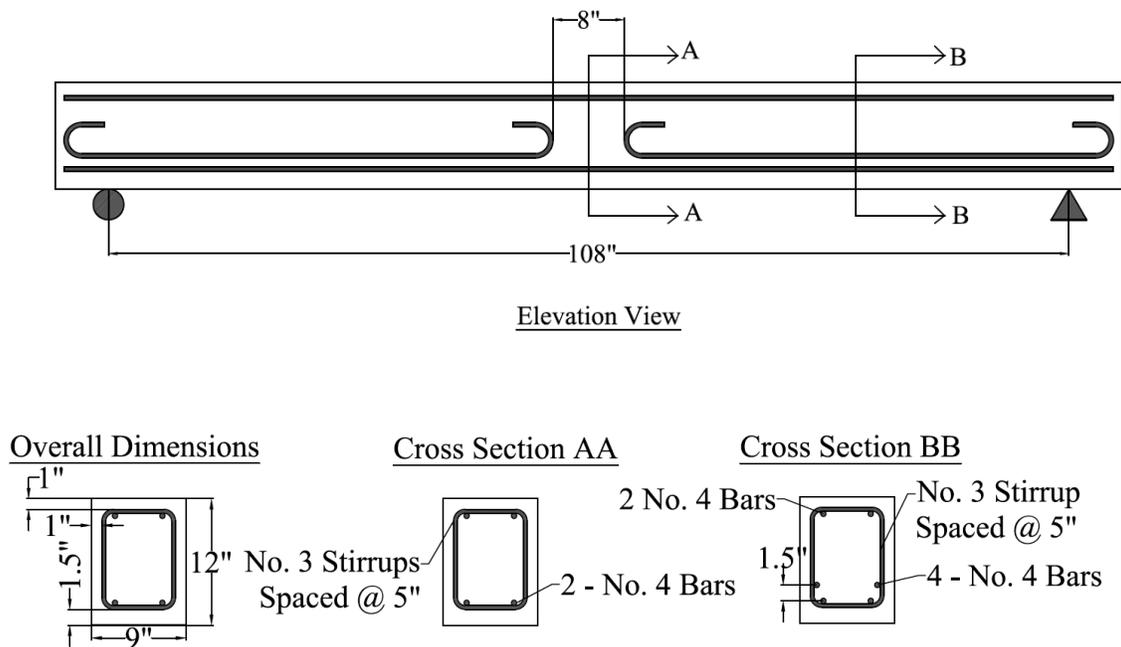
A615 Grade 60 longitudinal bars located in three layers (one top layer and two bottom layers, as shown in Figure 4.3). The specimens were built with an 8 in. long segment in the mid-span region, where half of the longitudinal reinforcement (the second layer from the bottom) was terminated with 180° hooks to create a weak region. This bar termination was to ensure that the beam would fail in a predictable manner in the mid-span region as well as to simulate a beam that required flexural strengthening. A similar three-point-loading test with a weak region in the center of the beam was previously used by Hassan and Rizkalla (2003) to investigate the effectiveness of NSM CFRP strips, as discussed in Section 2.8.1. The flexural reinforcement and beam cross-sections are shown in Figure 4.3.

Figure 4.3 - Beam Flexural Reinforcement and Cross Sections

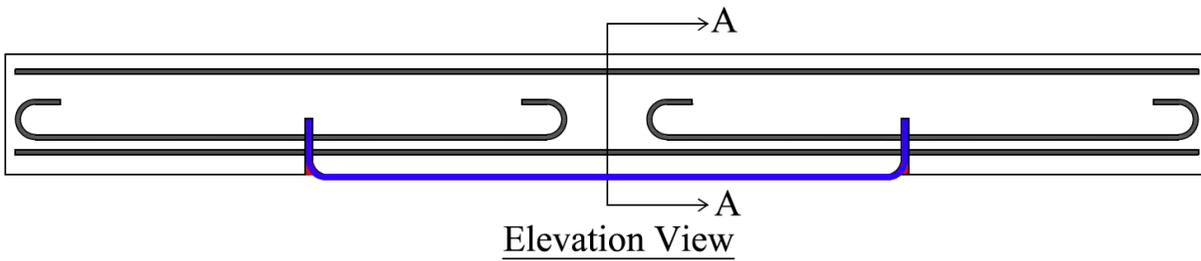
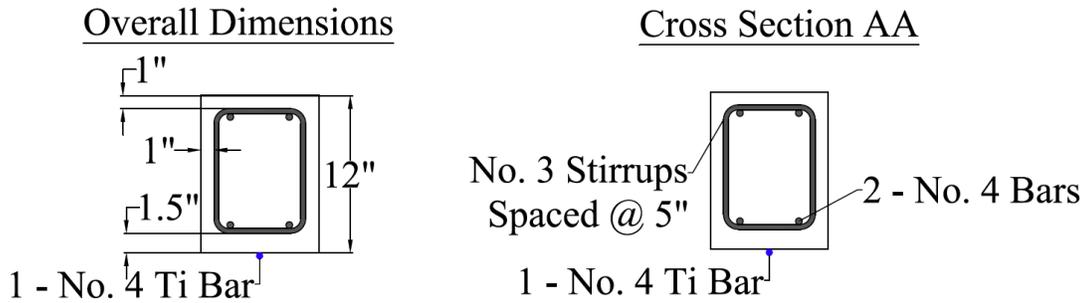
Hooked-unbonded TiAB specimens did not have a groove and the TiABs were flush with the bottom face of the beam with penetrating hooks epoxied into the concrete. Figure 4.9 depicts the elevation view of the hooked-unbonded specimens' flexural reinforcement, the mid-span cross-section, and cross-section dimensions.

Figure 4.9 - Hooked-Unbonded TiAB Specimen Design

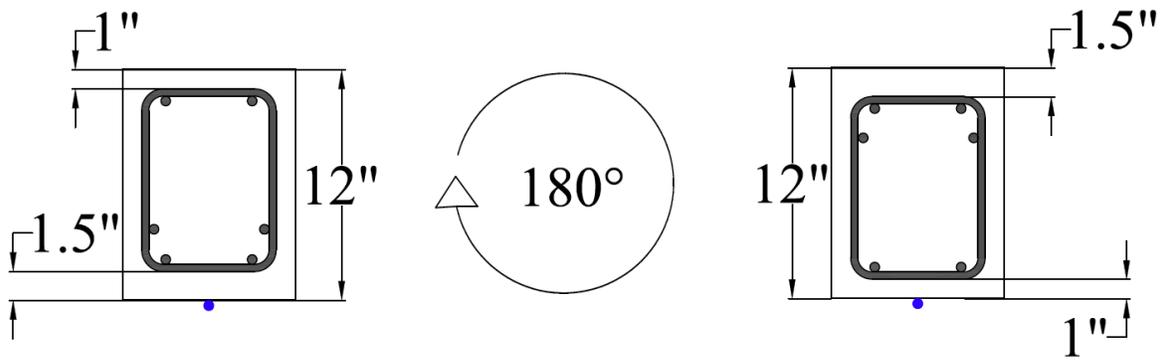
R.HU.60 was a unique specimen because it was tested in a flipped orientation resulting in different concrete clear covers and reinforcement configuration. An illustration of the midspan cross-section is shown in Figure 4.10. Due to the flipped orientation, the steel rebar in R.HU.60 had a structural depth of 10.38 inches rather than 9.88 inches. This was done because the beam was repurposed from its original intention as another hooked-bonded TiAB specimen. The hook bending diameter was also changed for R.HU.60 to mitigate the anchorage failure mode observed in other specimens with the same anchorage method. A larger hook bending diameter of 6 inches and tail length of 6 inches was used for this specimen to increase the bearing area against the concrete and to reduce the potential of anchorage slippage. The bending diameter for all the other hooks was 3 inches with a consistent tail length of 6 inches, as mentioned in Section 2.10.1.

Figure 4.10 – Normal Hooked-Unbonded (Left) and R.HU.60 (Right) Cross Sections

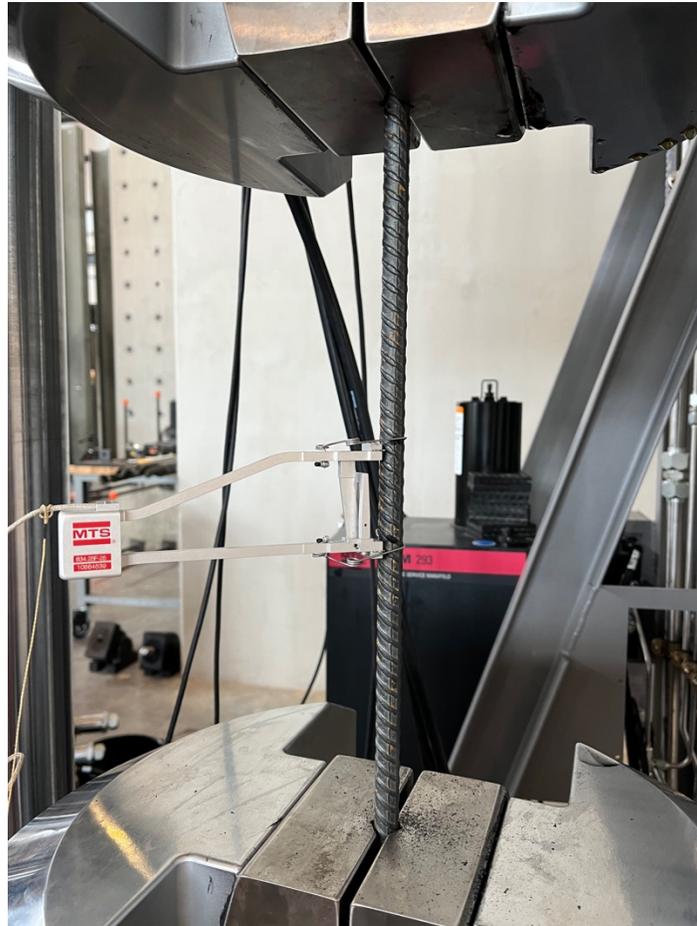
Figure 5.1 – Reinforcing Steel Tensile Test

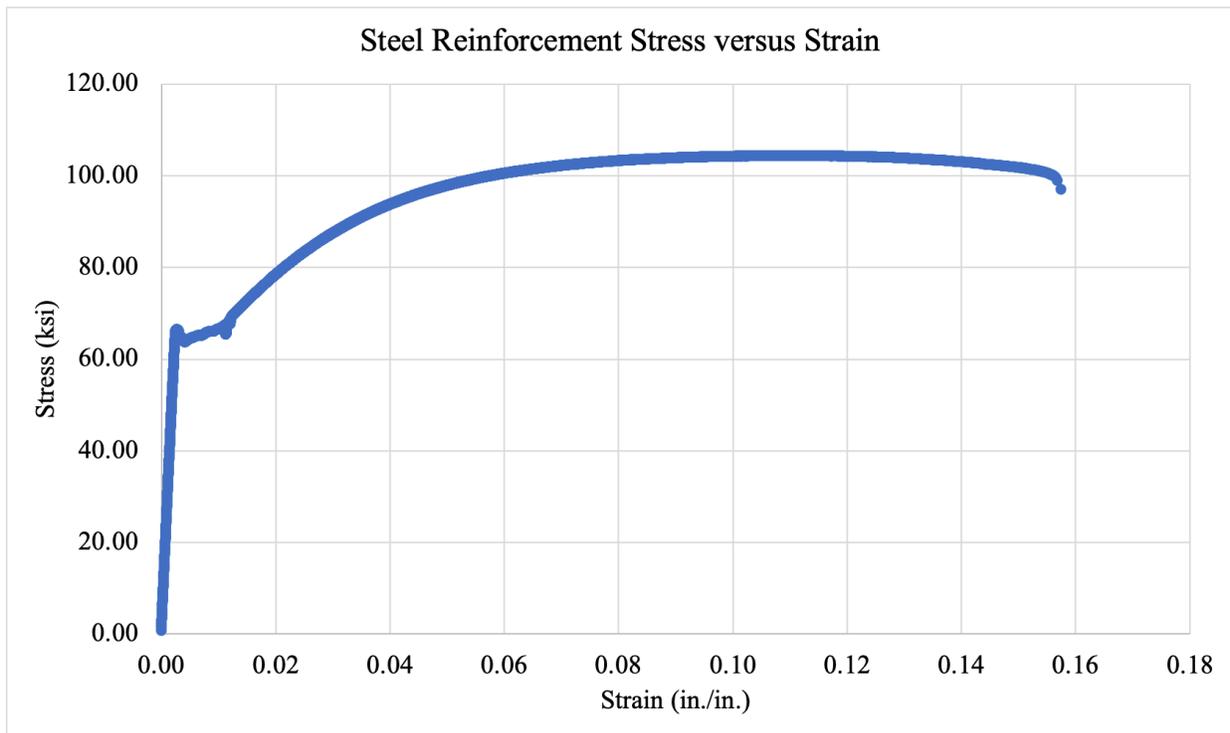
test and the mill certified test report (MCTR) values can be seen in Table 5.1. Figure 5.2 shows a typical stress-strain curve obtained from the tension tests.

Figure 5.2— Steel Reinforcement Measured Response

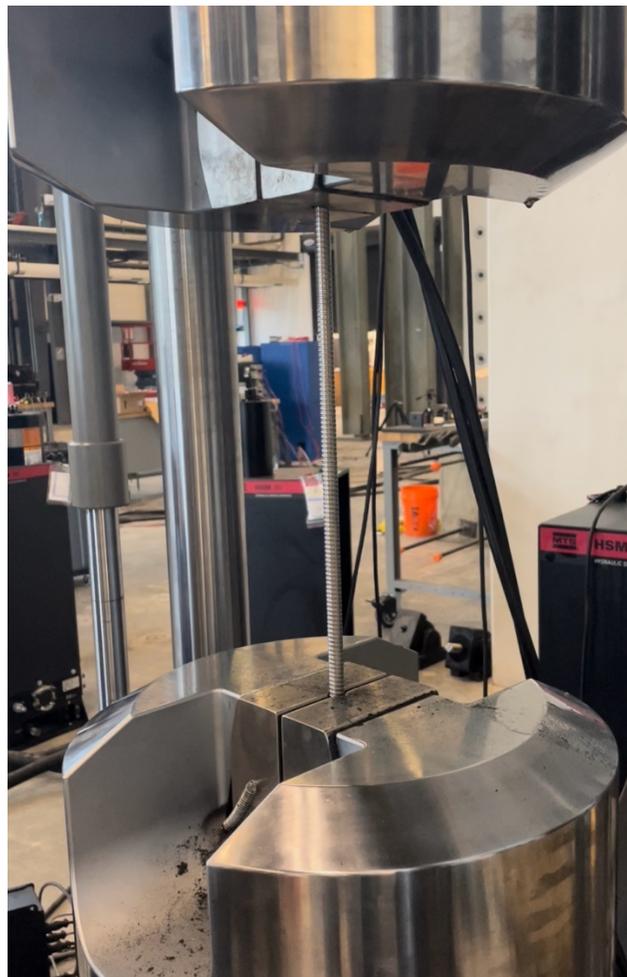
The surface pattern on the TiABs resembled threads on a threaded rod, and the peaks and valleys of the threaded pattern were slightly rounded to minimize stress concentrations (Amneus, 2014). The mill certification obtained from the manufacturer conformed to the requirements of ASTM B1009-(2022). Tensile testing was performed in the laboratory to verify the reported material properties and provide strength properties to be used for calculations and analysis. All the titanium bars were rolled from the same production run (mill certification provided in Appendix B), and tension tests were completed on samples taken from several bars. Figure 5.3 depicts a TiAB bar prior to tension testing using the UTM.

Figure 5.3— TiAB Tensile Test

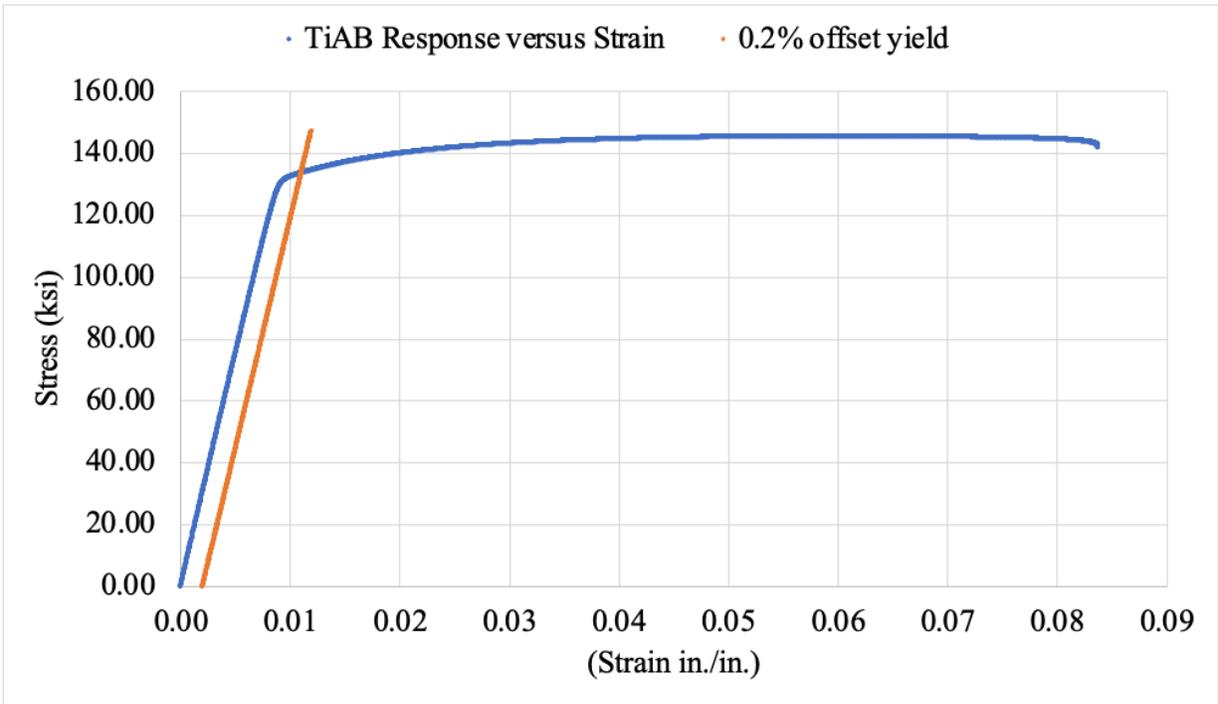
Figure 5.4— TiAB Measured Response

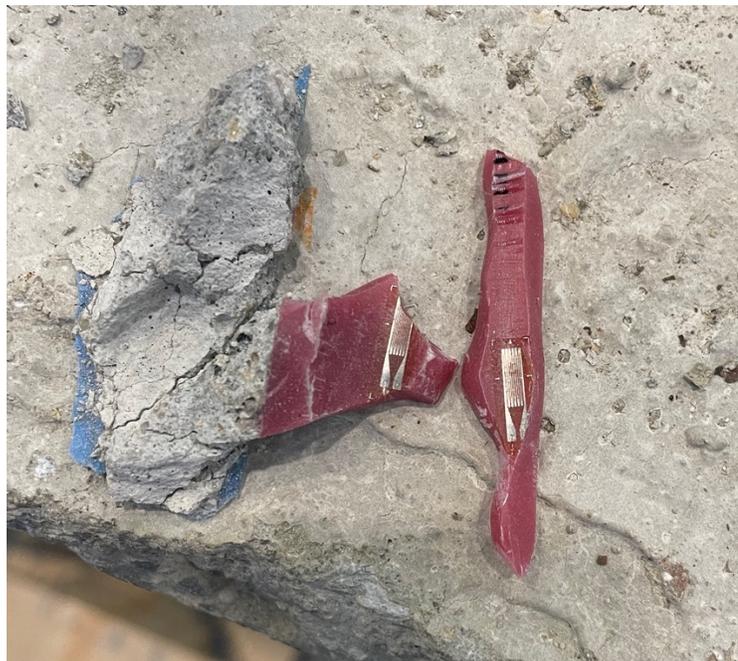
It was observed during the testing that the TiAB strain gauges for the bonded specimens malfunctioned during testing. The strain gauge malfunctioning typically occurred around 6000 microstrains, which is prior to capturing the TiAB yielding and (yielding of the TiAB occurs around 8500 microstrains). The strain gauges would adhere to the epoxy once the TiAB was mounted into the groove. The epoxy has a lower tensile strength than the TiAB and whenever the cracks formed the gauges would stop reporting values indicative of the TiAB. Figure 6.5 depicts strain gauges attached to the epoxy rather than the TiAB post-test.

Figure 6.5 – Strain Gauges and Epoxy Post-Test

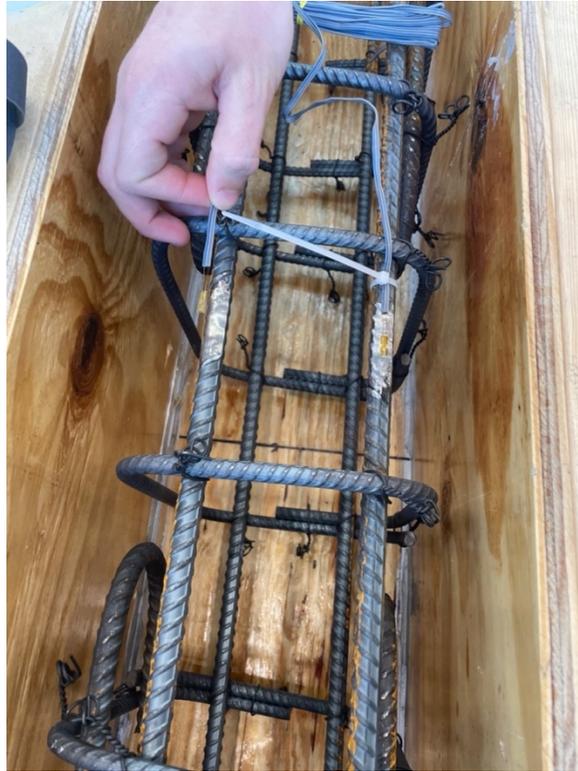
degreaser was used to remove any grease or oil from the smooth surface. The surface was then wet-sanded with 220-grit sandpaper followed by 320-grit with a mild phosphoric-acid conditioner. An ammonia-based neutralizer was then used to chemically neutralize the surface and clean any contaminants. The strain gauge was then attached to the bar using a cyanoacrylate adhesive. Figure 6.6 displays strain gauges attached to reinforcing bars.

Figure 6.6— Strain Gauge on Tension Steel

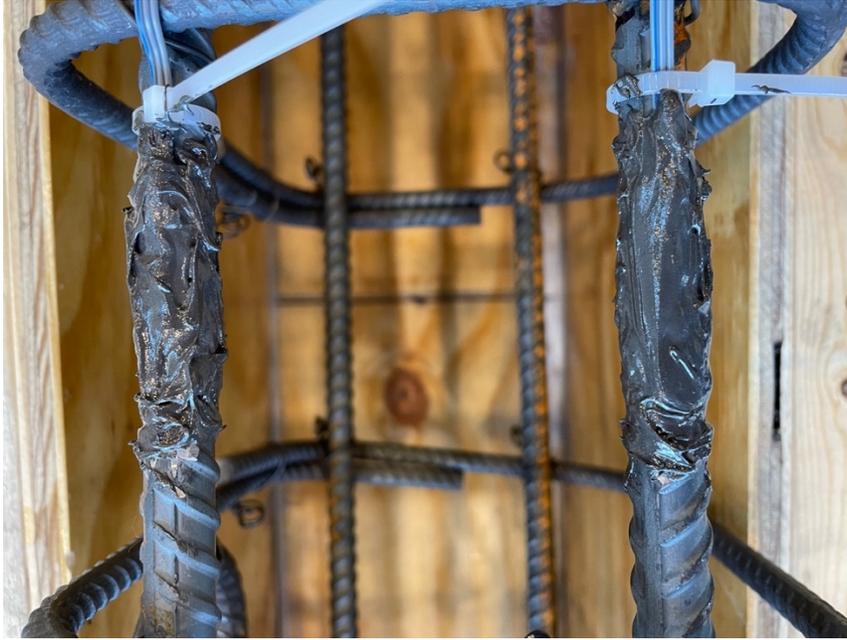
Figure 6.7— Strain Gauges with Polysulfide Coating

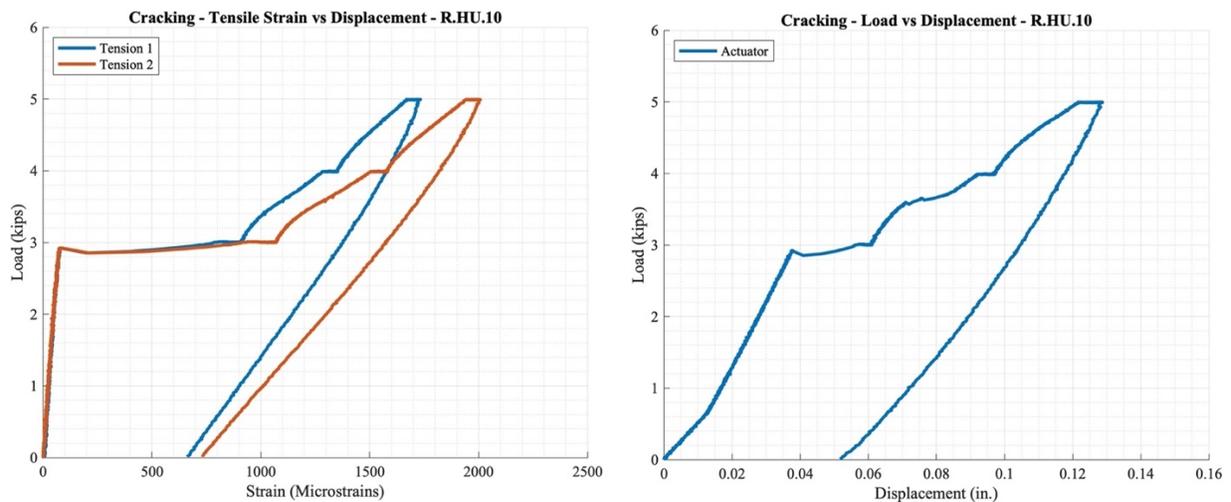
Figure 7.1— Example Tensile Strain vs Displacement (Left) Load vs Displacement (Right)

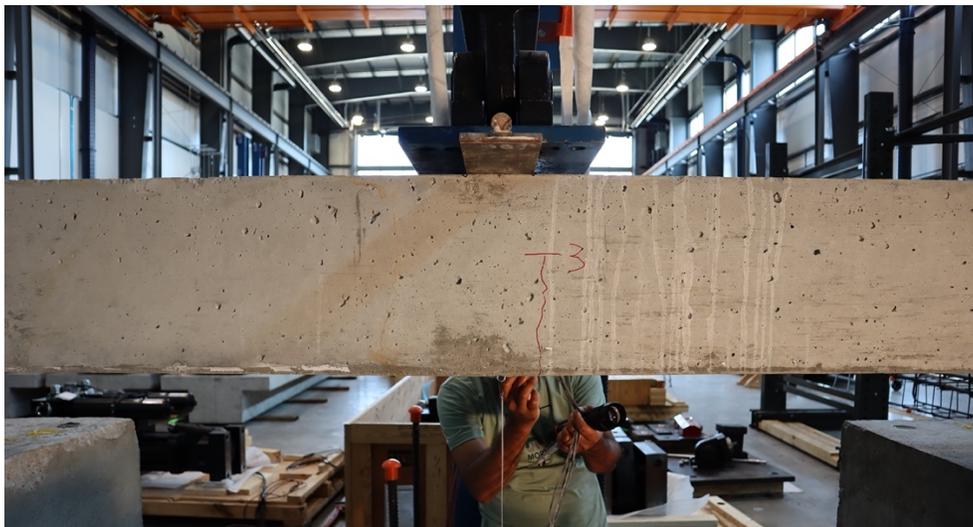
Figure 7.2— Crack initiation during Pre-Cracking

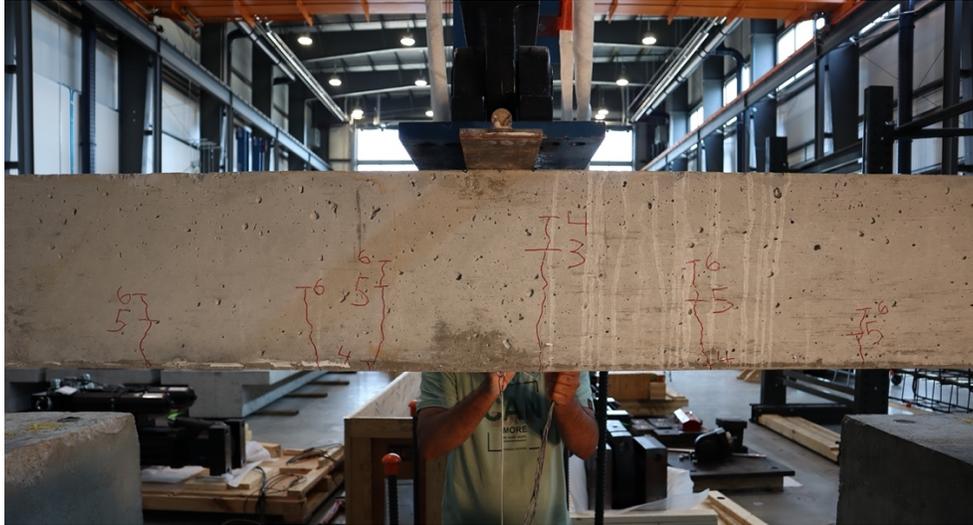
Figure 7.3— Typical Crack Pattern at end of Pre-Cracking

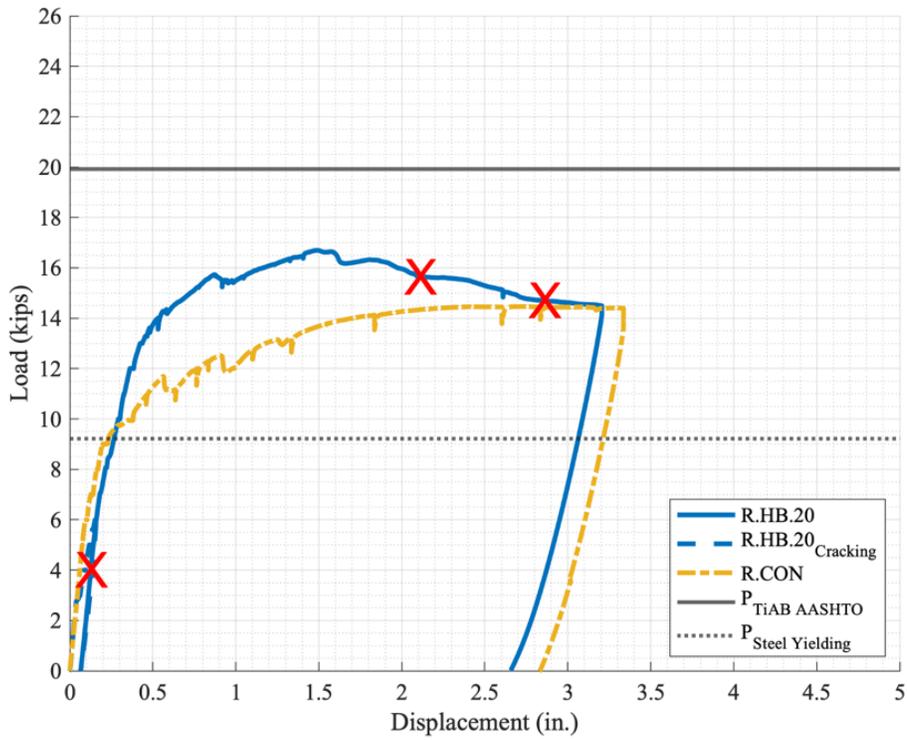
Figure 8.12— R.HB.20 Load versus Displacement Response

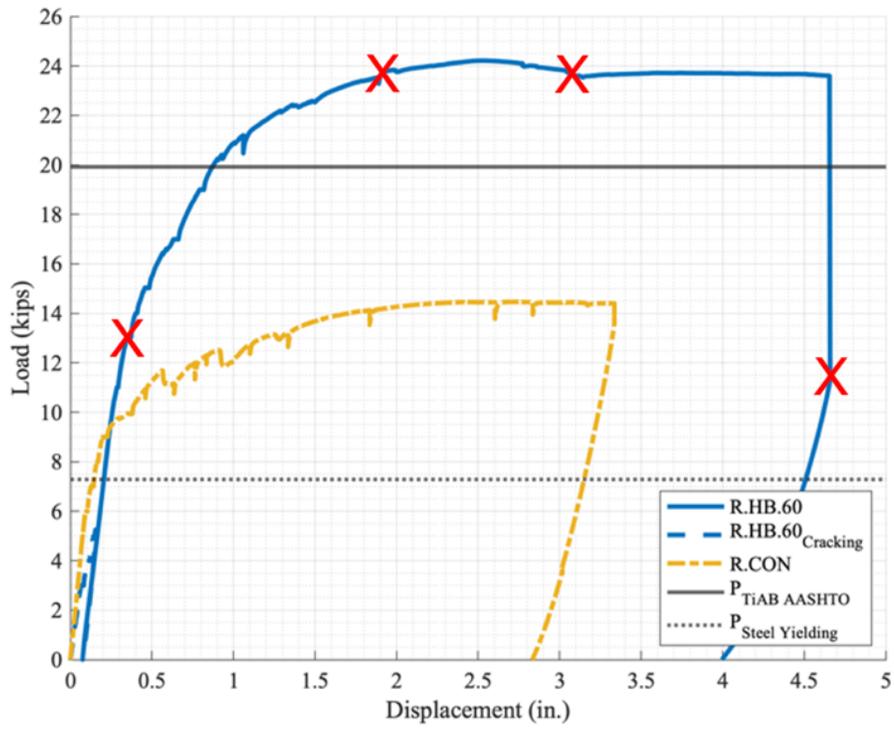
Figure 8.30— R.HB.60 Load versus Displacement Response

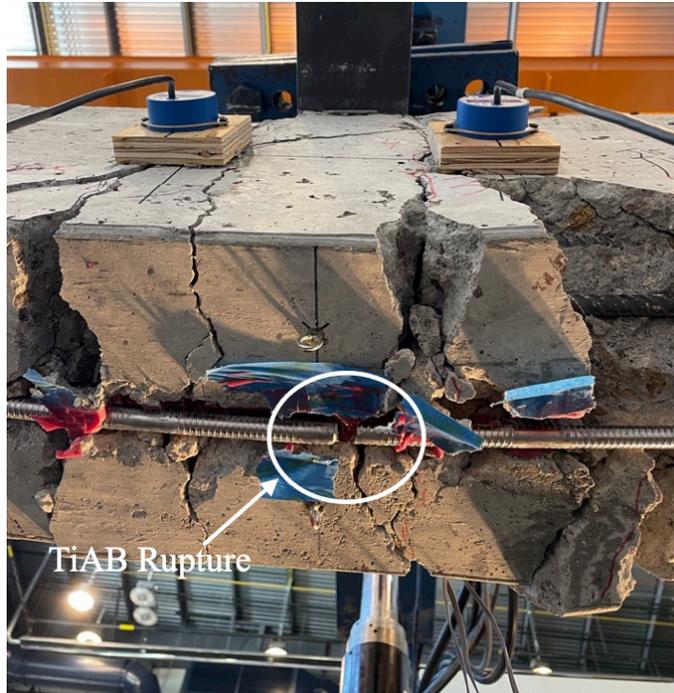
Figure 8.32— R.HB.60 Post Failure

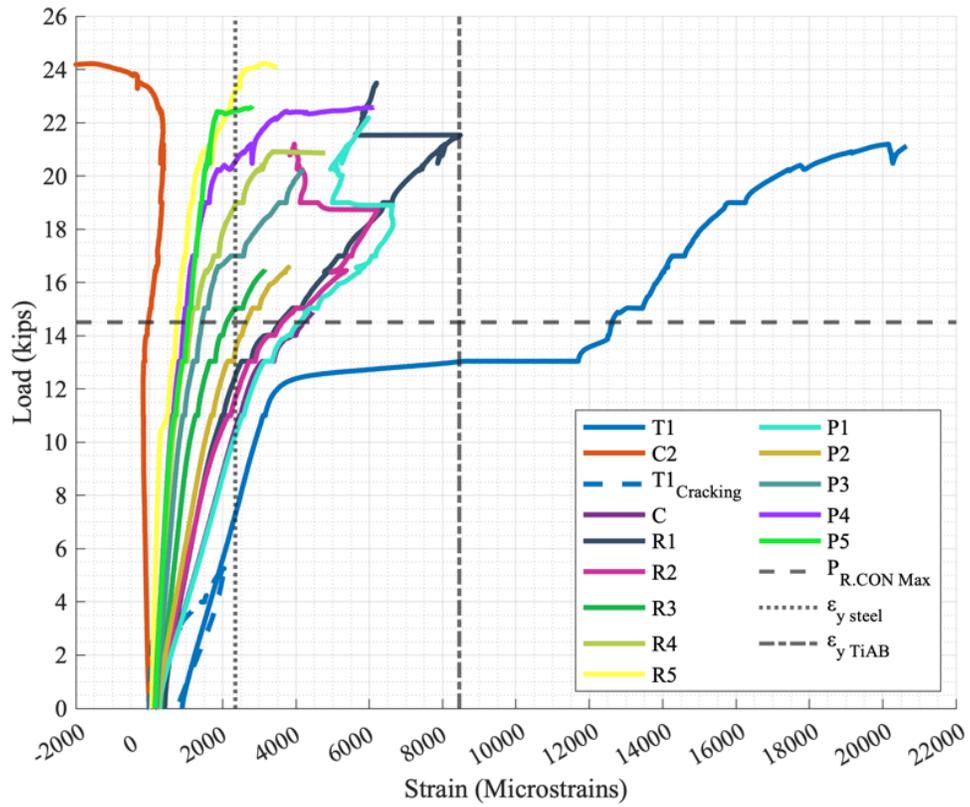
Figure 8.33 – R.HB.60 Load versus Strain Response

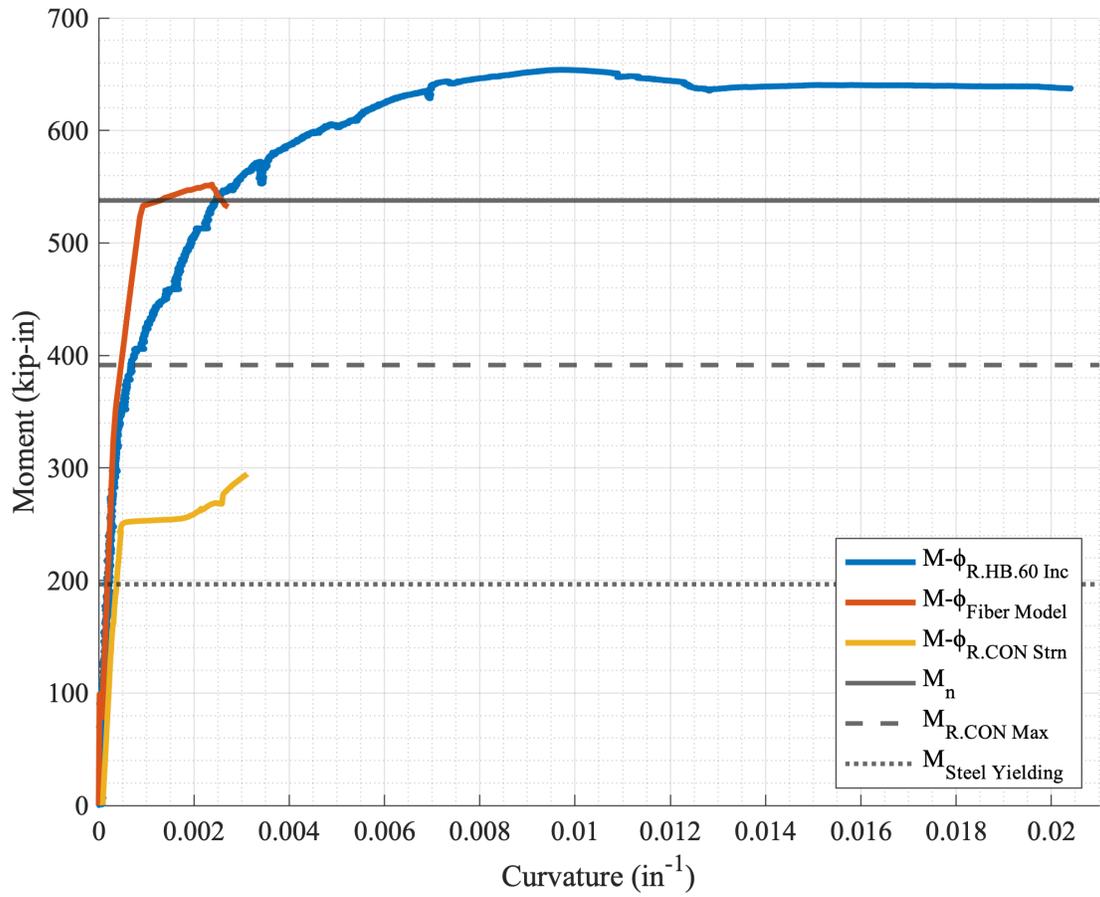
Figure 8.34 – R.HB.60 Moment versus Curvature Response
