**Determination of the Effective Bond Strength for Near-Surface Mounted
Titanium-Alloy Bars in Reinforced Concrete**

A thesis submitted to the Graduate Faculty of
Auburn University
in partial fulfillment of the
requirements for the Degree of
Master of Science

Keywords: Bond strength, Bridge Strengthening, Reinforced Concrete, Near Surface Mounting,
Titanium-Alloy Bars,

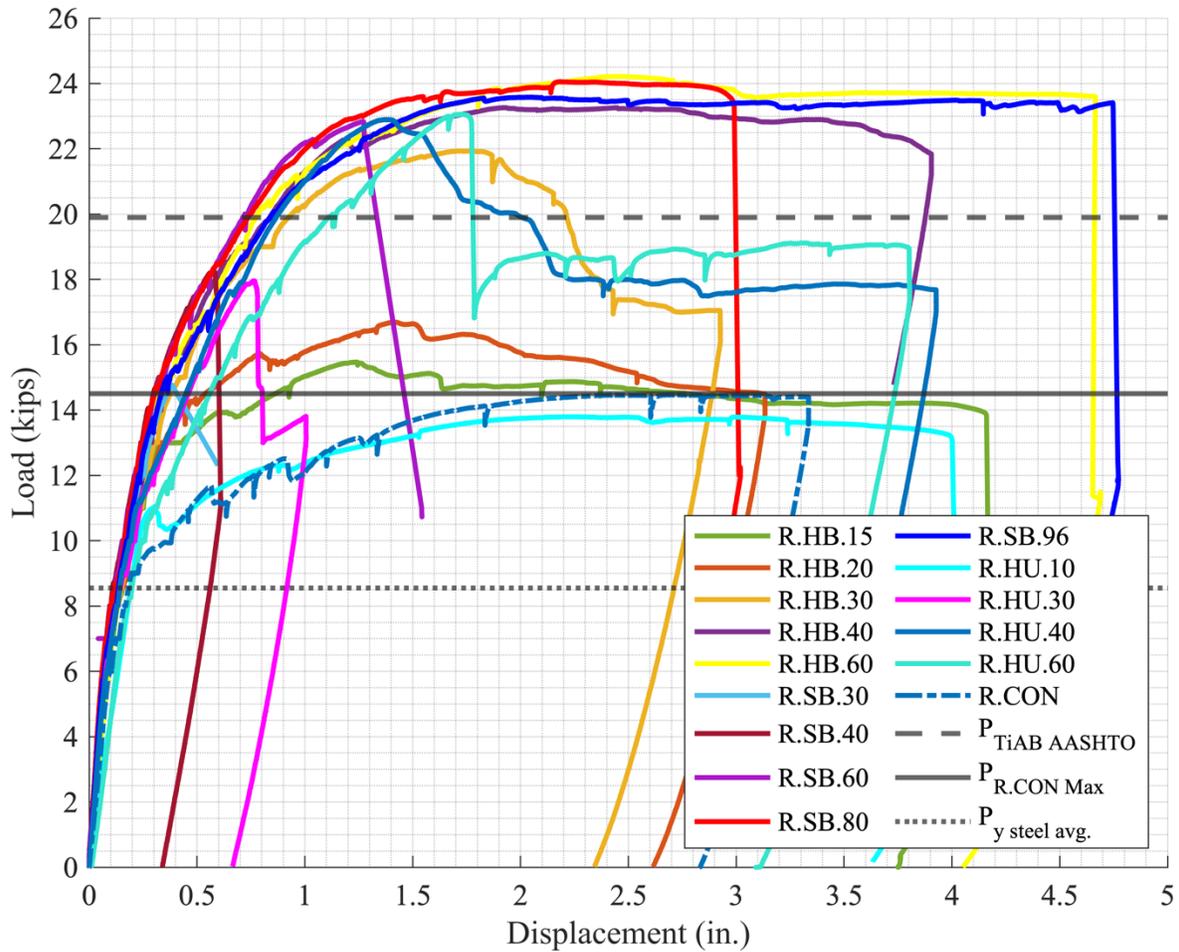
Figure 8.90 – All Specimens Load versus Displacement Response

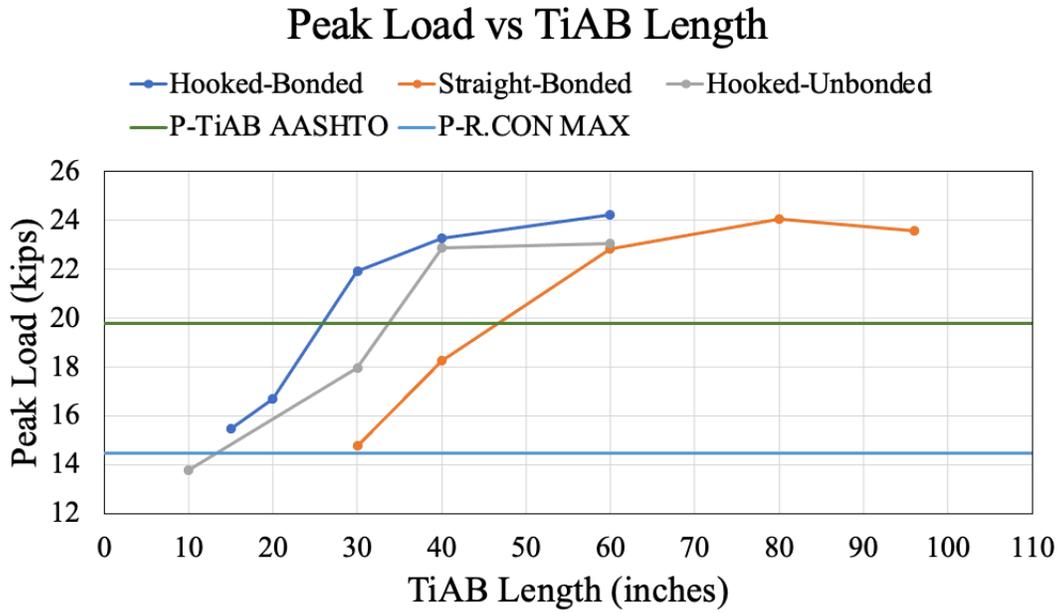
Figure 8.91 - Peak Load versus TiAB Length for all Anchorage Methods

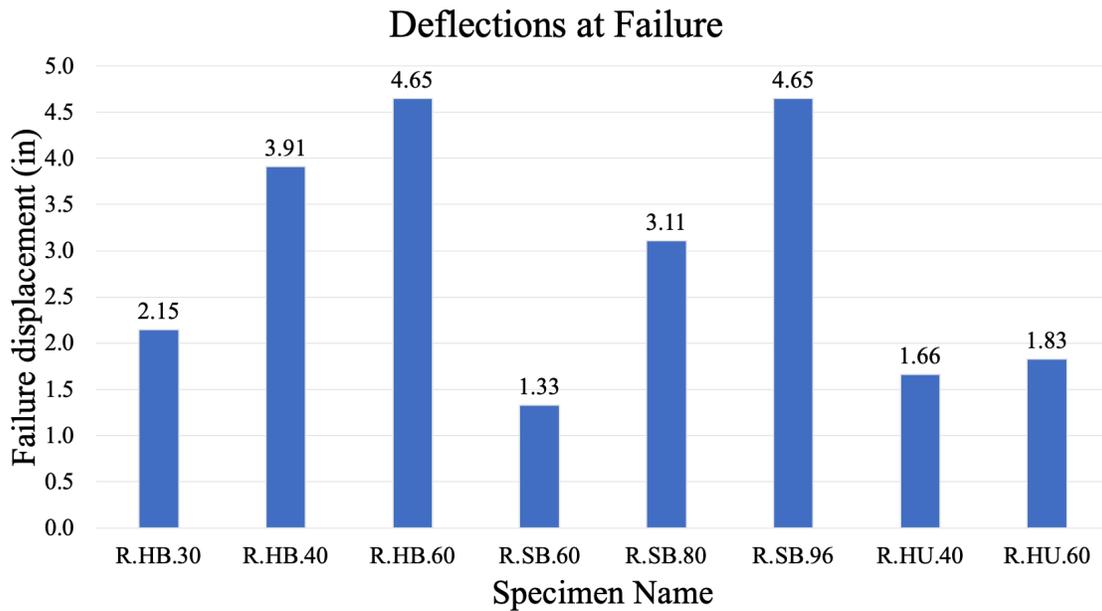
Figure 8.92 - Deflections at Failure for Specimens that reached TiAB Yielding

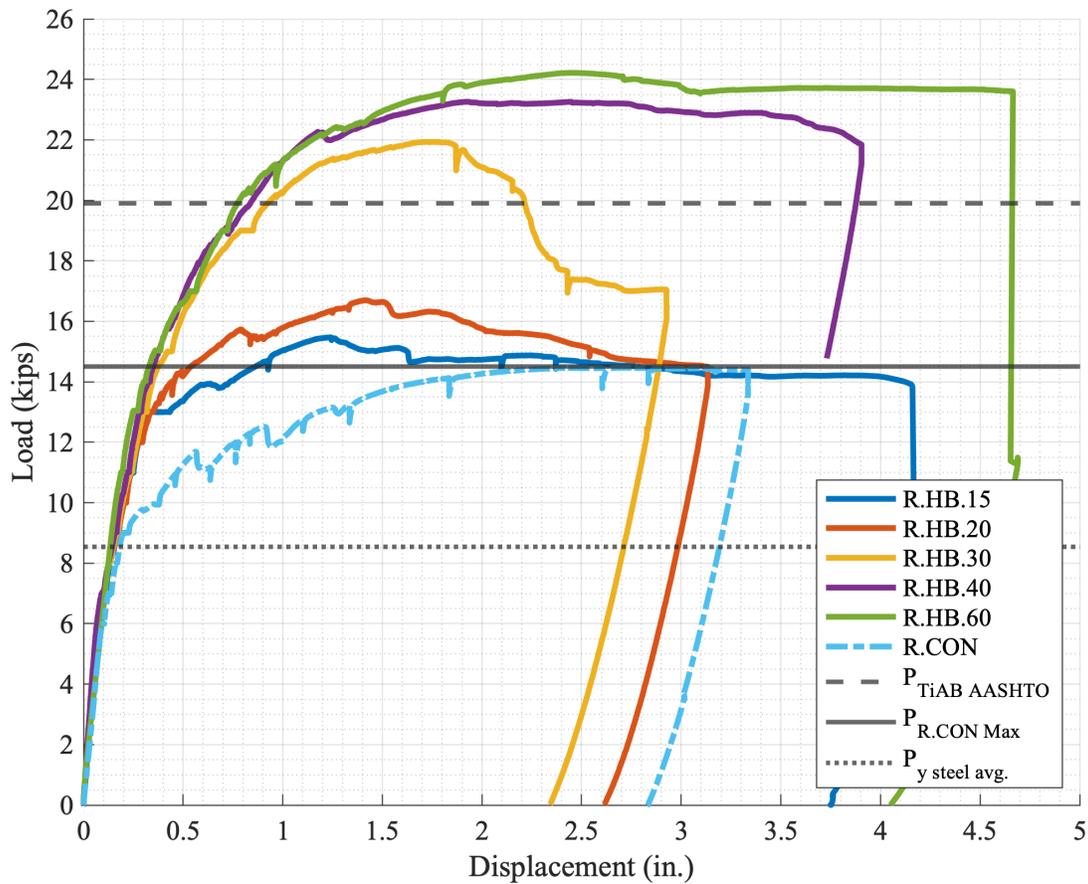
Figure 8.93 - Hooked-Bonded TiAB Load versus Displacement

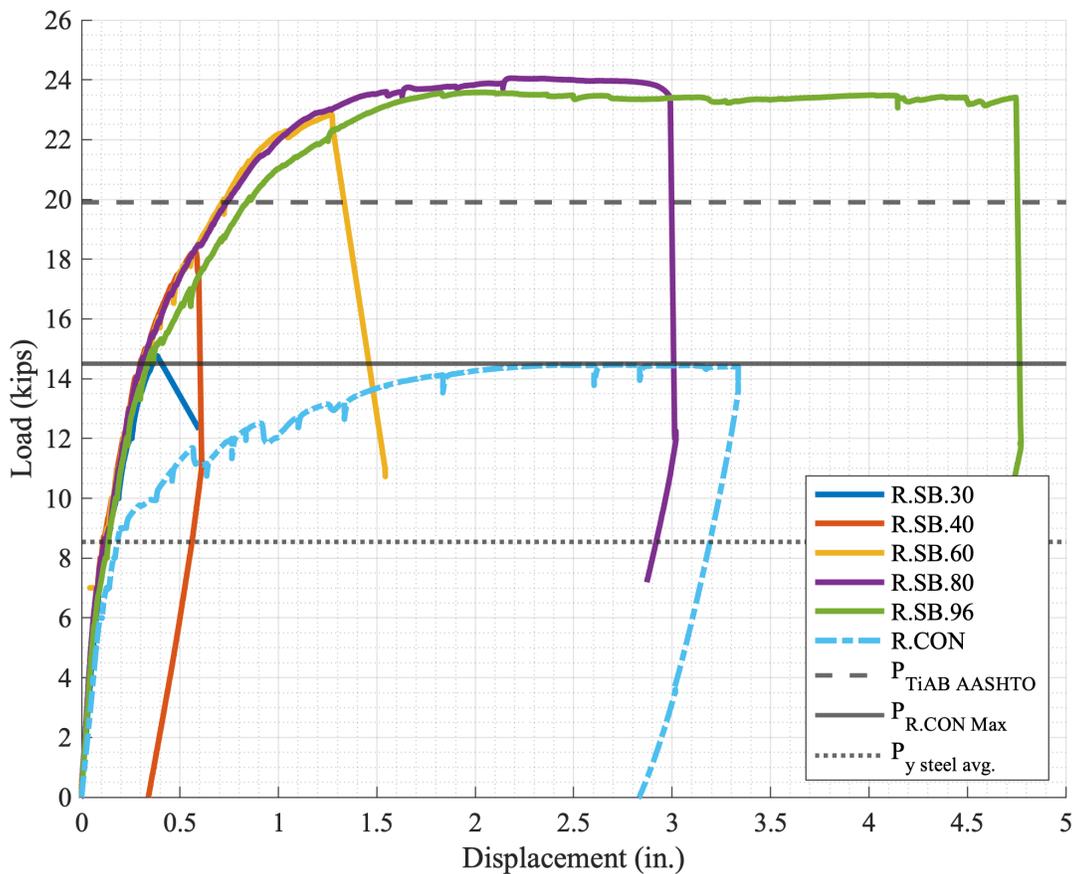
Figure 8.94 - Straight-Bonded Load versus Displacement

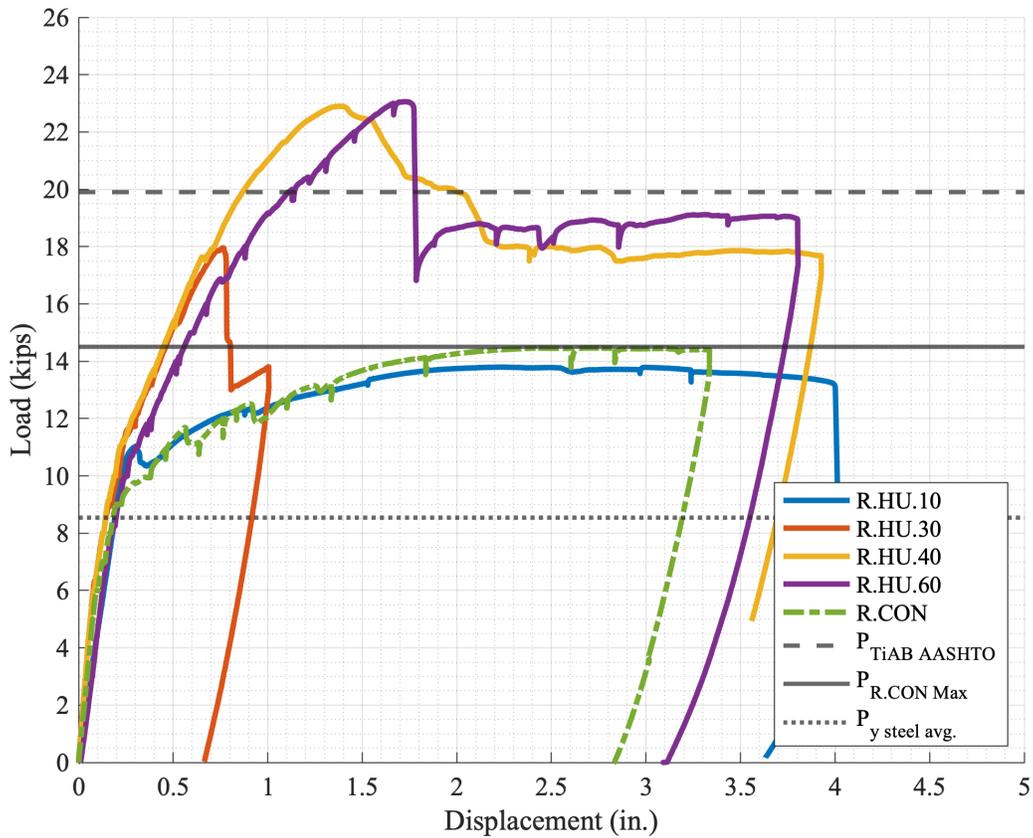
Figure 8.95 - Hooked-Unbonded Load versus Displacement

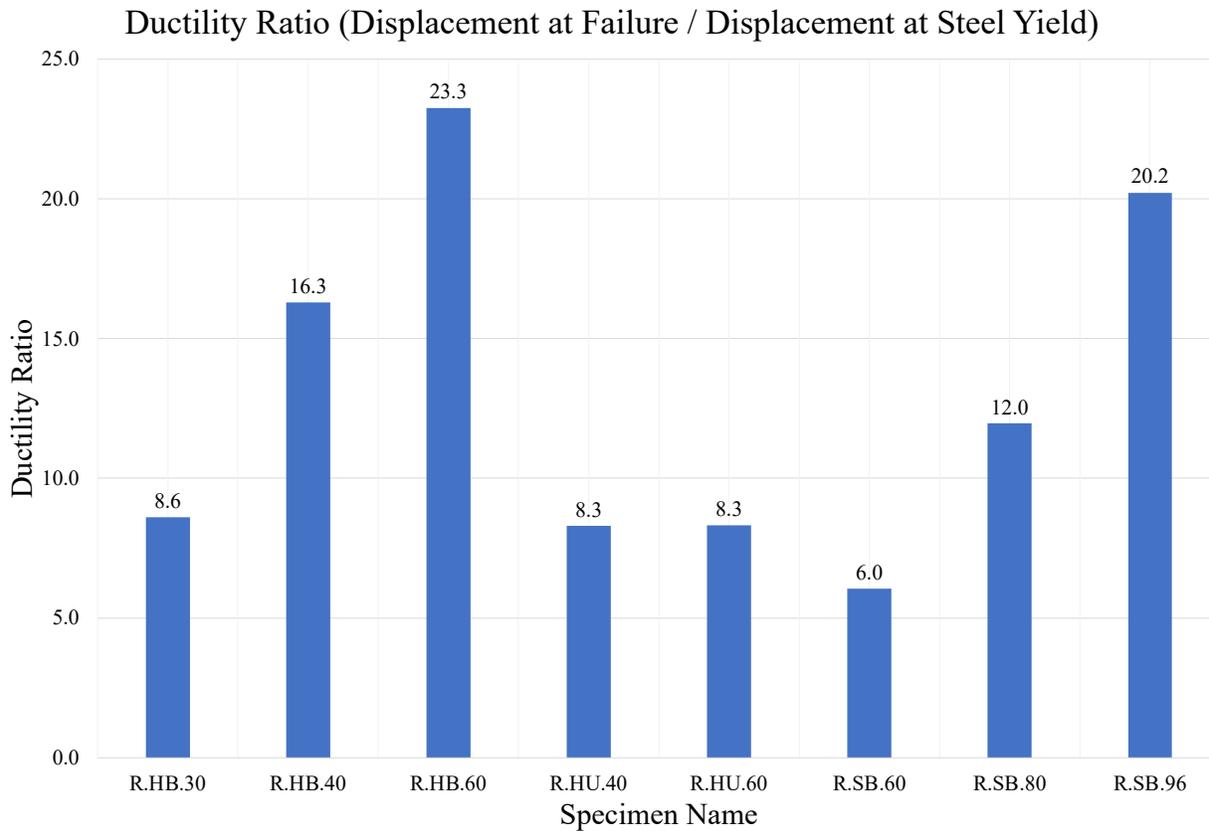
Figure 8.96 – Ductility Ratios using Steel Yield

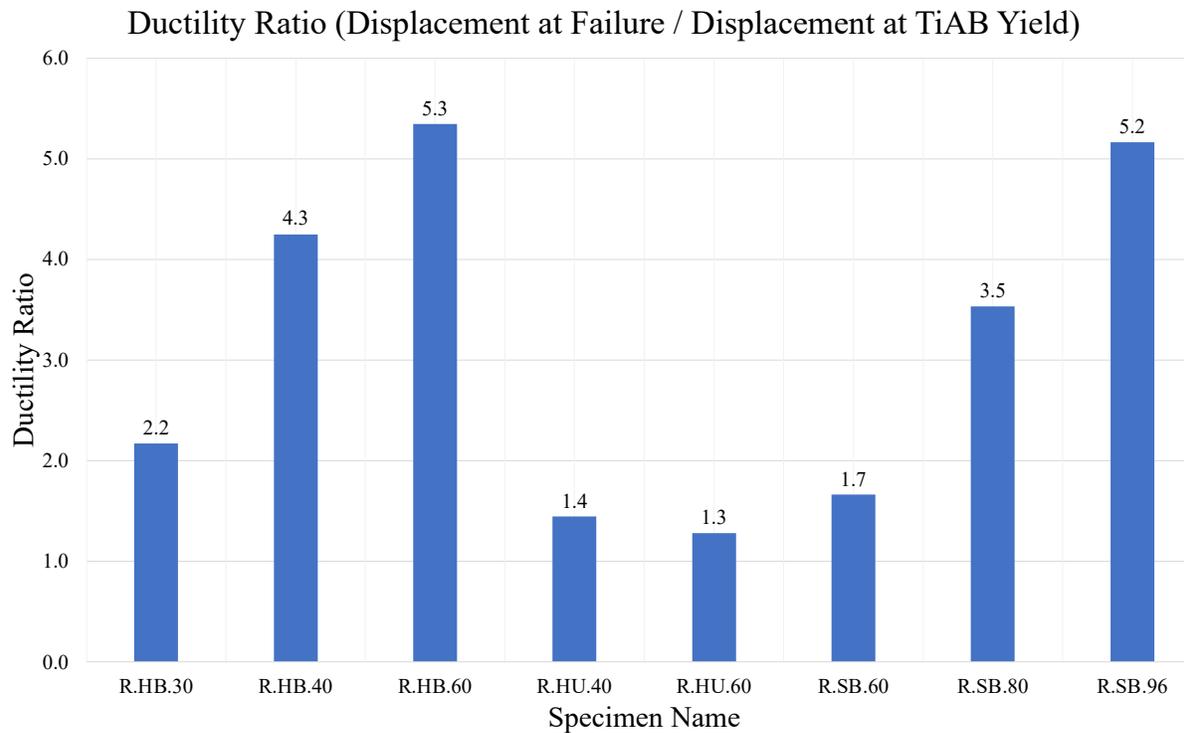
Figure 8.97 - Ductility Ratios using TiAB Yield
